DEMONSTRATION PROJECT: MITIGATION OF NON-POINT SOURCE IMPACT TO LITTORAL ZONE OF LAKE CARL BLACKWELL, PAYNE COUNTY, OKLAHOMA

FY-01 319(h) Task #01-003
CA # C9-996100-07 Project 3

Subtask 5.1.2 Bioengineering Demonstration
And
Subtask 5.1.3 Erosion Control Monitoring

September 2006

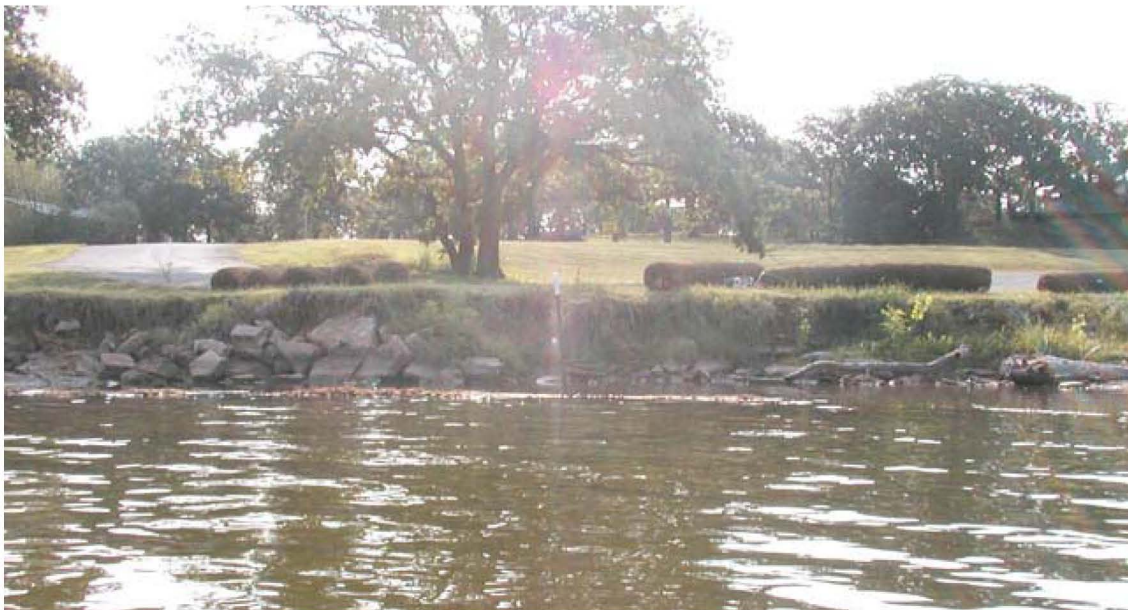
Figure 4: Site 3 (Transect 7) old concrete rip rap on bank. CGRs on shore

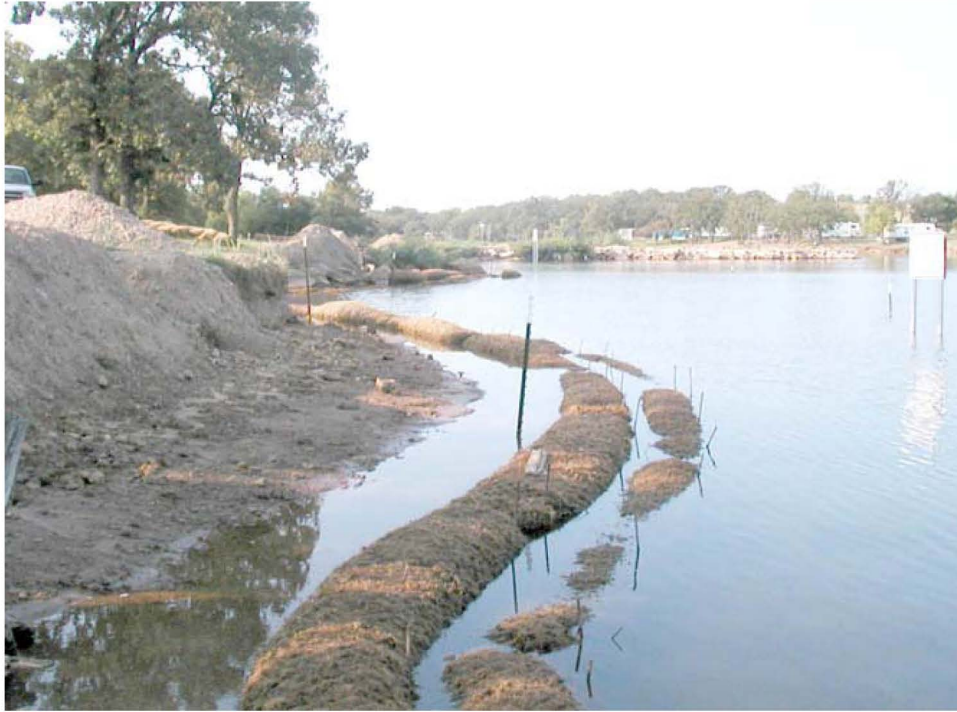
On June 28, 2005 the CGRs were initially set in place using 3/16" cabling tied down to rebar and wood stakes (Figure 5). CGRs were difficult to anchor in the substrate at site 3. This site had a combination of very hard clay sandstone bottom and soft unsettled sediment. In most instances, the stake either could not be driven sufficiently into the substrate or the substrate was too soft to hold the stake. After two unsuccessful attempts to stake the down the CGRs we purchased duckbill anchors on the advice of our consultant, AllEnvironment. These deep-cabled anchors used drive rods and beveled anchors that rotate 90° in the sediment when pulled taught. The CGR breakwater continued to wash out from persistent high water and waves. In some cases netting was torn from the anchors and the fiber spilled out. In other cases where the sediment was very soft the anchors themselves were pulled out.

Figure 5: Site 3 CGRs initially installed with rebars, later converted to duckbill anchors.

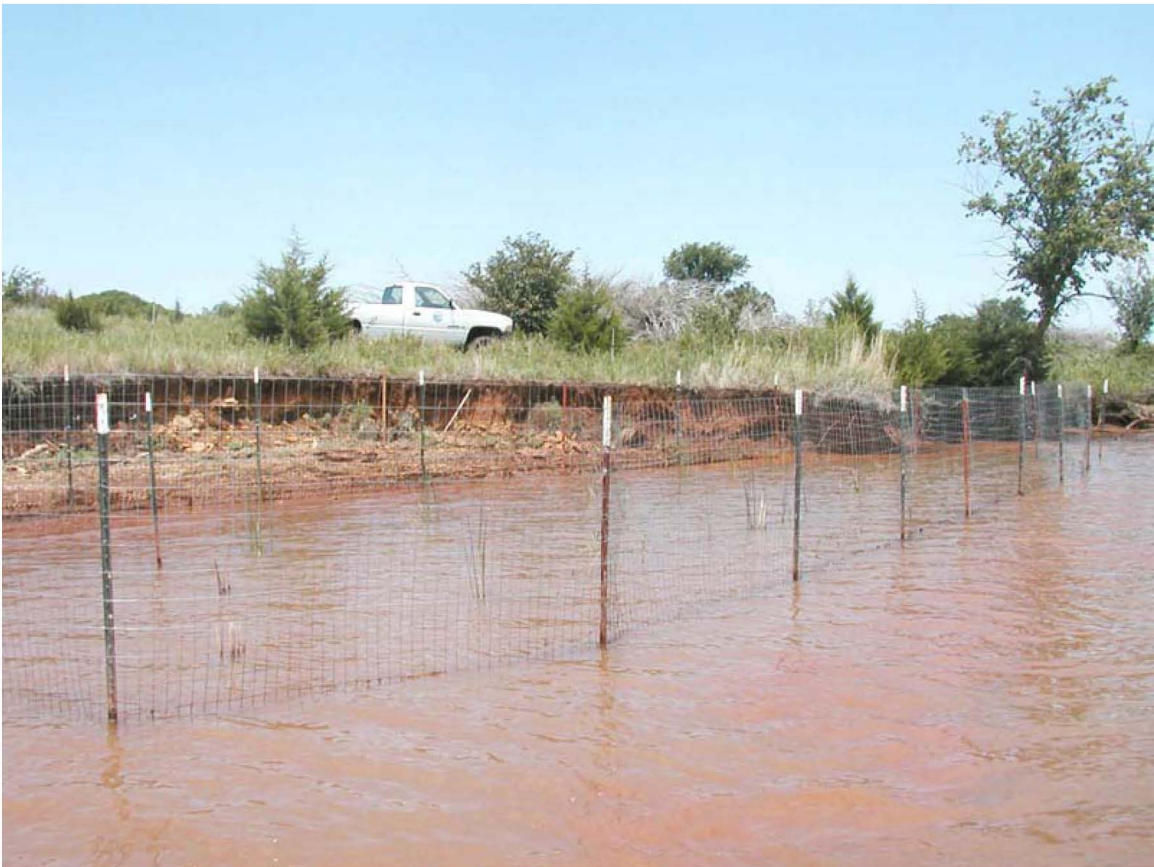
Planted fifty 6-inch pots of softstem bulrush in and constructed a 50' x 20' wire pen (Figure 14) to protect them from herbivory. The bulrush was planted in three rows and situated in front of an especially eroded portion of the bank. The expectation is that over time this pen will fill in completely and protect this area from further erosion. Observing the vigor of last year's caged bulrush from last year made it seem reasonable that 6-inch

Figure 14: Bulrush pen installed at Site 1

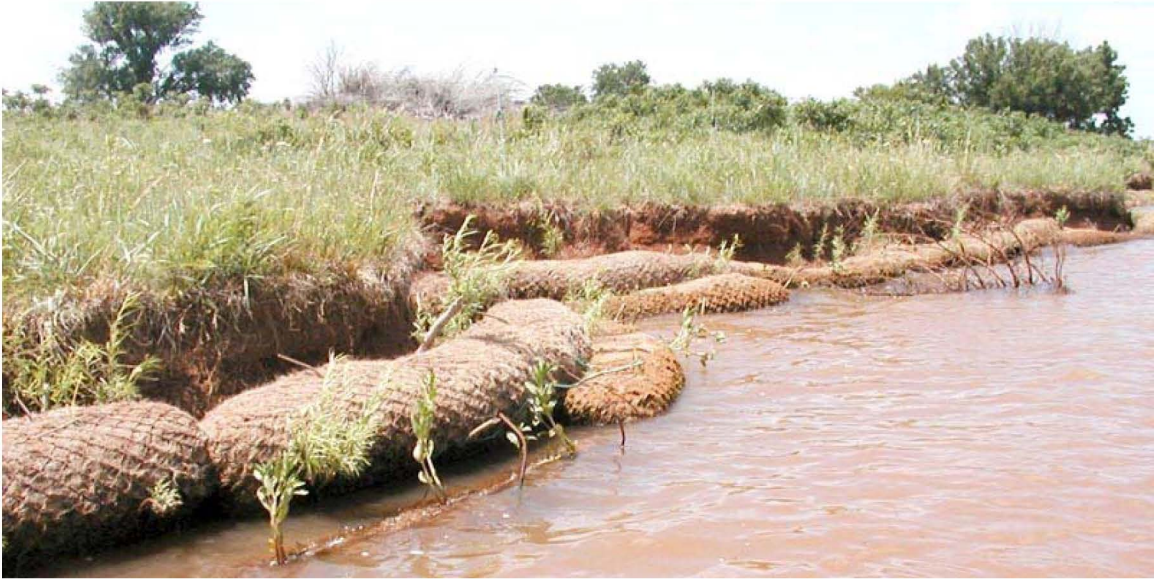
Survival of uncaged plants *in the water* at Site 1 was 0%. The only surviving uncaged plants were those up on the shore or planted into the escarpment. Plants on the upper shore *above the water line* or on the escarpment suffered neither wave action nor herbivory from rough fish and consequently had superior survival percentages. These plants are waterwillow, *Justicia americana*, and black willow, *Salix nigra*, plants in Table 2. In the table there are two waterwillow categories. The "waterwillow" category was planted throughout the site with the surviving 19 plants found on the shoreline of the site and not exposed to the waves or rough fish. "CGR waterwillow" as its name suggests were planted directly into the two CGR tiers and hence out of the water.

Figure 20: Survivors - black willow and waterwillow. Uncaged but out of water

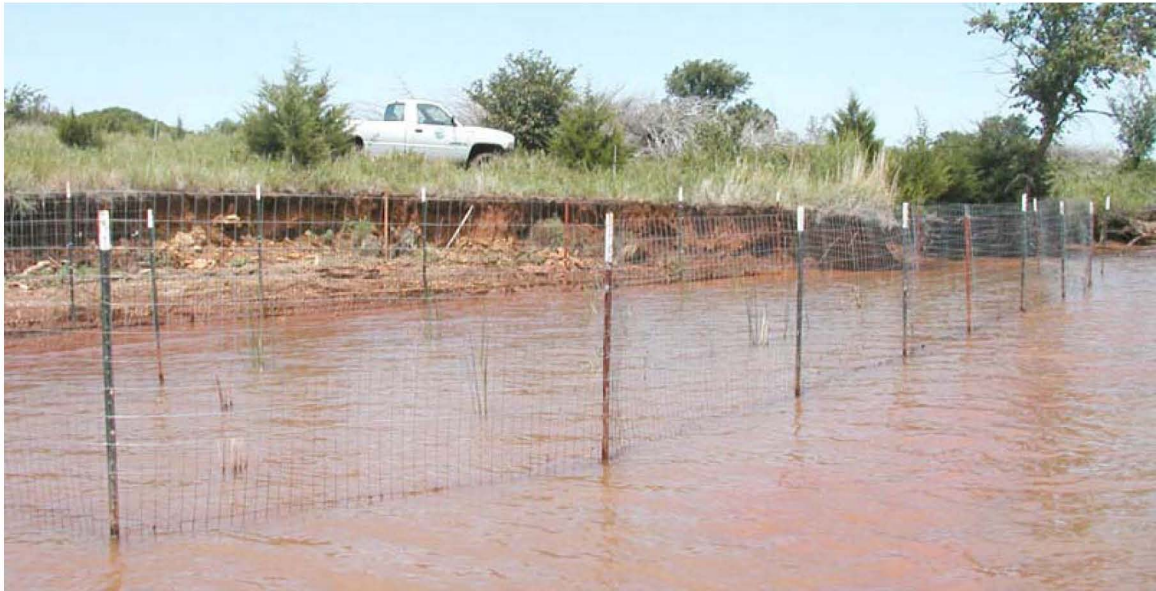
Noting the very healthy caged softstem bulrush already in place can survive well at this site an attempt was made to plant a large penned area (50'x20', Figure 22) directly in front of the worst eroded zone using vigorous 6" potted plants (see Section 5.3.7). This fast growing colonizer should grow into dense tall stands and fill the pen to perform an excellent shoreline buffer. This area was planted only 11 days before the final assessment, so it is too early to say with any certainty what these plants will achieve.

The initial results however were excellent showing 80% survival, new shoots and rhizomal spread.

Figure 22: Softstem bulrush pen

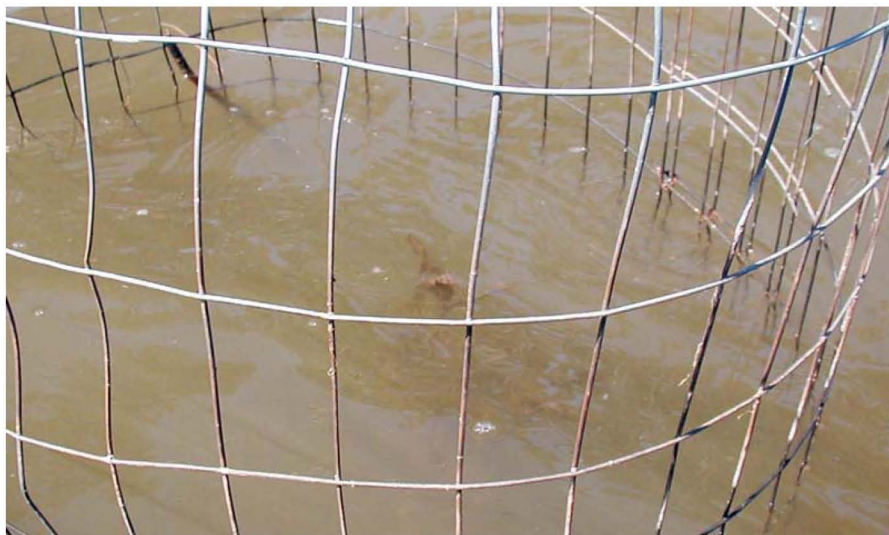
This site's poor plant survival, 1.4% overall, can be attributed to wave action since even the caged plants did not survive well. One cage of American pondweed did survive with expanded growth within the cage. The 50% coverage is credited as 2 plants out of the 7 planted for a survival of 28.6%. Six cages had been turned over during the spring with no surviving plants to be found. The remaining 6 cages were empty as well. Two individual waterwillow plants survived but did not send out rhizomes to make new plants. The breakwaters were not visibly effective at reducing the high-energy waves coming into the site. No further efforts were made to replant.

Figure 23: Potamogeton nodosus at Site 2

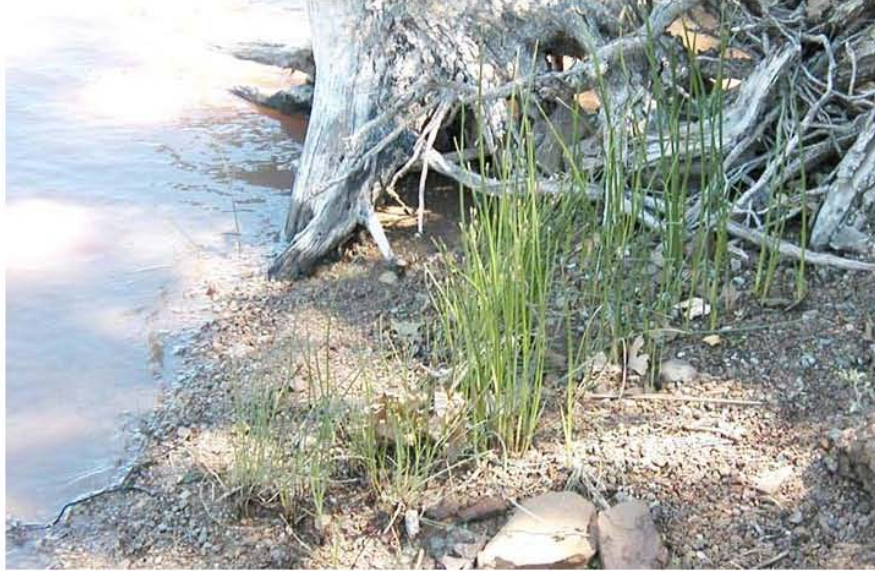
This site also had problems with herbivory and wave action. The only surviving plants were those out of the water or in a single cage protected further by its proximity to the north jetty. The surviving caged plants were American pondweed at 100% coverage. Surviving emergent plants were small clumps of squarestem spikerush, softstem bulrush and common bulrush found above the waterline and thus protected from wave action and aquatic herbivory. While this site was planted initially into and behind the CGR, the breakwater was unstable killing most of the site plants. The breakwater was eventually abandoned and CGRs moved to Site 1 to abut the bank there.

Figure 24: Spikerush and common bulrush above the waterline at Site 3

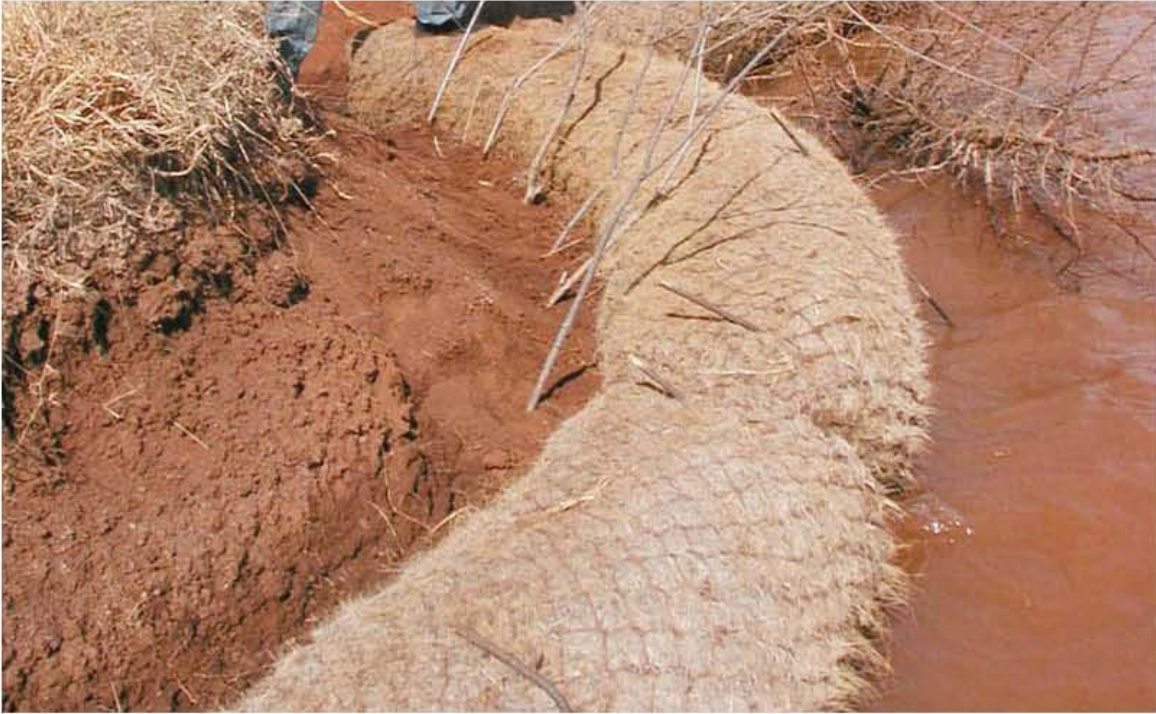
The CGRs against the escarpment however, are catching the eroded upland soils and demonstrate rapid backfilling. The CGRs in Figure 25 had been in place four months at the time of the photo. No initial measurements were taken nor was a system put in place to measure the backfilling rate or potential.

Figure 25: Erosion on escarpment backfilling CGRs

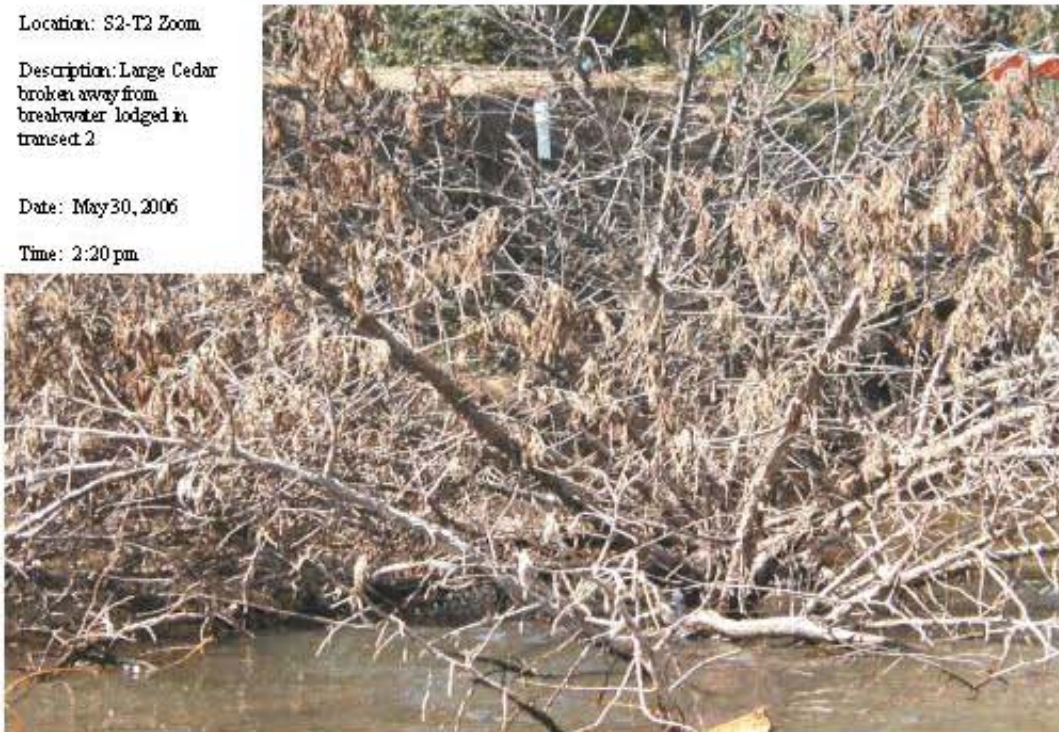
Site 2 Transect 2 Zoom

Description: Large Cedar
broken away from
breakwater lodged in
transect 2
