**AN INVESTIGATION OF
SOURCE OF GASOLINE
CONTAMINATION OF
WATER WELLS IN
RENFROW, OKLAHOMA**

OKLAHOMA WATER RESOURCES BOARD

March 1978

Publication #85

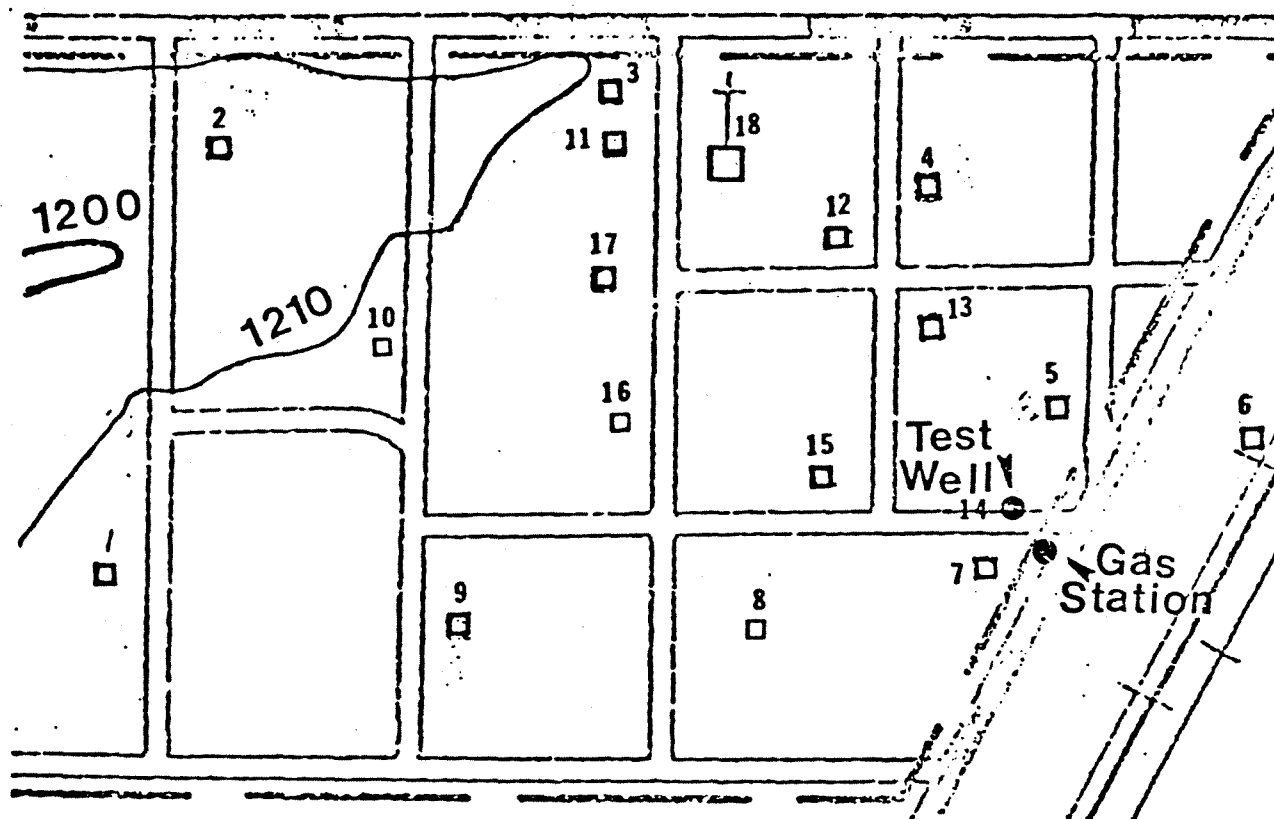
FIGURE 2

Location of Water Wells and Test Hole in Reference to the Gasoline Station in Renfrow, Oklahoma

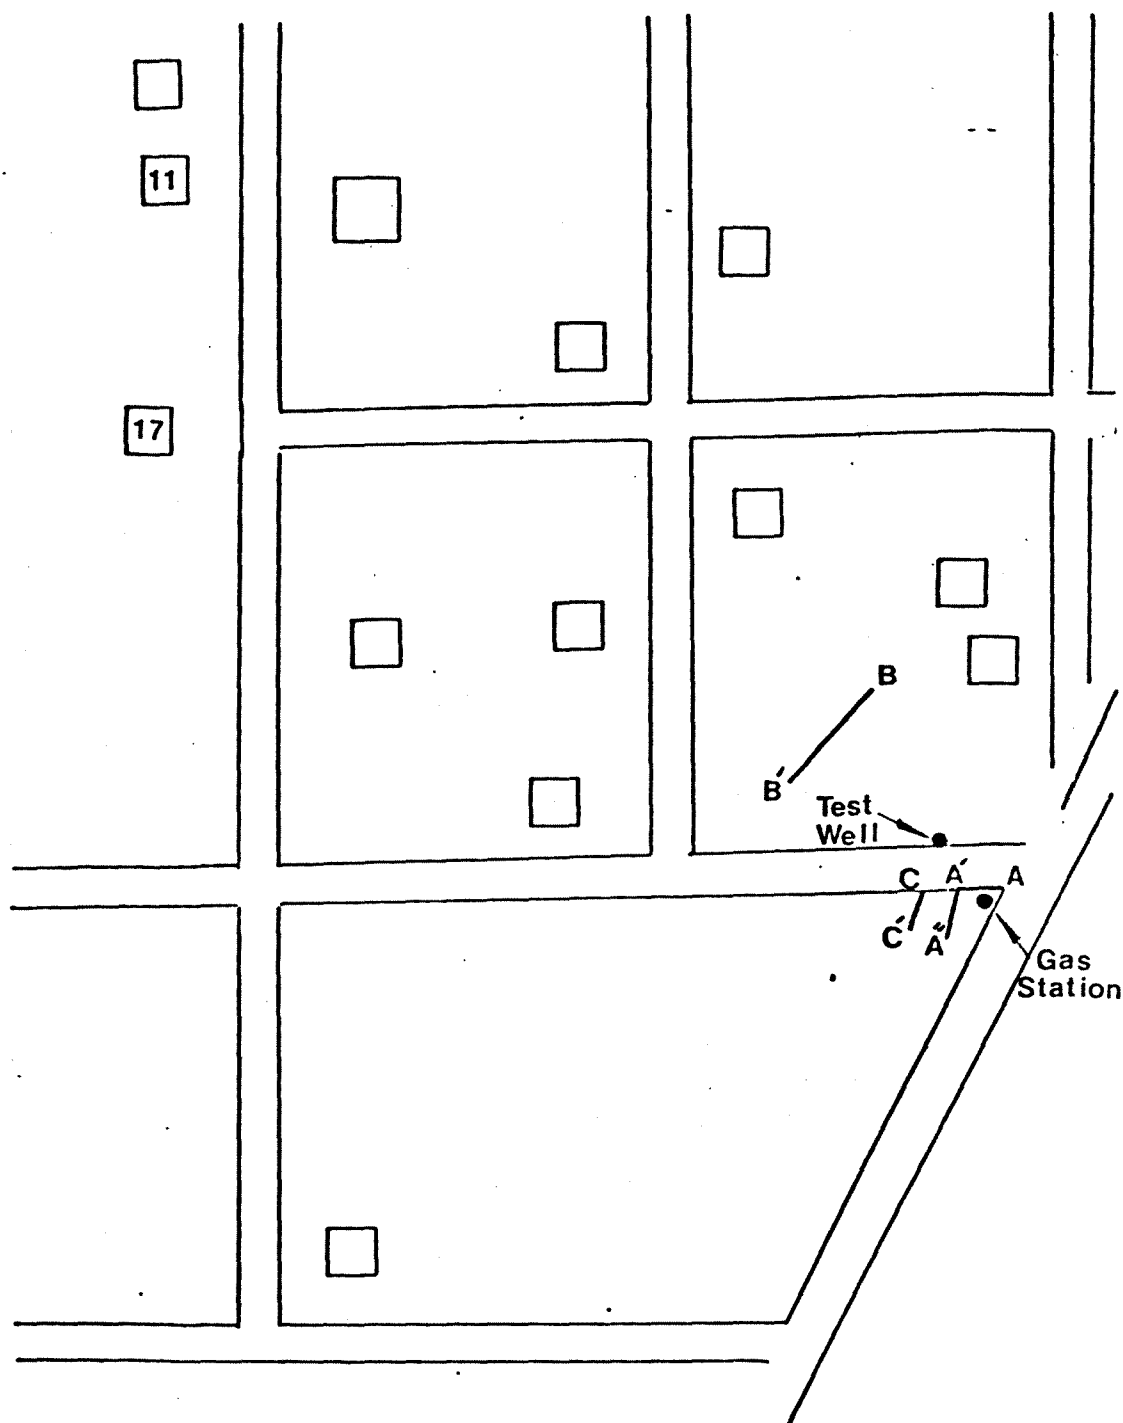
FIGURE 6

Location of the Investigation Trenches in
Relation to the Gas Station in Renfrow, Oklahoma

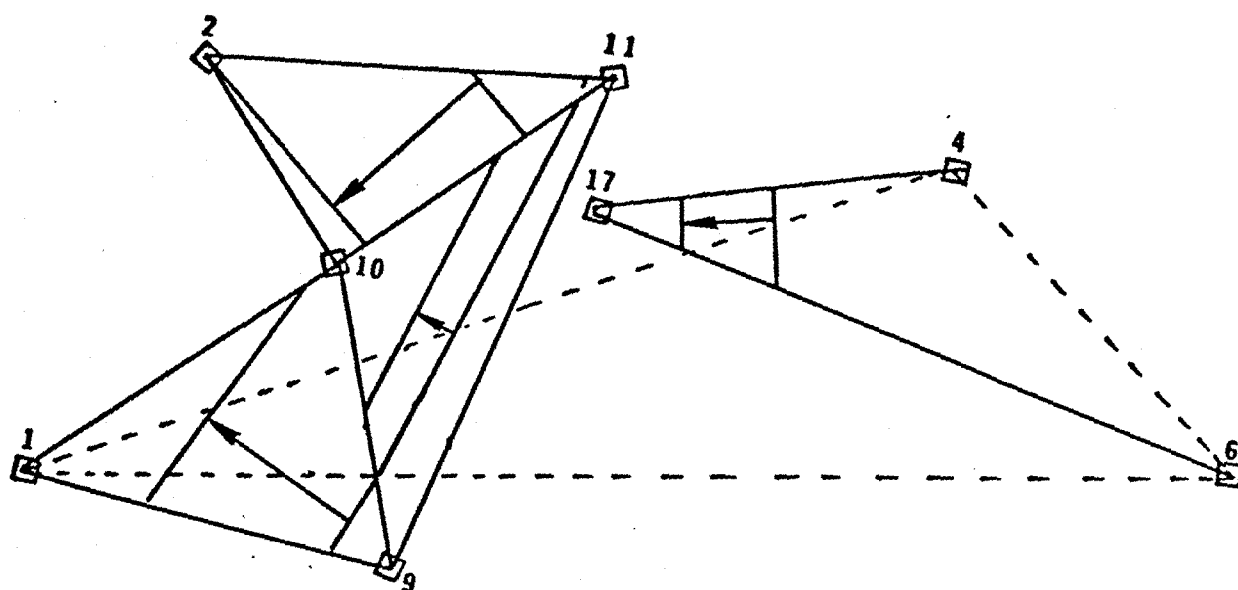
FIGURE 7
Ground Water Hydrological Profile Analysis Using
the Triangulation Technique (Todd, 1959) for
Equipotential Lines

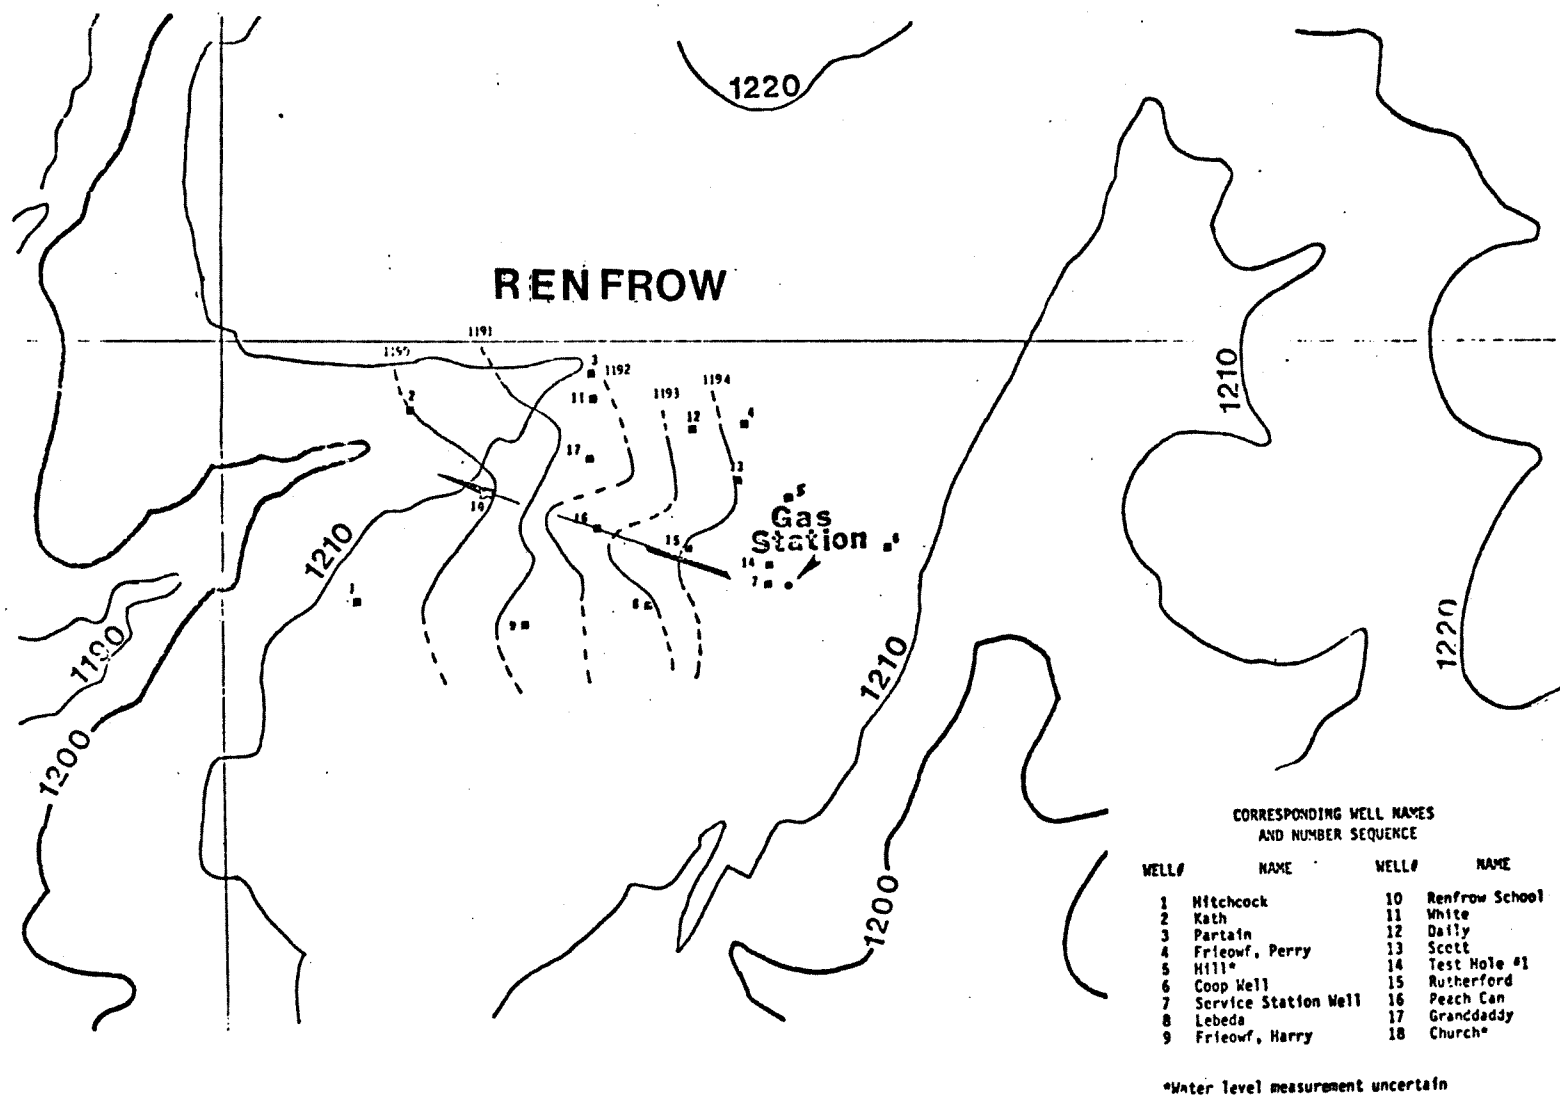
FIGURE 8

Ground Water Contours and the General Direction of the Slope of the Water Table in the Renfrow Area

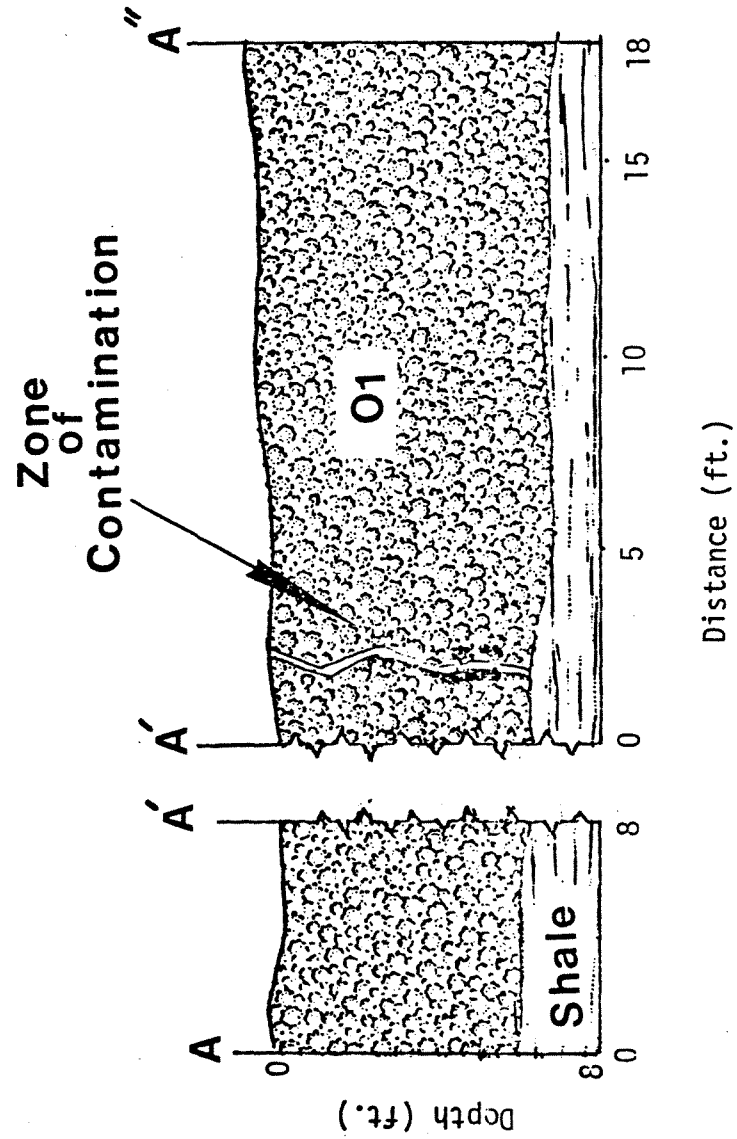
FIGURE 10
Cross-sectional Profile of the Investigation Trench A-A'-A'',
Showing the Distribution of Shale and Clay

<u>Depth (ft.)</u>	<u>Description</u>
0 -1	medium hard to hard, dark colored weathered granular silty clay with occassional roots.
1 -2	medium hard to hard, dark colored silty clay with visible cracks.
2 -3	hard, blocky, plastic silty clay with occasional concretions
3 -4	hard, dark colored plastic silty clay with strong smell of gasoline
4 -5	dark colored plastic silty clay with strong smell of gasoline
5 -6	dark colored plastic silty clay with strong smell of gasoline
6 -7	hard, light brown colored silty clay, presence of lime concretions and smell of gasoline.
7 -8	reddish brown plastic silty clay with mild smell of gasoline

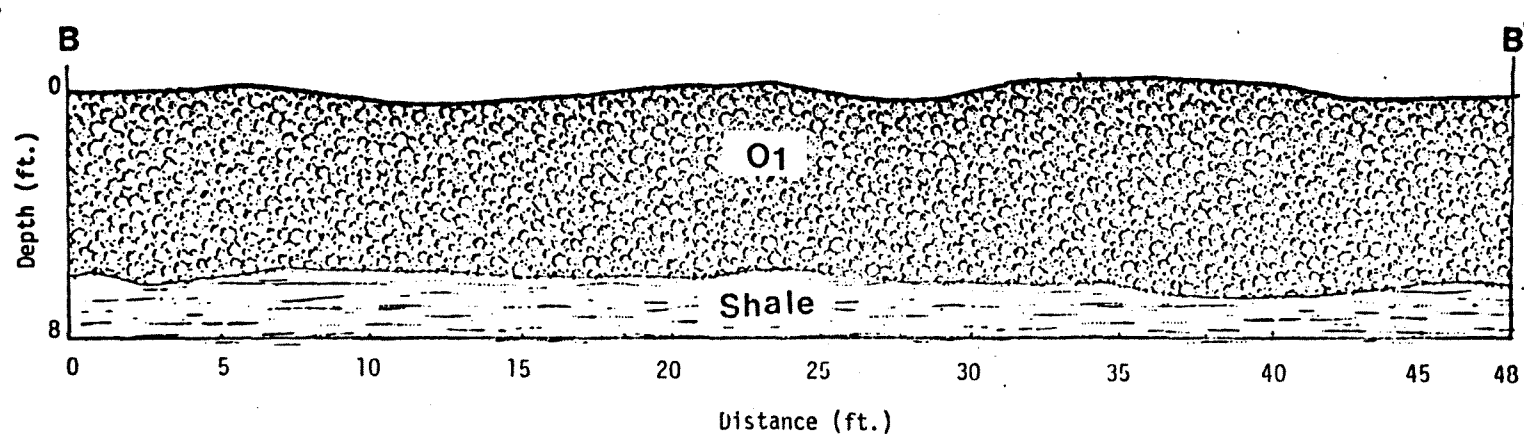
FIGURE 11

Cross-sectional Profile of the Investigation Trench B-B',
Showing the Distribution of Shale and Clay

Depth (ft.)	<u>Description</u>
0 -1	medium hard to hard, dark colored highly weathered grannular silty clay with occasional presence of roots
1 -2	medium hard to hard, dark colored tight silty clay with some fractures.
2 -3	medium hard, blocky structure, dark colored silty clay with some lime concretion and fractures.
3 -4	medium hard, dark silty clay grading to brown silty clay
4 -5	light brown, medium hard silty clay
5 -6	reddish brown, medium hard silty clay with some concretion
6 -8	reddish brown, medium hard silty clay

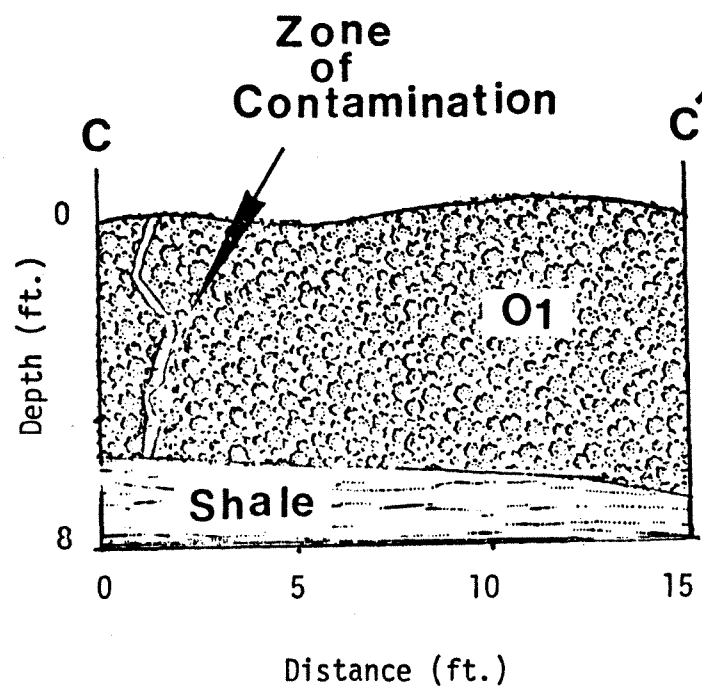
FIGURE 12

The trench C-C' is illustrated in Figure 12. The trench was logged, and the soil samples were collected from the zone of contamination (see Table 8).

An examination of the soil profile at the zone of contamination indicated that in both cases the top soil (Oswego silty clay) was fractured. The presence of fractures of as much as $1\frac{1}{2}$ inches in width in Oswego silty clay were documented by Goke, 1933. It appears that the gasoline traveled through the cracks horizontally and vertically before establishing a gasoline-water interface. The movement of the gasoline was therefore dictated more by the pattern of the cracks and not by the hydraulic gradient. It is safe to assume that the gasoline might have traveled quite rapidly through the cracks, but since most crack patterns are extremely tortuous, the total distance traveled by the gasoline may be considerably more than the distance between two points. Therefore, the apparent time lag of several years between the span of leakage and detection of the gasoline is not considered unusual.

Cross-sectional Profile of the Investigation Trench C-C',
Showing the Zone of Gasoline Contamination

<u>Depth (ft.)</u>	<u>Description</u>
0 -1	medium hard to hard, dark colored, highly weathered silty clay.
1 -2	medium hard to hard, dark colored silty clay, with visible cracks and lime concretions.
2 -3	medium hard, dark colored silty clay with occasional fractures.
3 -4	medium hard, dark colored silty clay with strong smell of gasoline.
4 -5	light brown, medium hard silty clay with smell of gasoline
5 -6	reddish brown, medium hard silty clay with smell of gasoline.
6 -7	reddish brown, medium hard silty clay with lime concretion and mild smell of gasoline.
