FINAL REPORT

Creation of a Vegetated Wetland Throughout The Littoral Zone of Lake Stanley Draper

Agency: Oklahoma Water Resources Board (OWRB)

Location: Lake Stanley Draper, WBID OK520810000130_00,
HUC 11090203

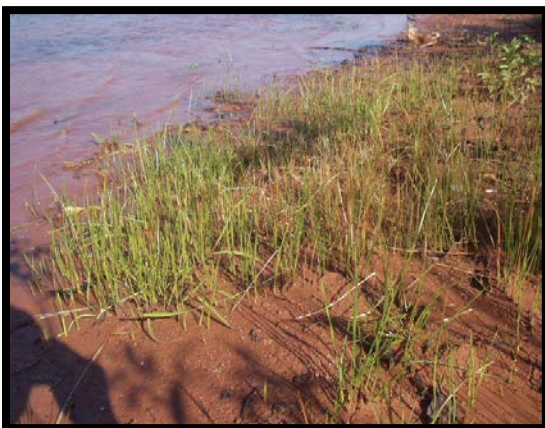
Figure 2: Existing stand of *Eleocharis* spp.

The lake has many well-protected coves with easy access by boat or by truck. The substrate is generally sandy clay. There are intermittent existing colonies or individuals of aquatic macrophytes. Some of these likely come from Lake Atoka, namely *Juncus effuses*, *Cephalanthus occidentalis* and *Eleocharis spp.* Other current resident plant species are listed in the Baseline Assessment in Appendix A. The first summer of the project in 2006 the conditions were correct to promote submersed plant growth. Hence the lake had small littoral populations of various species of *Juncus*, *Eleocharis*, *Schoenoplectus*, and *Potamogeton* (Figure 2 and Figure 3).

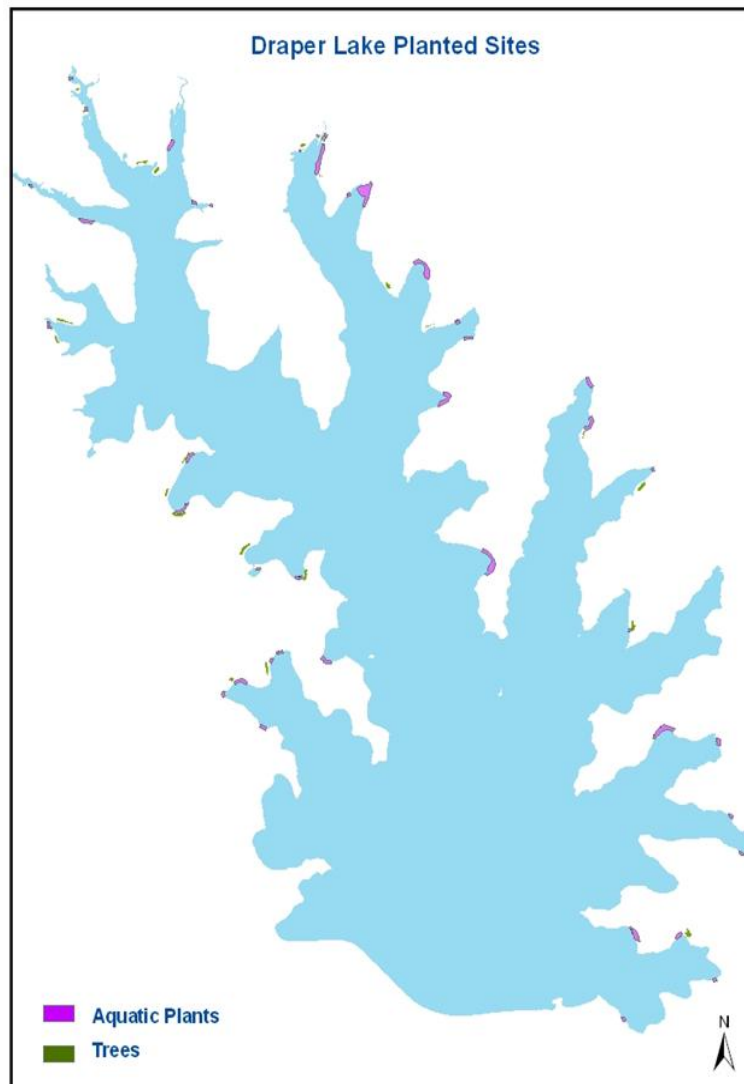
Figure 4: Planted sites of Lake Stanley Draper

Outcome: Thirty-three sub-sites (Figure 4) were planted with 2,930 plants and 28 species over three seasons (Maps of each planted site can be found in Appendix C – Site Maps).

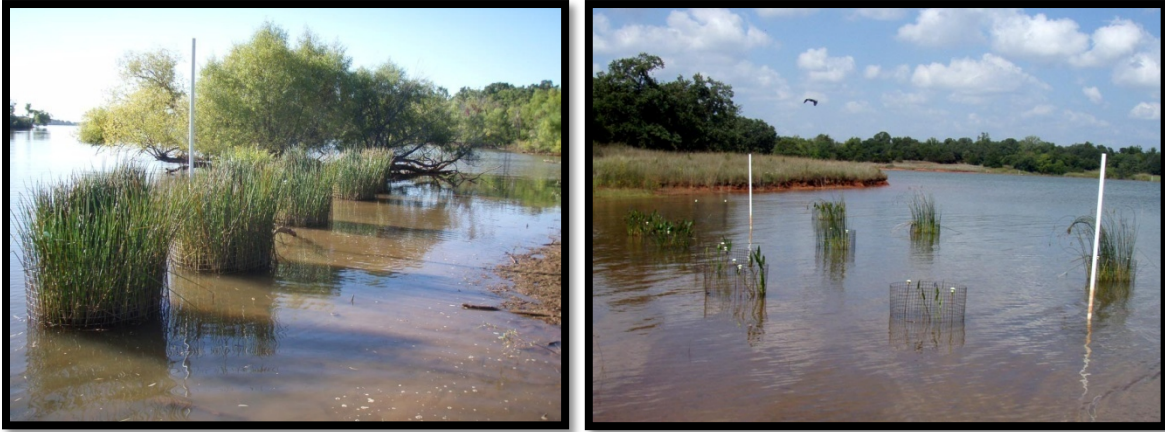
As of the 2008 fall assessment the lake had 392 cages of viable plants. Caged plantings are those plants put inside a plastic-coated wire mesh to protect them from herbivores. These cages were usually 4 feet in diameter and ranged from 3 ft. for higher plantings to 5 ft. in height for deeper plantings (Figure 5). Upper elevation plantings used a 2"x4" mesh that is sufficient to control terrestrial grazers. Deeper plantings used a 2"x 2" mesh to filter out small turtles and fish. Tops were constructed for very deep plantings of submersed plants where cages were expected to be overtopped most of the time.

Figure 5: Site 7 *Eleocharis quadrangulata* fills cages; Site 3a: typical caged site.

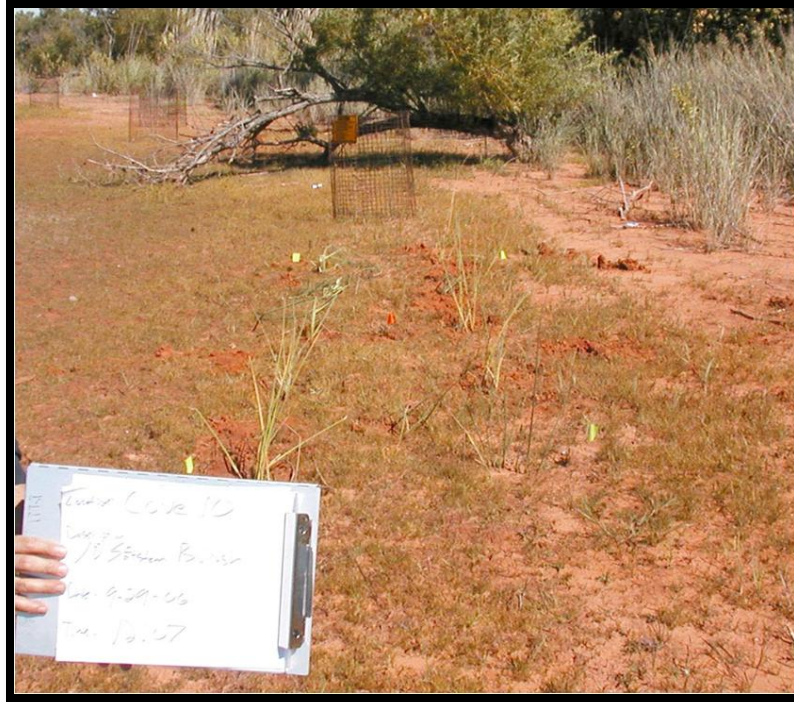
Over the first season, 2006, 127 uncaged plots (1,160 plants) were set up in a roughly 10'x10' square plot of 9 to 16 plants (Figure 6). These plots were done with the numerous 2" plugs of sedges and rushes as well as bare root water-willow transplants from Lake Thunderbird. These plots, in general, looked healthy and grew well in the exposed mud.

Figure 6: Typical uncaged plot of Softstem bulrush delineated by the yellow flags

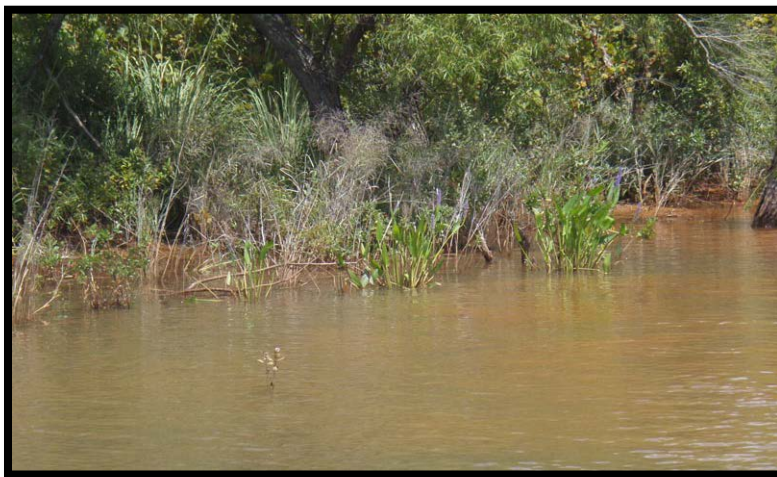
Figure 7: Uncaged planting of *Pontederia cordata* after one year

With more plants available than caging material, 231 new uncaged plants were planted in cove's 10, 17, and 23 in September 2007. Plots were planted with help from Oklahoma City and ODWC. Lake levels rose again to cover these uncaged plots. While these plantings were not included in the overall assessment numbers these plots were visited from time to time. Most of these plants were lost; however, one cove had healthy *Pontederia cordata* growing a year later in September 2008 (Figure 7).

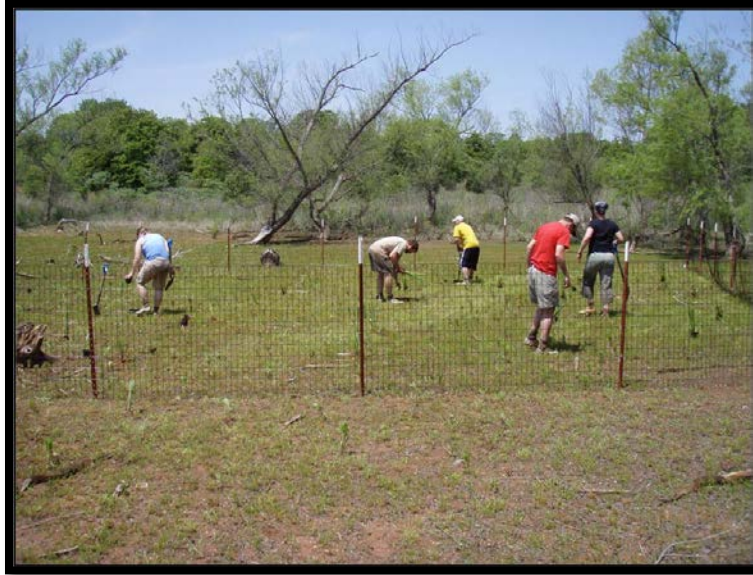
Seven pen plantings were put in place in 2007. These were the most successful and diverse communities in the project (see Results). In a fifty-foot by fifty-foot (50'x 50') pen (Figure 8), plant populations and their seeds, can multiply beyond ring cage plantings by one or two orders of magnitude. The pen methodology was incorporated in the second season after witnessing the vast plant densities observed in the Grand Lake plantings in the 2006 season.

Figure 8: Construction and planting of a new pen in May, 2007

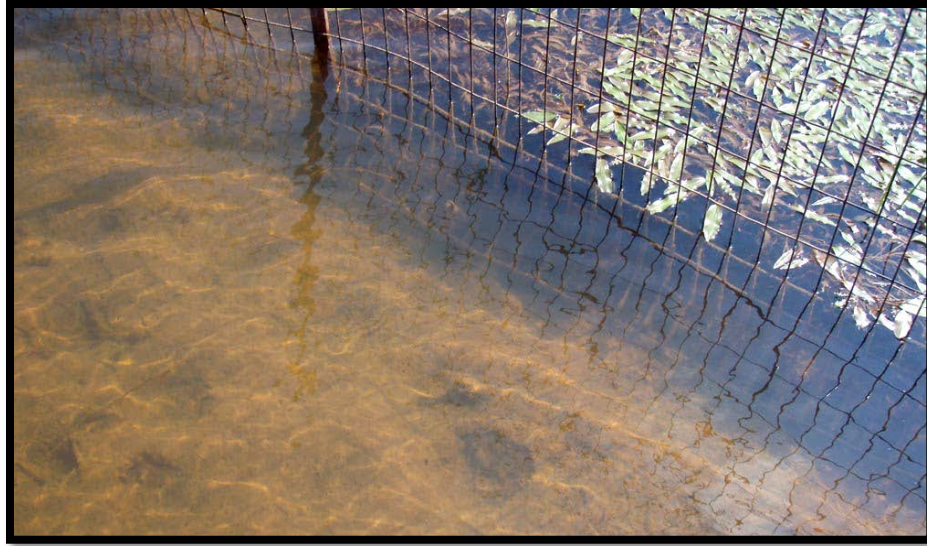
Diverse plant communities can develop as well as habitat for younger age classes of fishes. While not caught on camera, project staff witnessed on multiple occasions young fish darting in and out of the 2"x 4" mesh pens as staff approached. Figure 9 does not show the young fish yet deftly illuminates the outstanding multiple levels of habitat and protection these pens can create.

Figure 9: A canopy of *Potamogeton nodosus* and wire mesh provide outstanding cover for young age-class fishes

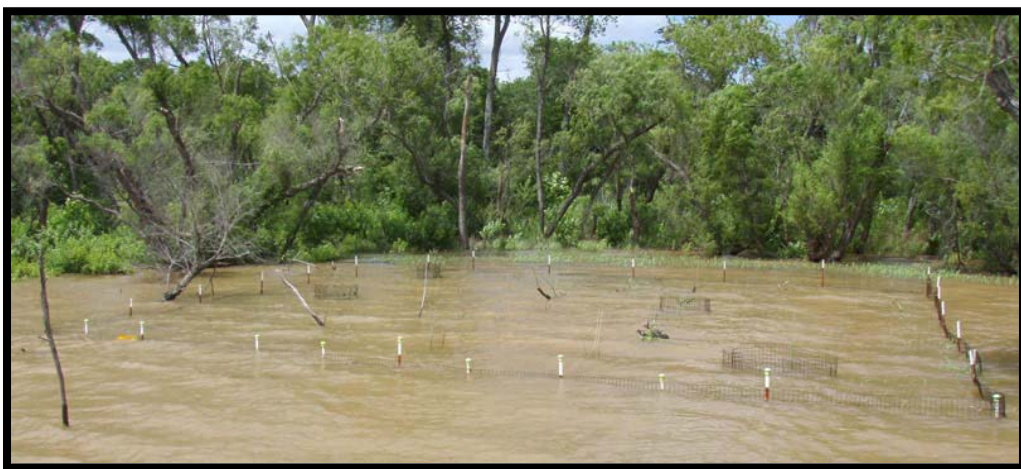
Figure 10: Pen - 11; July 18, 2007

In general, the pens did as expected; creating a mixed community of aquatic macrophytes. The caged and uncaged plants generally spread well, filling both their ring cages and the pen (Figure 10 & Figure 11). These pens also illustrated the magnitude of herbivory pressure in the unprotected waters as these protected plots quickly sprouted with numerous submersed plants, presumably introduced to the lake well prior to this project. These were, by and large, composed of several species of *Potamogeton* and *Naiad* (Figure 12). Based on these results, we concluded that Draper has a good seed bank in place for these species and when protection is provided, they germinate and fill cages and pens in many parts of the lake.

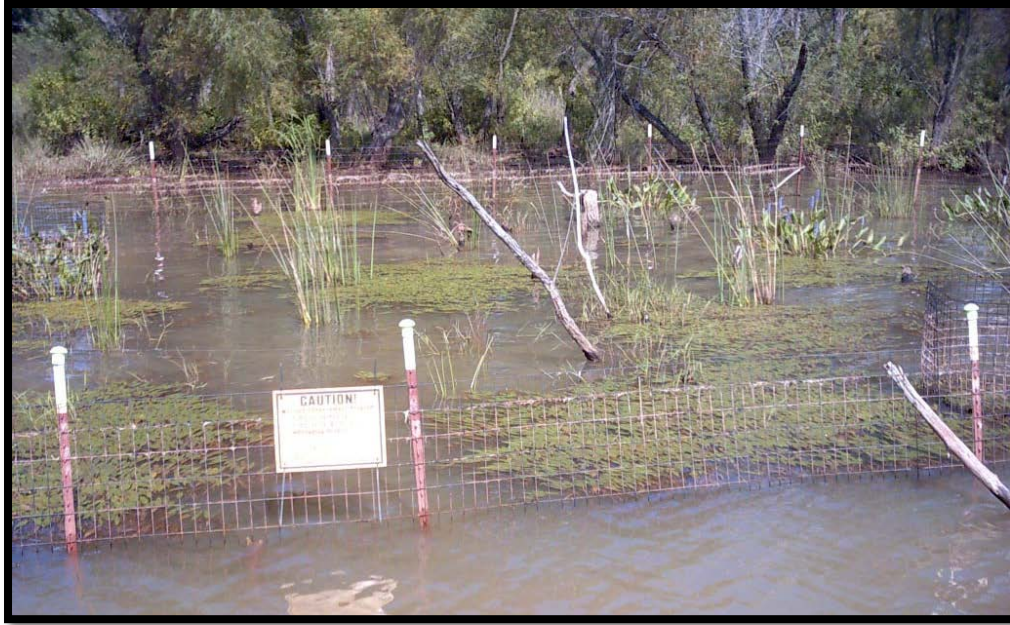
Figure 11: Pen 11 - 2 months later; September 21, 2007. Developed community of *P. nodosus*, *S. tabernaemontani*, *P. cordata*, *S. graminea*, *Chara*, *N. guadalupensis* and other species.

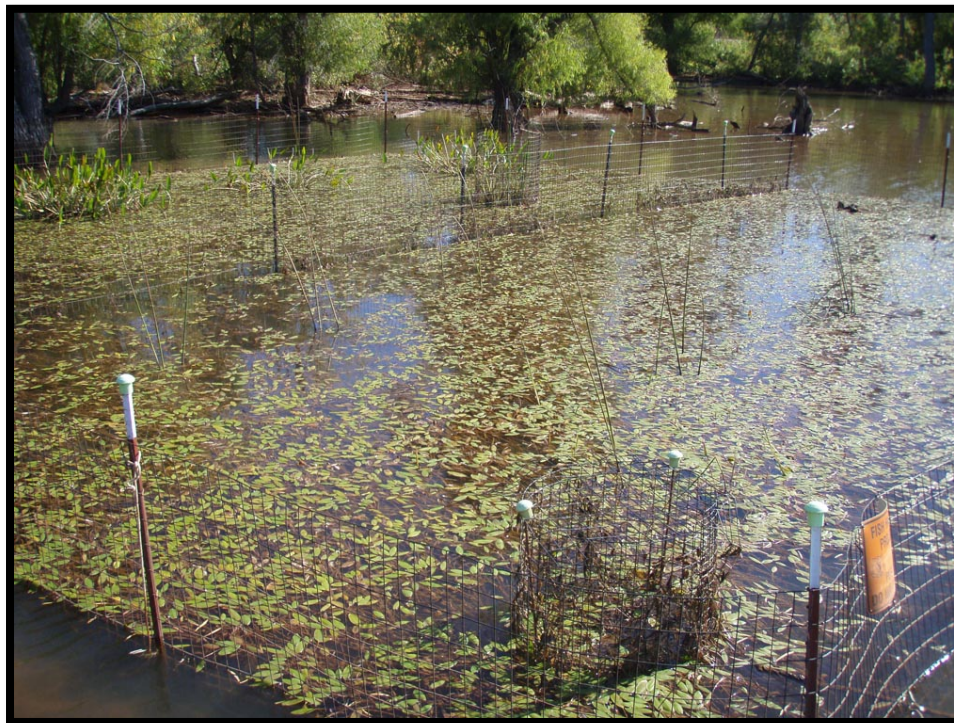
Figure 12: Dense submersed community of Potamogeton species and Naiad. Pen 10, September 2008.

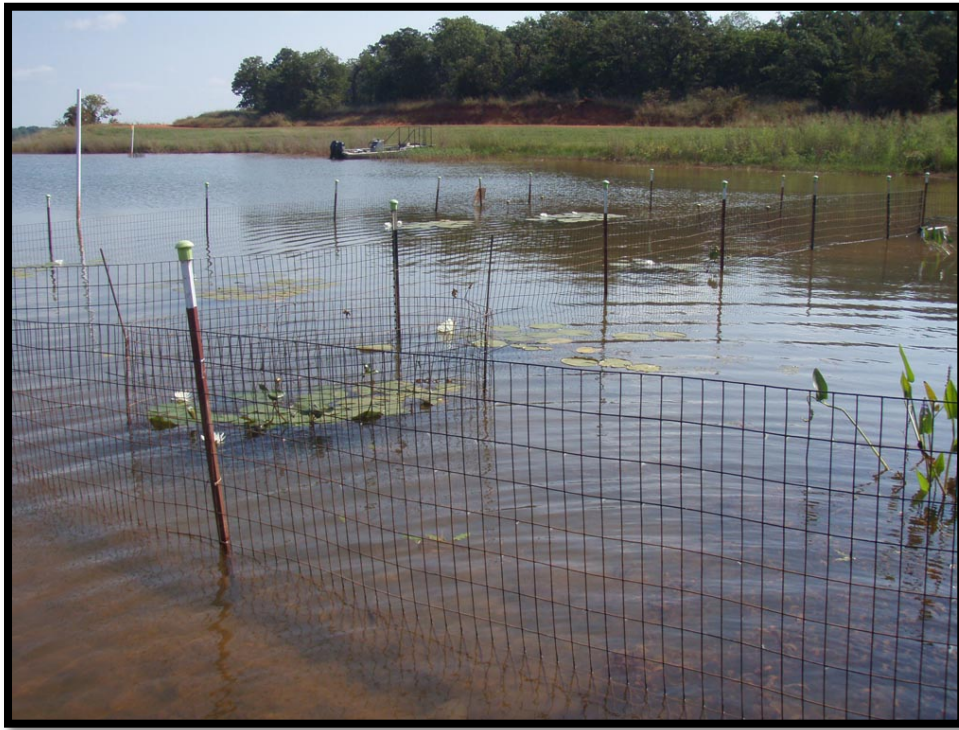
Figure 13: Pen at Cove 4, September 16, 2008

Not all pens were as densely populated. Pens 4, 16, and 23 had fewer plants, see Figure 13, usually with *N. odorata*, *P. cordata*, and *S. graminea* being the dominant plants. The noticeable distinction for these sites was their substrates tended to be sandier and less organic.

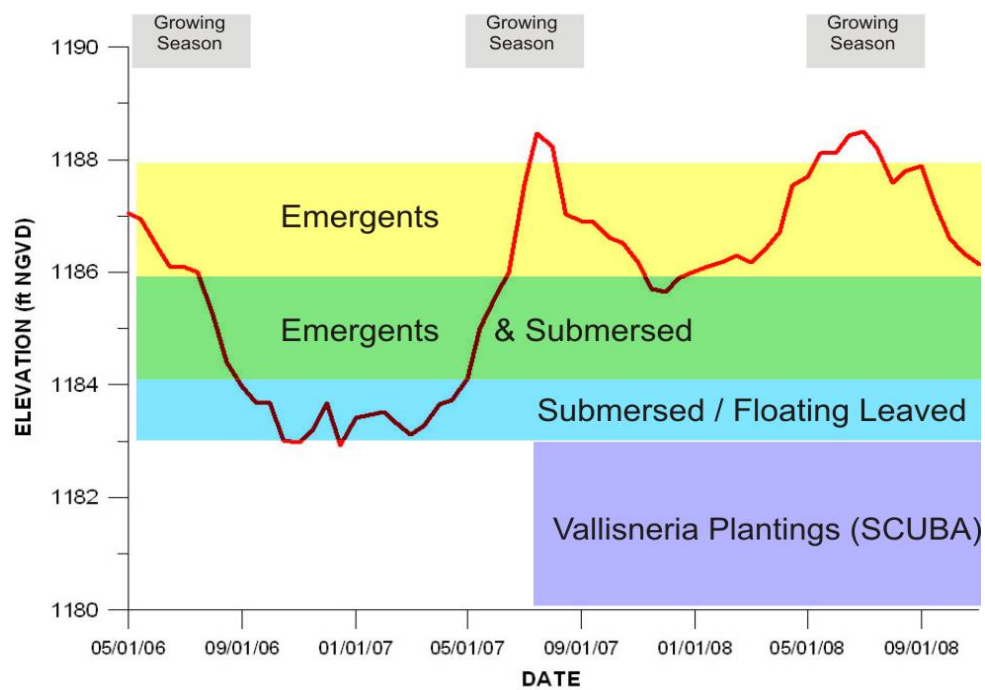
Figure 15: Graph of Planting Regimes as Related to Lake Elevations

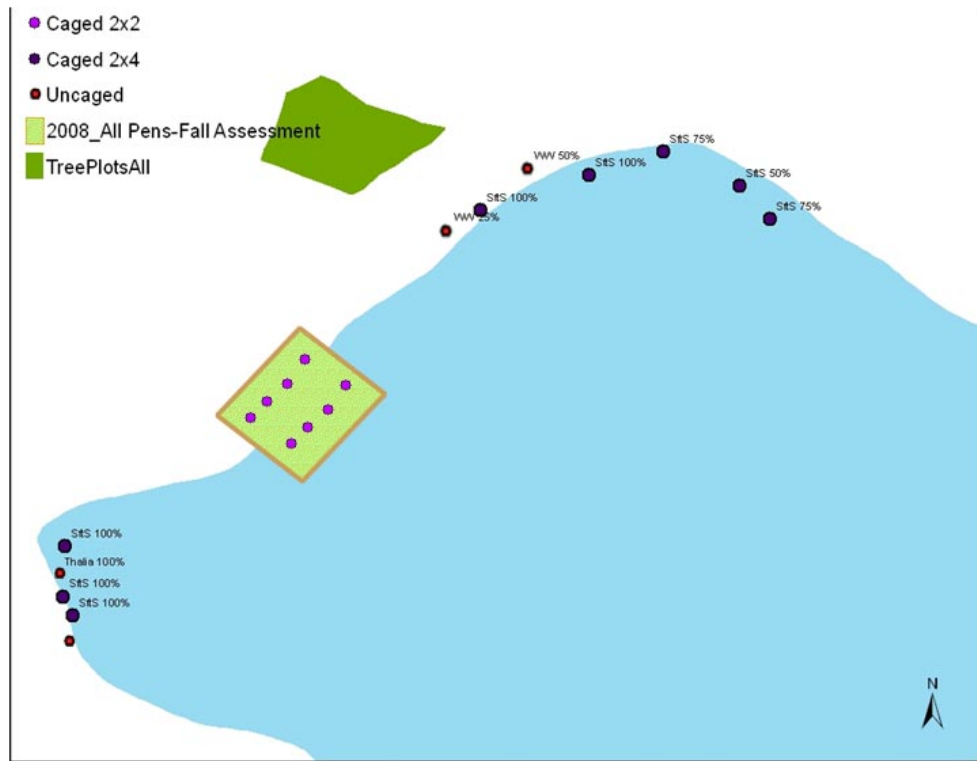
By the second season many of the sites were transformed to have fewer deep cages or uncaged sites. This was also the time that pens were added (Figure 16). The expectation was that the plants had a better chance of surviving the upper elevations and eventual drought conditions than lower elevations where they may be inundated for longer periods of time. Deep waters can lead to plants expending their energy on elongation rather than expansive growth. Therefore plantings were moved to higher ground.

Figure 16: Typical site layout in 2007 with fewer deep cages or uncaged plots. Pens were added in 2007 as well.

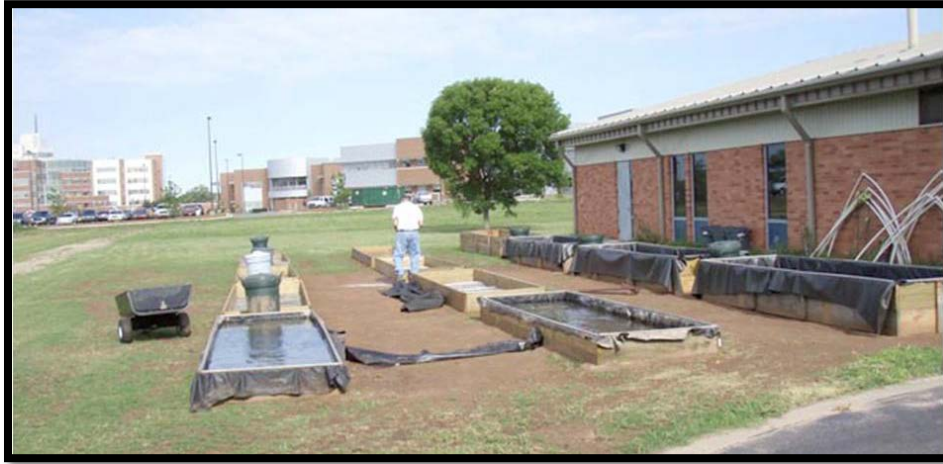
Many of the project plants came from the aquatic plant nursery at the Oklahoma Department of Wildlife Conservation (ODWC). Using the ODWC design, OWRB staff doubled capacity by adding 6 new ponds to their existing 6 ponds (Figure 19). Staff transferred propagules from local

Figure 19: Aquatic plant nursery expansion construction at ODWC Fisheries Lab in Norman, OK

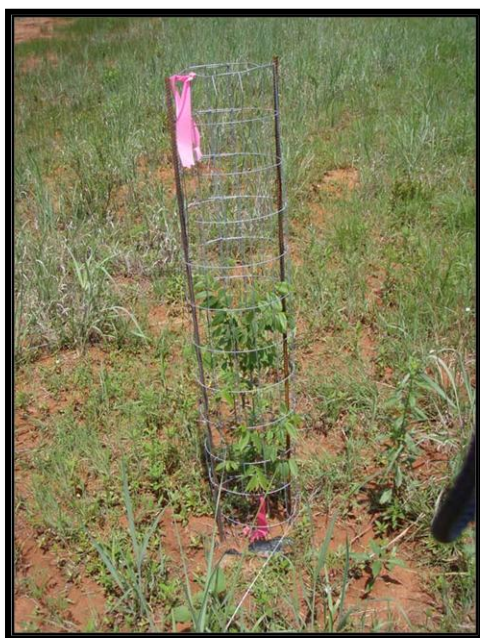
Trees were planted with assistance from Oklahoma City, First Step Center, and Boy Scout Troop 211. Bare-root seedlings from the Oklahoma Forest Regeneration Center in Goldsby, Oklahoma were used for this portion of the project (Figure 20). Approximately 10 trees were caged per site with 2x4 welded wire and flagged for visibility (Figure 21). These cages were placed mostly on the perimeter trees to delineate the site boundary for our use and to help those mowing the areas. The caged seedlings were the only ones to be assessed, this was in part because finding the small seedlings once the tall grasses have grown around them is so time consuming even with flagging. The first summer, there were communication gaps between OWRB staff and the lake grounds crew resulting in several of the trees sites getting mowed down. This was rectified through further discussions with the city and replanting those sites the next winter. Cages were flagged better to insure their visibility. Post-project visits in 2009 have shown that grounds crews have continued to avoid the tree plots during their mowing.

Figure 21: Caged tree seedling at ~ 6 months

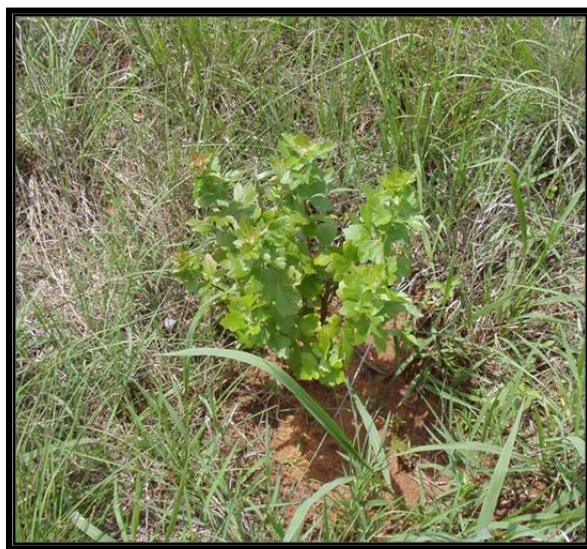
Figure 22: Uncaged tree seedling

Tree plantings were designed, where possible, to compliment the aquatic plantings by providing wildlife habitat species, many of which could be classified as bottomland hardwoods such as Pecan (*Carya illinoensis*) and Sycamore (*Platanus occidentalis*). These tree plots would provide exceptional browse, nesting and cover for multiple species (Figure 22).

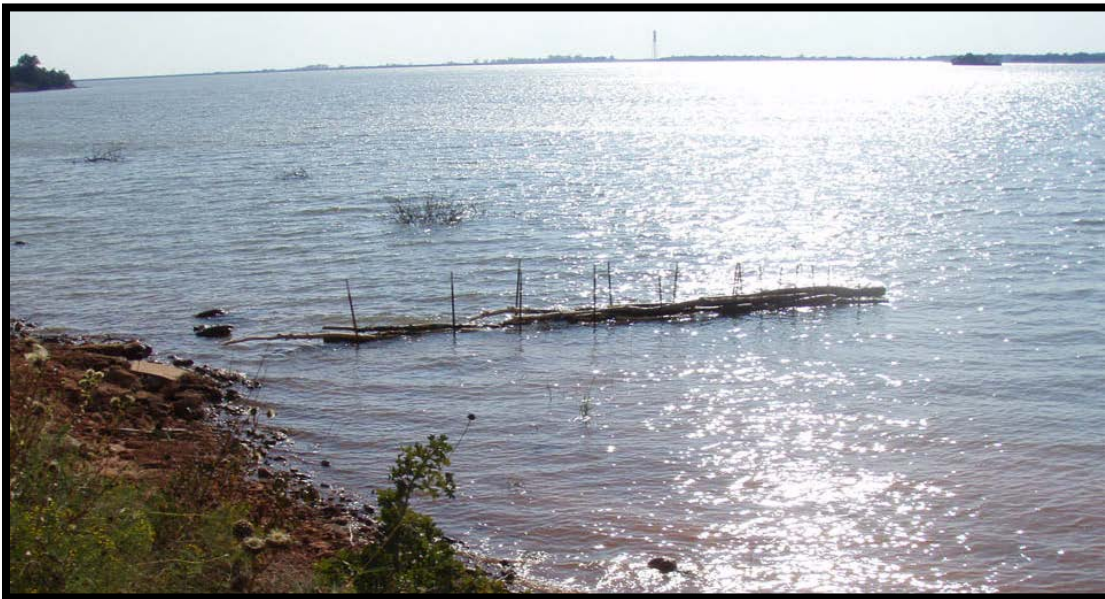
Figure 24: Completed breakwater

There were large waves the day of construction. While it could be seen that the breakwater visibly dampened the wave energy it did not reduce it as much as hoped. This site was planted with 23 plants; four plants were caged. The lake remained very high and thus planting had to be done in one to three feet of water where wave action might still be significant. None of the plants survived behind the breakwater in 2008. Since no evidence of the plants were found at all it is plausible to assume they washed out. Beavers were also another problem for the breakwater. Beavers found and damaged some of the logs on the first night after construction. The damage was primarily on the upper end of the logs that were in the shallows and had no significant effect overall.

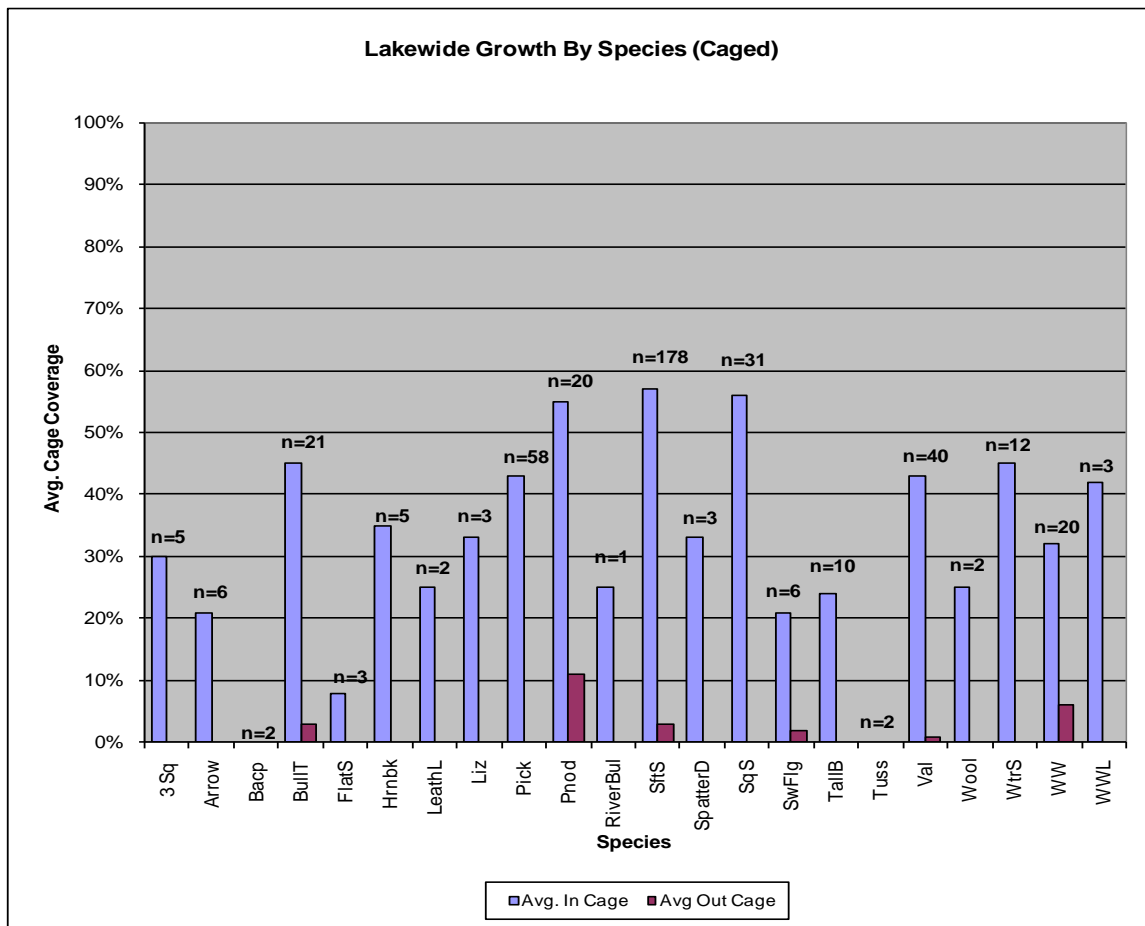
celery (*Vallisneria americana*). Some species did not survive at all, namely Tussock sedge (*Carex stricta*), Bacopa (*Bacopa monnieri*), and woolgrass (*Scirpus cyperinus*; not on graph).

* Numbers above each bar indicates the number of cages in the sample set. Some sample sets may prove too small to be substantive.

Figure 25: Lake-wide Cage Coverage by Species (Caged)

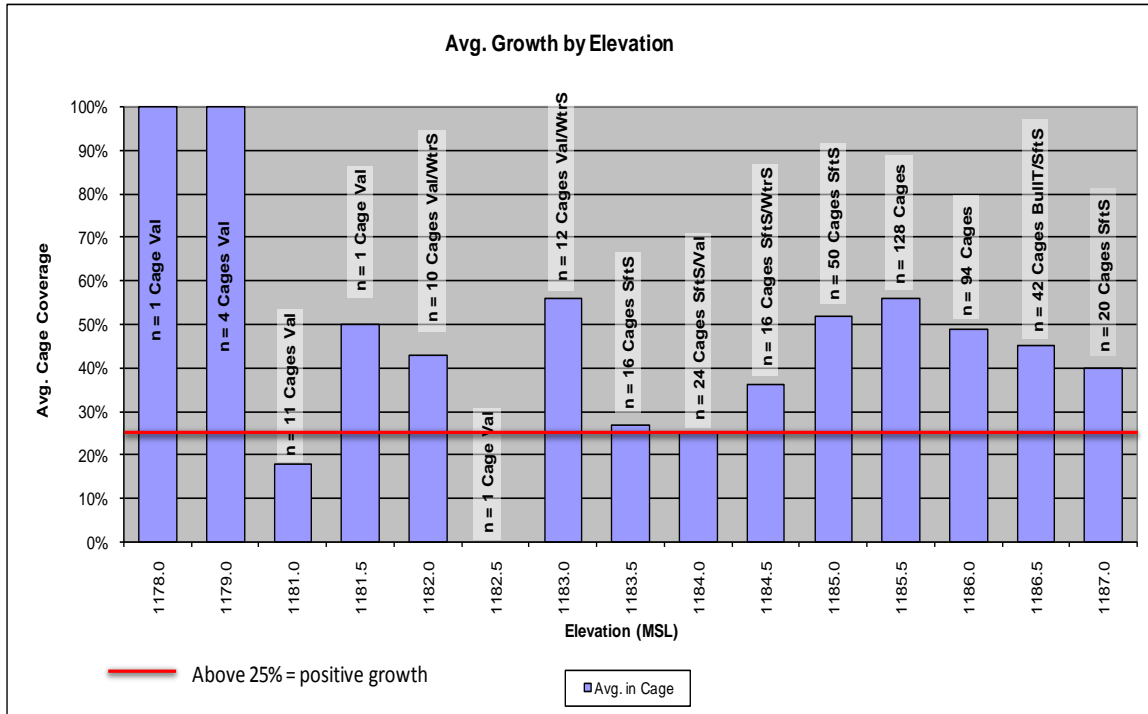
* Numbers on or above each bar indicates the number of cages in the sample set and the predominant species at that elevation. Some sample sets may prove too small to be substantive.

Figure 26: Average Growth by Elevation

Elevations below 1184' MSL are generally from one site, Cove 11, where deep water submersed plantings were held. A vast majority of the project cages are between 1184' and 1187'. Since the plantings are designated at 25% initially it would seem that elevations with an average growth near or below 25% are displaying only nominal growth. Plantings at elevations $\geq 1185'$ showed average coverages $\geq 40\%$. The deep water cages seemed to do very well overall with 100% coverage even in the deepest cage. The data suggests that this lake's clarity can support deepwater plantings for submersed plants which circumvent problems from common annual fluctuations. The 11 cages at 1181' did the poorest at $< 20\%$. This result was due to 2 empty cages from the 2007 planting. The remaining cages at this elevation were planted in 2008 and were quite healthy. The mortality may likely be due to some factor(s) other than elevation given there are multiple successes both above and below them. All cages above 1187' died in earlier seasons and does not appear to be a valid planting elevation for this lake. Results further indicate that emergent plants should not be planted below 1185' (Figure 26).

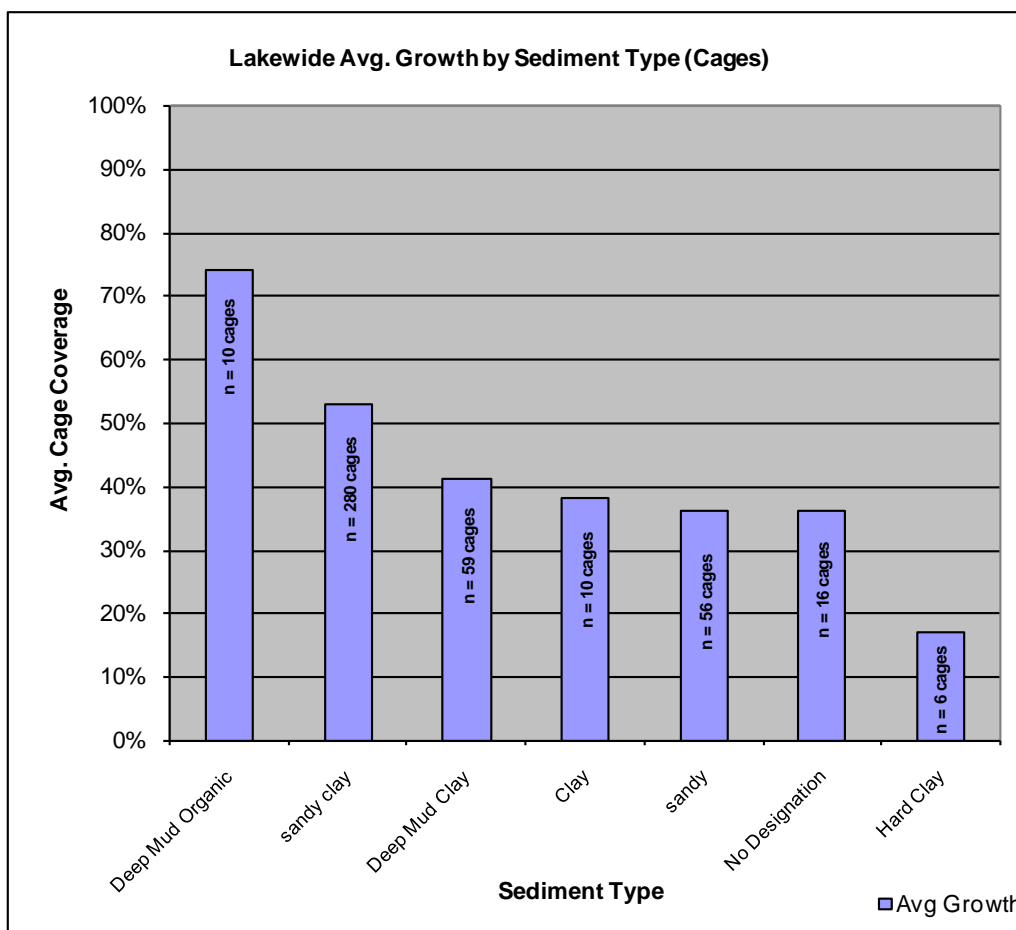
* Numbers on each bar indicates the number of cages in the sample set. Some sample sets may prove too small to be substantive.

Figure 27: Average Growth by Sediment

Sediment type was another factor for consideration. The highest cage coverage percentage with the *Deep Mud Organic* type is 74% (Figure 27). An organic substrate is uncommon however at this lake. *Sandy-Clay* is the by far the most common substrate found. Serendipitously, this is also a very productive substrate with an average coverage of 53%. *Hard clay* had the lowest productivity at 17%. It is an uncommon substrate in Draper Lake.

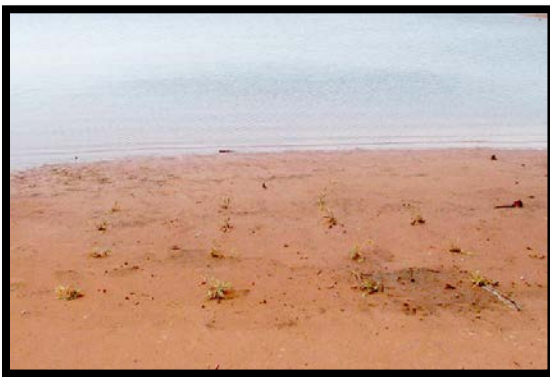
In year one of the project 129 unprotected plots (Figure 28) were sprigged lake-wide with 1,164 plants. These plots had acceptable results for the first season (Table 9). Most of these plantings were uprooted by herbivores apart from four sites: two sites of *Justicia americana*, one site of *Schoenoplectus tabernaemontani* and one site of *Thalia dealbata*. Photo-monitoring for uncaged plots for the fall were typically bare patches of water. With the poor results of uncaged sites uncaged plantings were discontinued.

Figure 28: Uncaged plot of *Justicia americana*

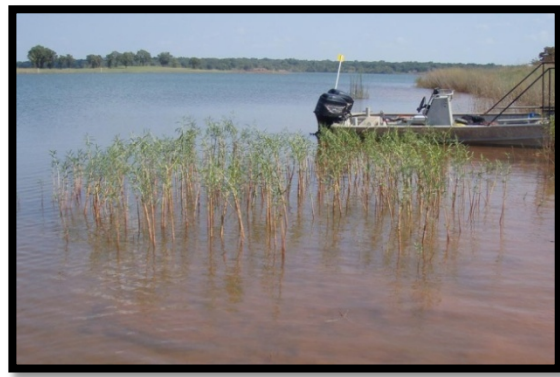
Over the 2008 season, the remaining 2 of 16 uncaged plots of *Justicia americana* did extremely well with a coverage inside and outside of the plot of 100% (Figure 29). *T. dealbata* only had one plant and yet also multiplied considerably (Figure 30). In addition, while the *S. tabernaemontani* remained within its original plot it was dense and appeared well established. In Table 10 the results are based on the change from the initial 2006 plantings to their state as of the final assessment in the fall of 2008. From that table, it is obvious that for most species the uncaged method is a dismal failure. However, considering only the successful plantings the average coverage inside the plot is 58.3%. This substantial percentage is worth looking into further. Table 11 looks at the percent survival of only the remaining species. Of these *J. americana* at 12.5% is notable because it is so easy to propagate. *T. dealbata* at 100%, while a considerable percentage, is limited in scope because it had only one sample in the set. Nonetheless, this plant certainly merits further trials.

Figure 29: Similar plot at project end.

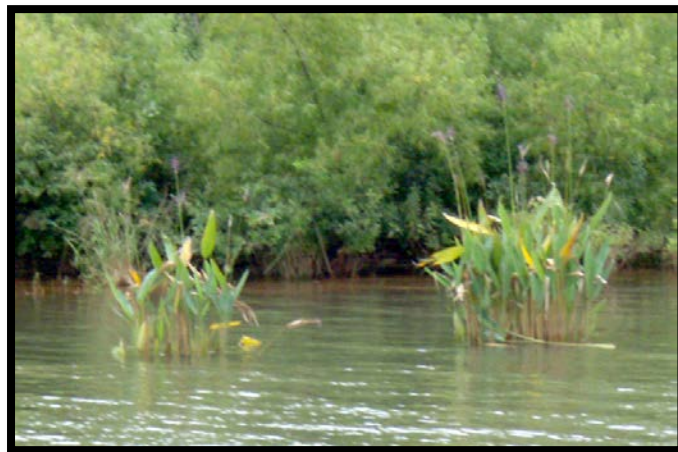
Figure 30: Uncaged plot of *Thalia dealbata*

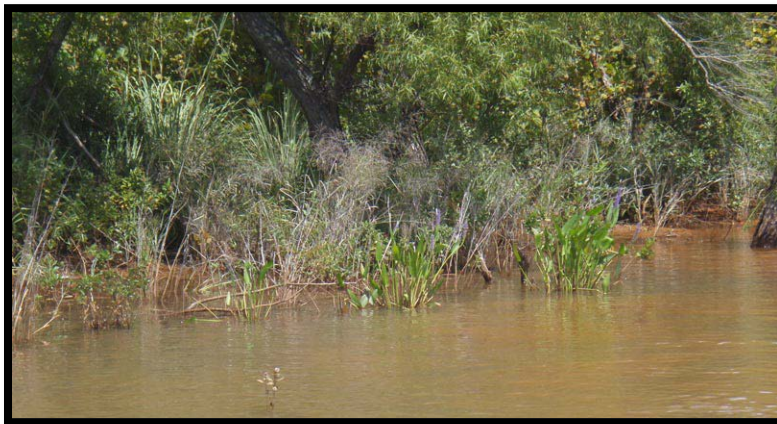
Another uncaged planting that survived but was not mapped or logged by GPS was a plot of *Pontederia cordata* from a planting done in September of 2007. While not assessed and given a percentage it is worth noting that *P. cordata* is viable for uncaged plantings in the upper pool elevations. Its results can be seen in Figure 31.

Figure 31: Unprotected planting of *Pontederia cordata* after one year

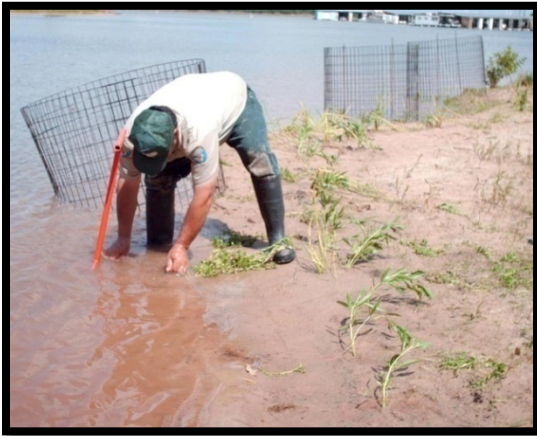
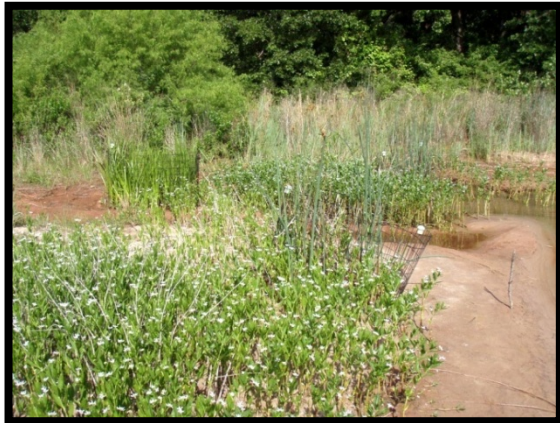
Maintenance site visits in 2009 (post-project) for OKC have exceeded expectations and warrant mention in this report: Some *J. americana* plots were planted in May, 2006 as seen in Figure 32 only to perform marginally well for the 2007 & 2008 seasons. However, the 2009 season has provided a slowly dropping pool, exposing the sediment and allowing for rapid spread and full establishment of *J. americana* at some sites. Draper had no water-willow in its system prior to this project. As a result of the *J. americana* colony in Figure 29, the final recommendations were to plant more *J. americana* during the subsequent maintenance phase. Multiple plots were planted in July of 2009.

Figure 32: Planting *J. americana*; east, May, 2006 Same site of *J. americana* looking west; June, 2009

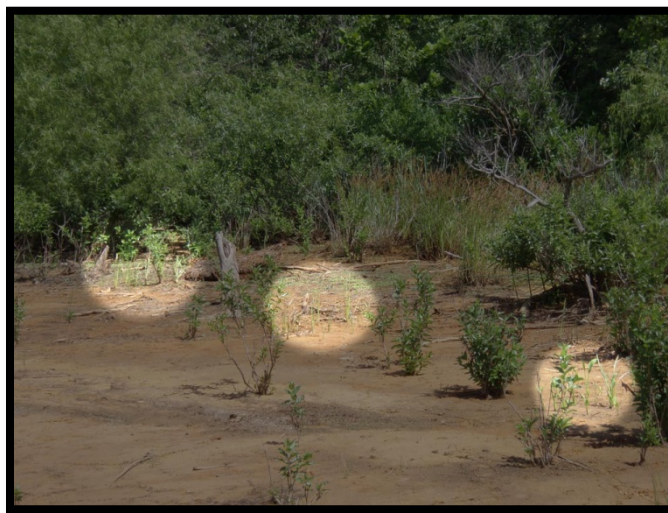
S. graminea was also found in July, 2009 growing on its own, independent of cage protection (Figure 33). These plants are extremely interesting because they are likely to be the successful result of sexual reproduction by project plants.

Figure 33: *S. graminea* propagules spreading along shoreline

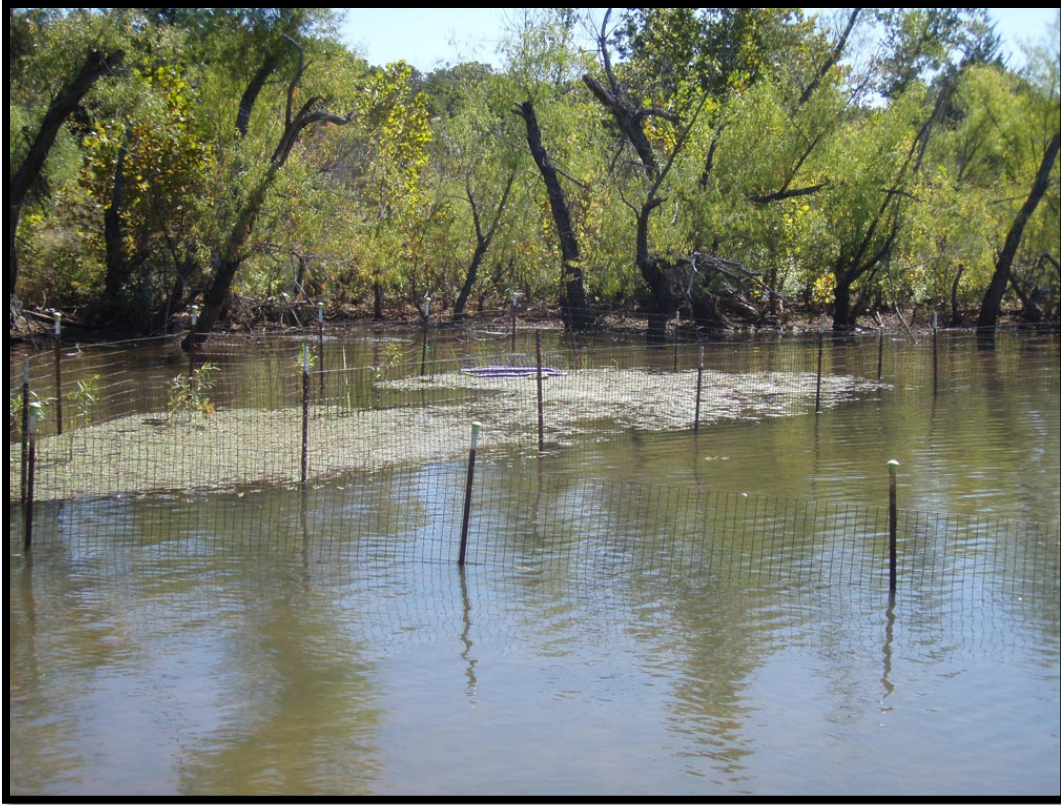
The results were highly varied, due in large part to any breaches or overtopping that had or had not occurred. Pen placement was intended to cover roughly two or three feet of elevation change from the normal pool level. While this made it possible for the pen to house both emergent and submergent plants it also created the possibility that high waters may overtop the 4 ½ foot tall fence on the deep end and expose the whole community to herbivory. Therefore the pens were bisected by depth to protect shallower plants from aquatic herbivory. This endeavor proved valuable as the results show stark differences between these upper and lower bisections, as can be seen in Figure 34 of Pen 17, where the upper portions approach 100% coverage and the lower portion was virtually empty.

Figure 34: Bisected pen in Cove 17. Lower portion was overtopped weeks before and denuded
It should be noted that all pens have recovered in 2009 as waters receded.

This pen was 100% full of American pondweed but only in the upper bisect. The lower bisect of the pen was nearly absent of visible plants as seen at the first of this section in Figure 34.

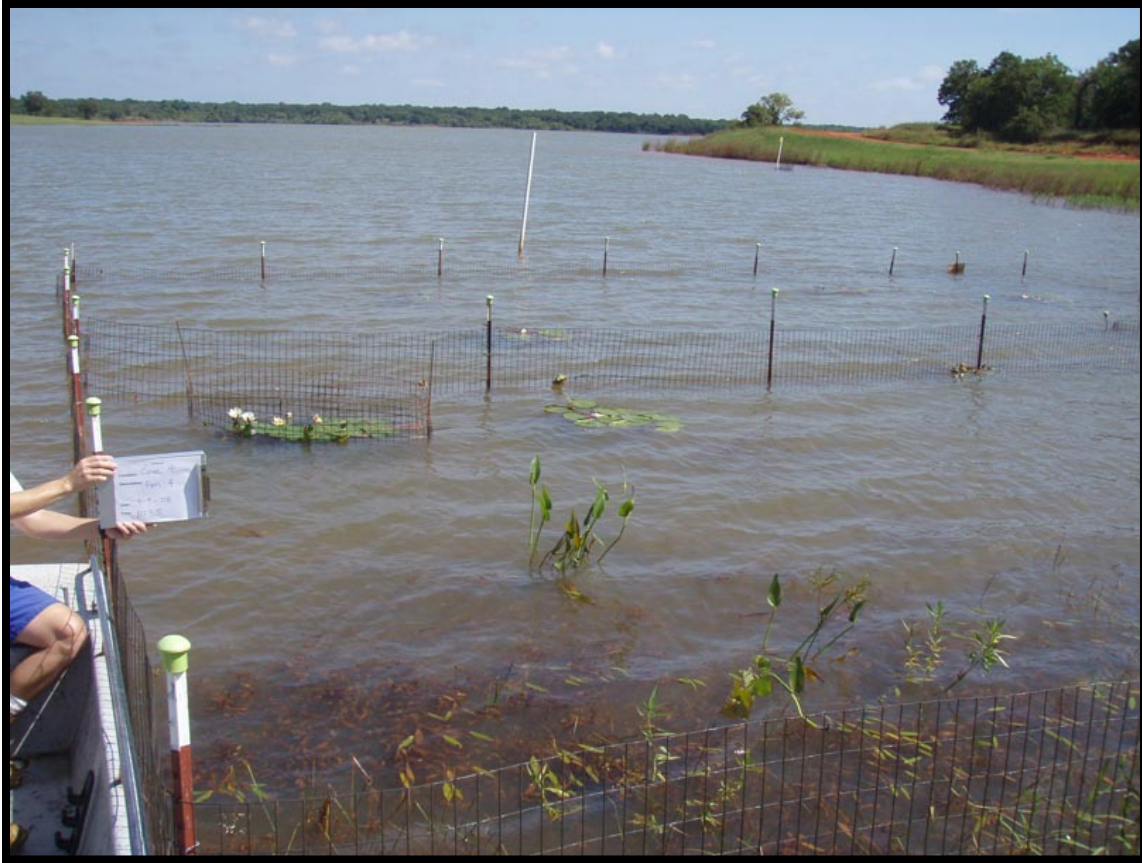
Figure 35: Pen in Cove 4

This pen was less prolific than others. It had a sandy bottom that seemed to do well in the shallows with *S. graminea*, *P. cordata* and an existing colony of *Eleocharis*. The rest of the pen did well with *N. odorata* which fared well given the herbivory pressures from multiple episodes of overtopping (Figure 35).

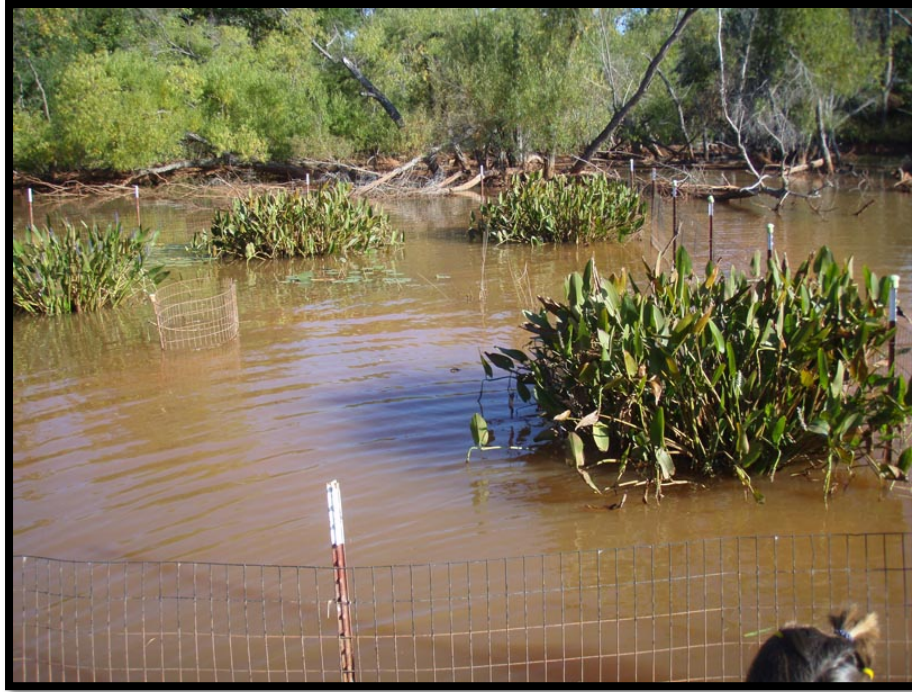
Figure 36: Pen in Cove 7

While at the time of assessment the pen had been despoiled from herbivory and hence was rated with a 50% coverage, it had previously been the best project pen overall for spread of multiple project species; most notably *S. graminea*, *Pontederia cordata* and *Nymphaea odorata*. Earlier in the season these plants had covered virtually the entire pen. In addition, the existing American pondweed seed bank had filled in between and around the new sprouts of project plants to create a dense community. Incidentally, this pen in 2009 has shown excellent recovery and is again a diverse and well populated site (Figure 36).

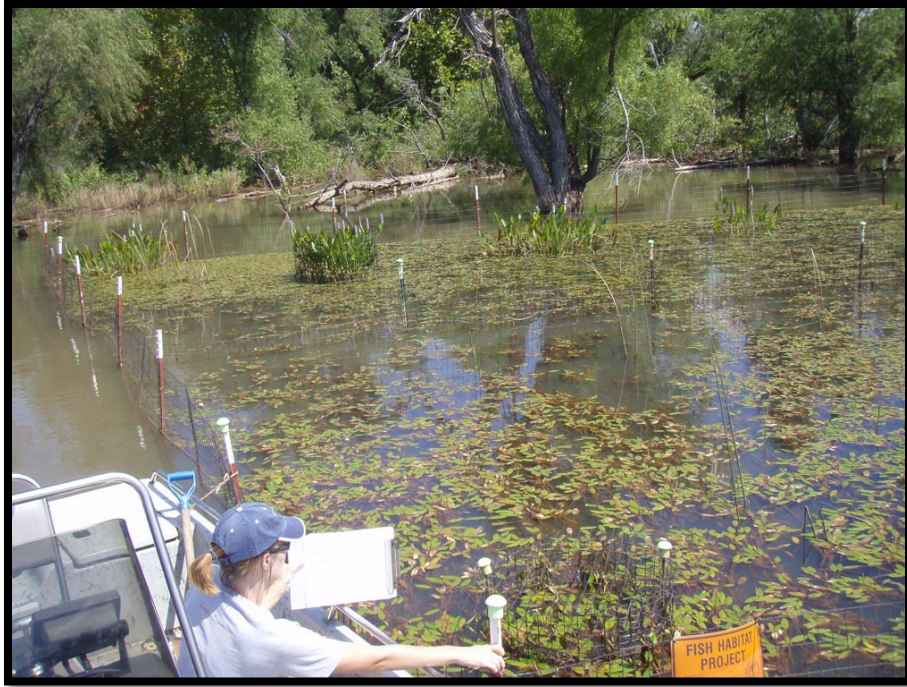
Figure 37: Pen in Cove 10

The 100% coverage rating is due by and large from pondweed and naiad that germinated independent of project plantings (Figure 37). However these were protected and allowed to grow due to project exclosures. *P. nodosus* and *S. tabernaemontani* were prominent species.

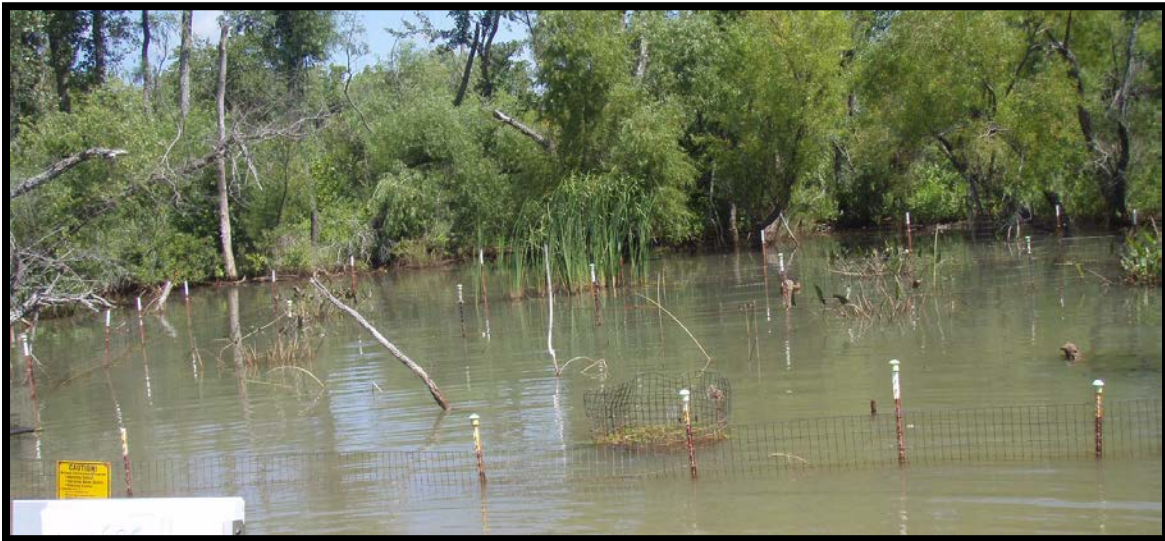
Figure 38: Pen in Cove 11

Historically this pen was a very full and diverse pen but was knocked back by the high waters at project end (Figure 38). Most of the remaining macrophytes were further protected within ring cages. *P. cordata*, *P. nodosus*, *S. tabernaemontani*, and *S. graminea* were prominent species as well as a volunteer colony of *Typha latifolia*.

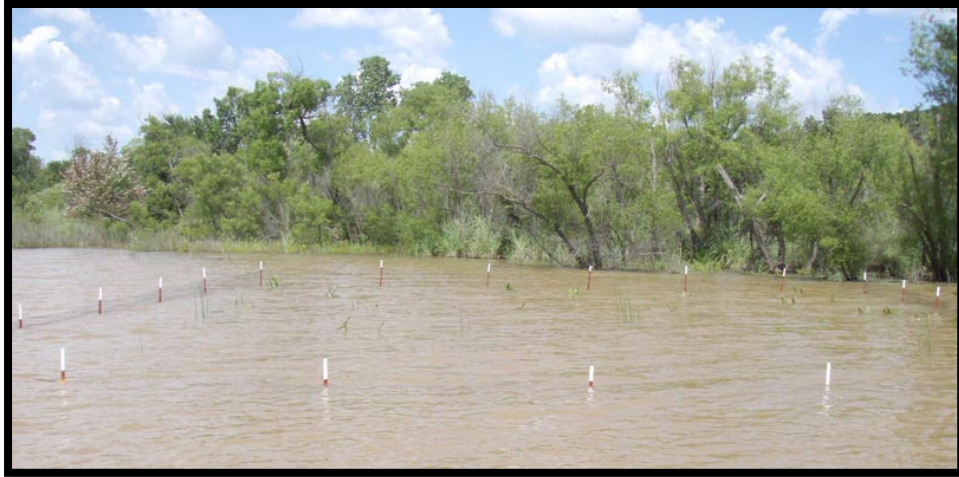
Figure 39: Pen in Cove 16 – High water overtops the pen. Arrowhead, pickerel and softstem bulrush visible.

This was another sandy site that had minimal spread from plantings. This site was also exposed to more wave action than other pens and never showed significant expansion. Most survival at the final assessment was found in the upper bisect of the pen or in a ring cage (Figure 39).
