FINAL REPORT

Creation of a Vegetated Wetland Throughout The Littoral Zone of Lake Stanley Draper

Agency: Oklahoma Water Resources Board (OWRB)

Location: Lake Stanley Draper, WBID OK520810000130_00,
HUC 11090203

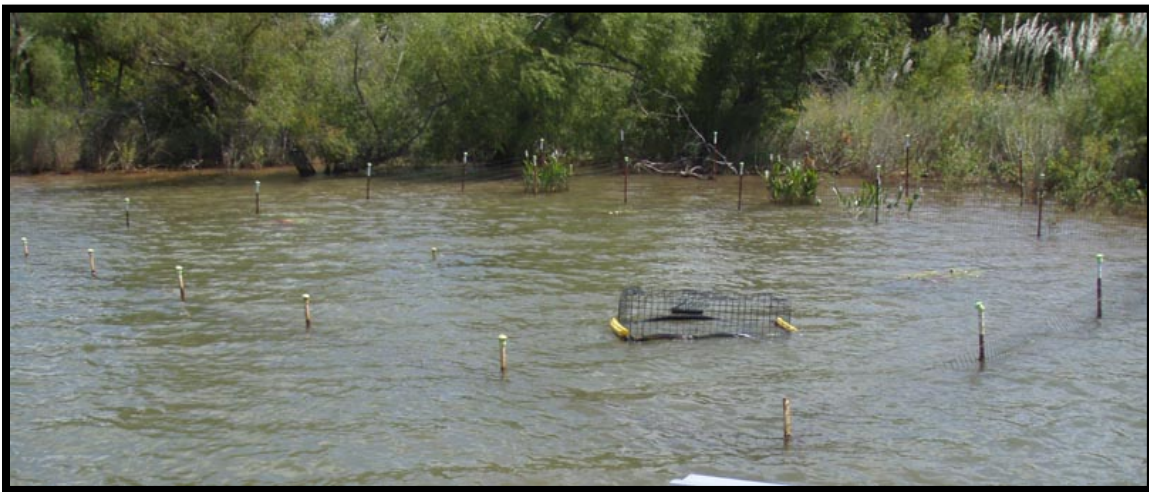
Figure 40: Pen in Cove 23 - Three *N. odorata* plants (lilies) are visible with *P. cordata* in back.
