# Electrical Resistivity Imaging of the Arbuckle-Simpson Aquifer

FINAL REPORT

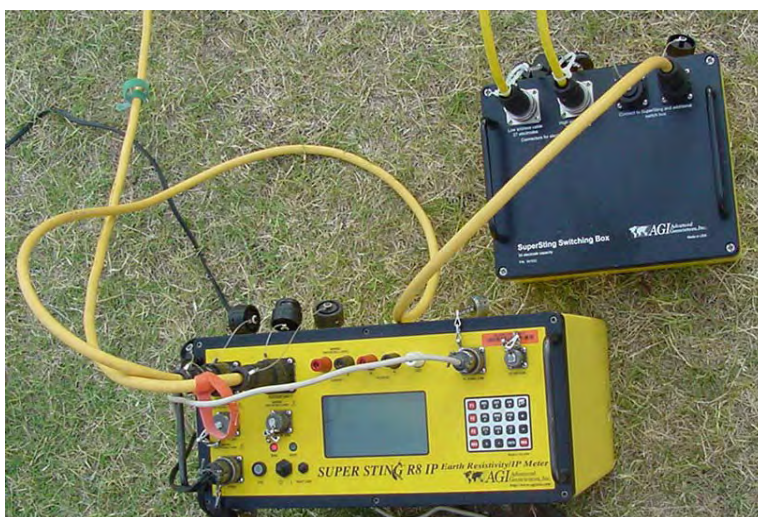
Data were collected for this study using an Advanced Geosciences, Inc. SuperSting 8-channel resistivity instrument (Figure 1).

*Figure 1. SuperSting 8-channel resistivity instrument and switchbox.*

A 36-electrode and 56-electrode surface cable were used to collect surface data. The 36-electrode cable used “smart electrodes” which performed switching at the electrodes (Figure 2). The 56-electrode system performed switching with a switchbox (Figure 1).

ft). Surface surveys were conducted using only the SuperSting and the 36-electrode cable. Subsurface surveys utilized a switchbox to communicate to the borehole cable (Figure 1).

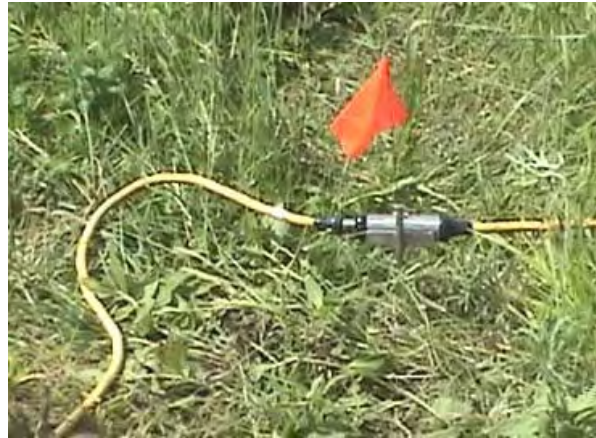
*Figure 2.* Surface electrodes used to collect resistivity data.

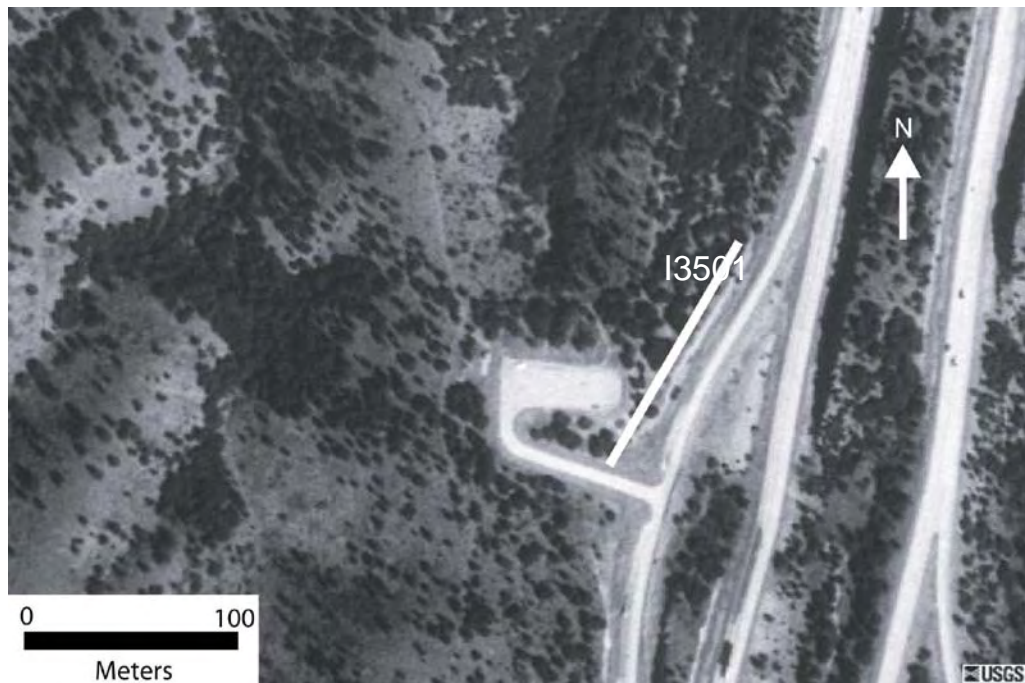
One line was collected at this field site. It is an approximately south to north 56 electrode line. An electrode spacing of 2.5 meters was used giving a total line length of 137.5 meters and a depth of investigation of approximately 27.5 meters. This site was difficult due to the traffic and required drilling to obtain contact with the electrodes.

*Figure 13. I-35 Mile Marker 49 site location showing the electrode line location (from Riley, 2007). Aerial photo courtesy of USGS.*

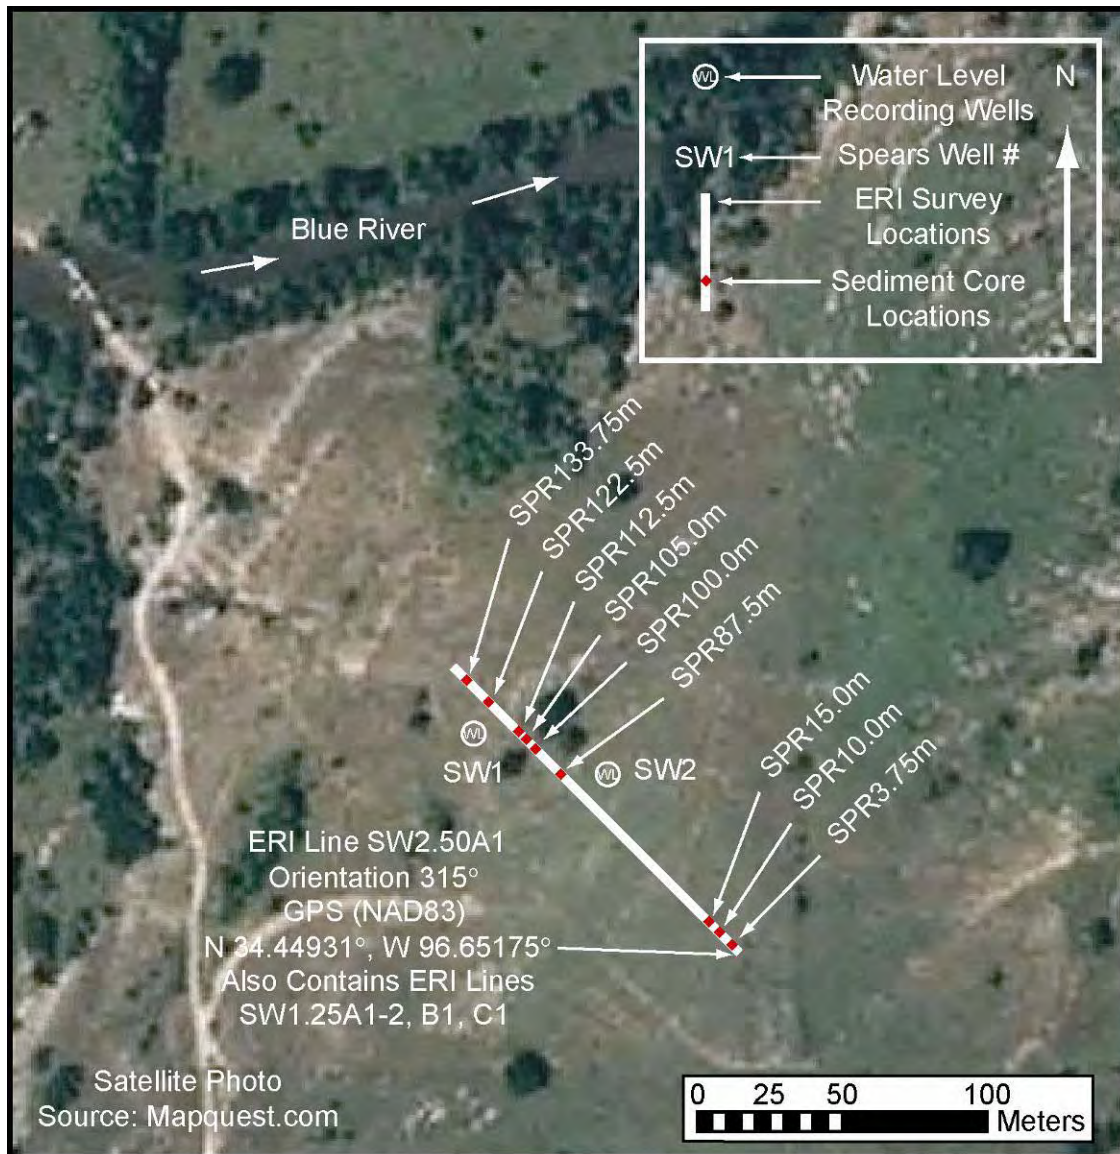
Eight ERI datasets were collected at the site (Table 1). Three were collected to assist with finding a location for the research wells on the site (Figure 14) and five were collected to assist in characterizing the epikarst at the site (Figure 15).

Figure 15. Spears Ranch site map with surface electrical resistivity and direct push locations and well locations (from Sample, 2008). Aerial photo courtesy of Mapquest.

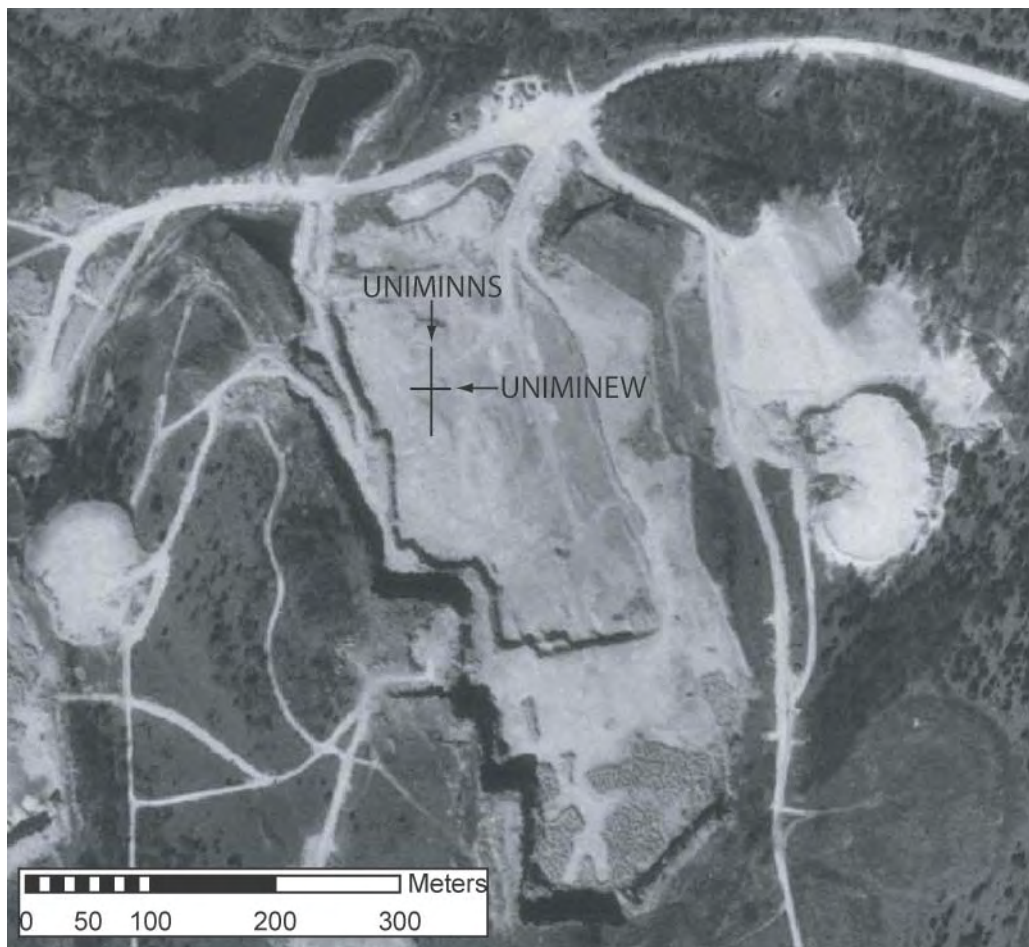
The Unimin Quarry is located three miles west of Troy, Oklahoma. The quarry mines the Butterly and Royer Dolomite in the area of investigation. The investigation was performed to evaluate the lithological response of the dolomite using the ERI technique. The site was the quarry floor at the time of the study. Two ERI lines were collected on the site (Table 1). Both were difficult to collect as the dolomite was dry and needed to be drilled to accommodate electrodes.

*Figure 16. Unimin Quarry Site with location of surface electrode placement. Aerial photo courtesy of USGS.*

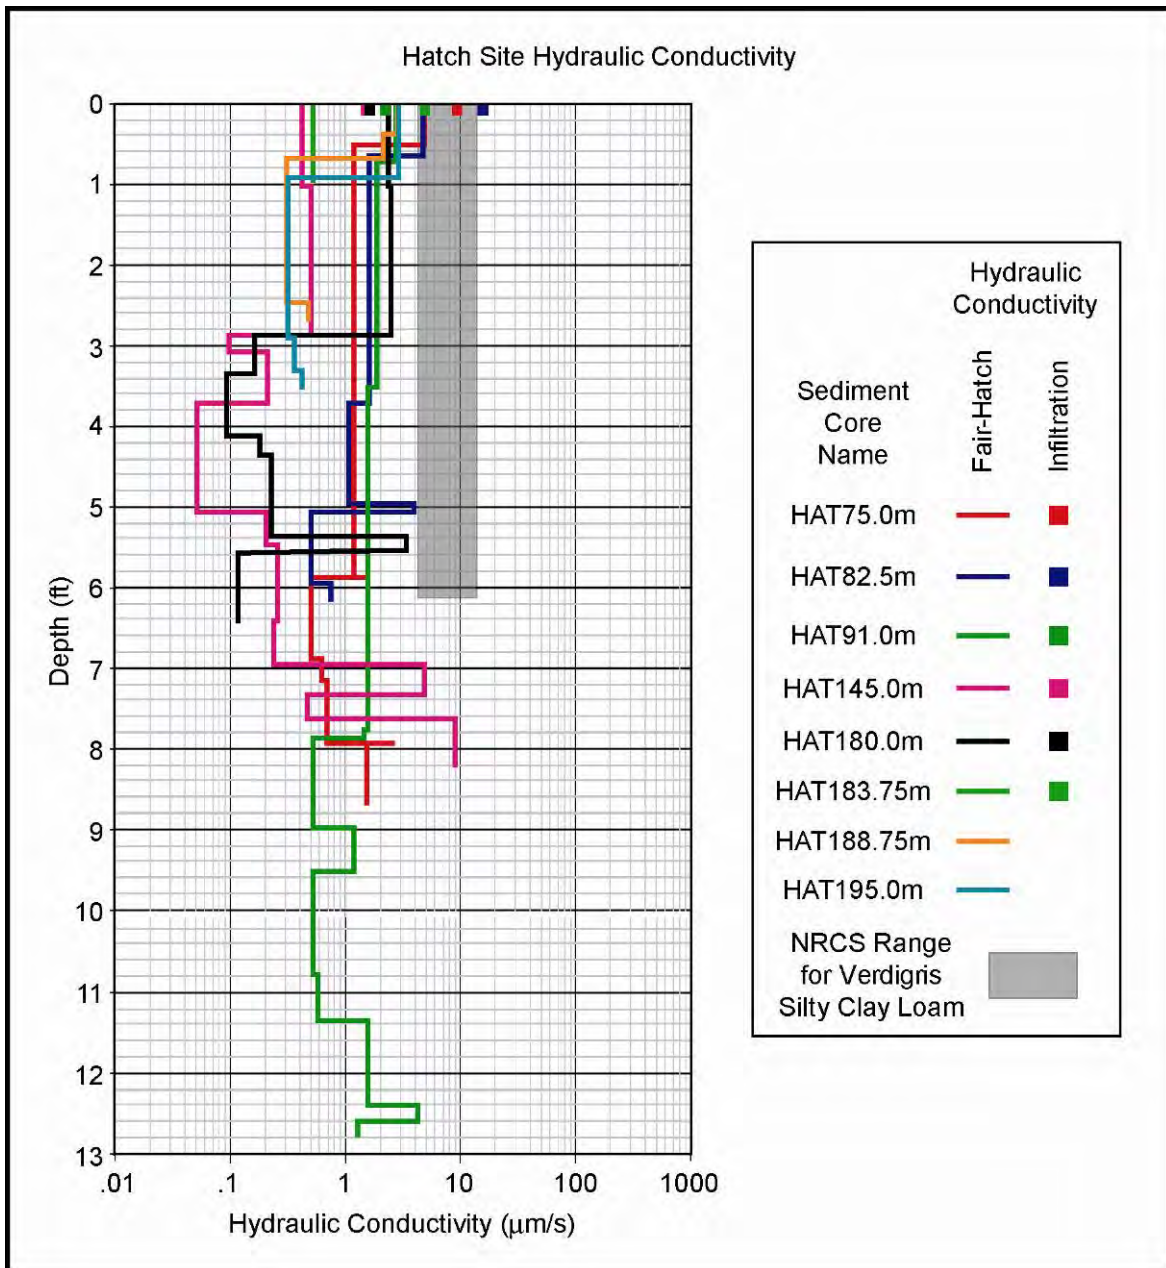
Figure 29. Hydraulic conductivity results corresponding with the Verdigris Silty Clay loam soil type.

Several of the infiltration results fell within the expected range for the identified MIADS soils (Figure 29) but the majority of the infiltration tests produced hydraulic conductivity values that were below the expected range by, on average, one order of magnitude. The sediment core analysis results plotted as hydraulic conductivity profiles show hydraulic conductivity values that are, on average, approximately one order of magnitude lower than the expected hydraulic conductivity range. The hydraulic conductivity values empirically calculated from the sediment core analysis do not have any directional orientation and thus can not be used to say anything specific about vertical anisotropy in the sediments above the epikarst zone. The gaps seen in the hydraulic conductivity profile represents core intervals with no data due to the loss of data (Figure 29). Gaps in the data from the other field sites (not shown) indicate intervals of weathered rock in the sediment cores. The weathered rock intervals were not subjected to porosity and grain size distribution analysis because the methods used for the sediment core analyses were not appropriate for the analysis of rock fragments.

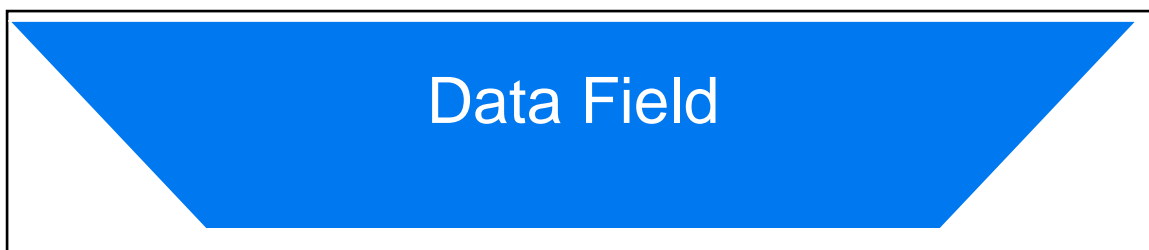
Figure 31. Data field for a standard resistivity survey.

Due to the nature of surface multielectrode resistivity measurements the data are collected in a set that results in a wedge shaped dataset (Figure 31). This is a result of the ability to resolve boundary conditions outside of this field.

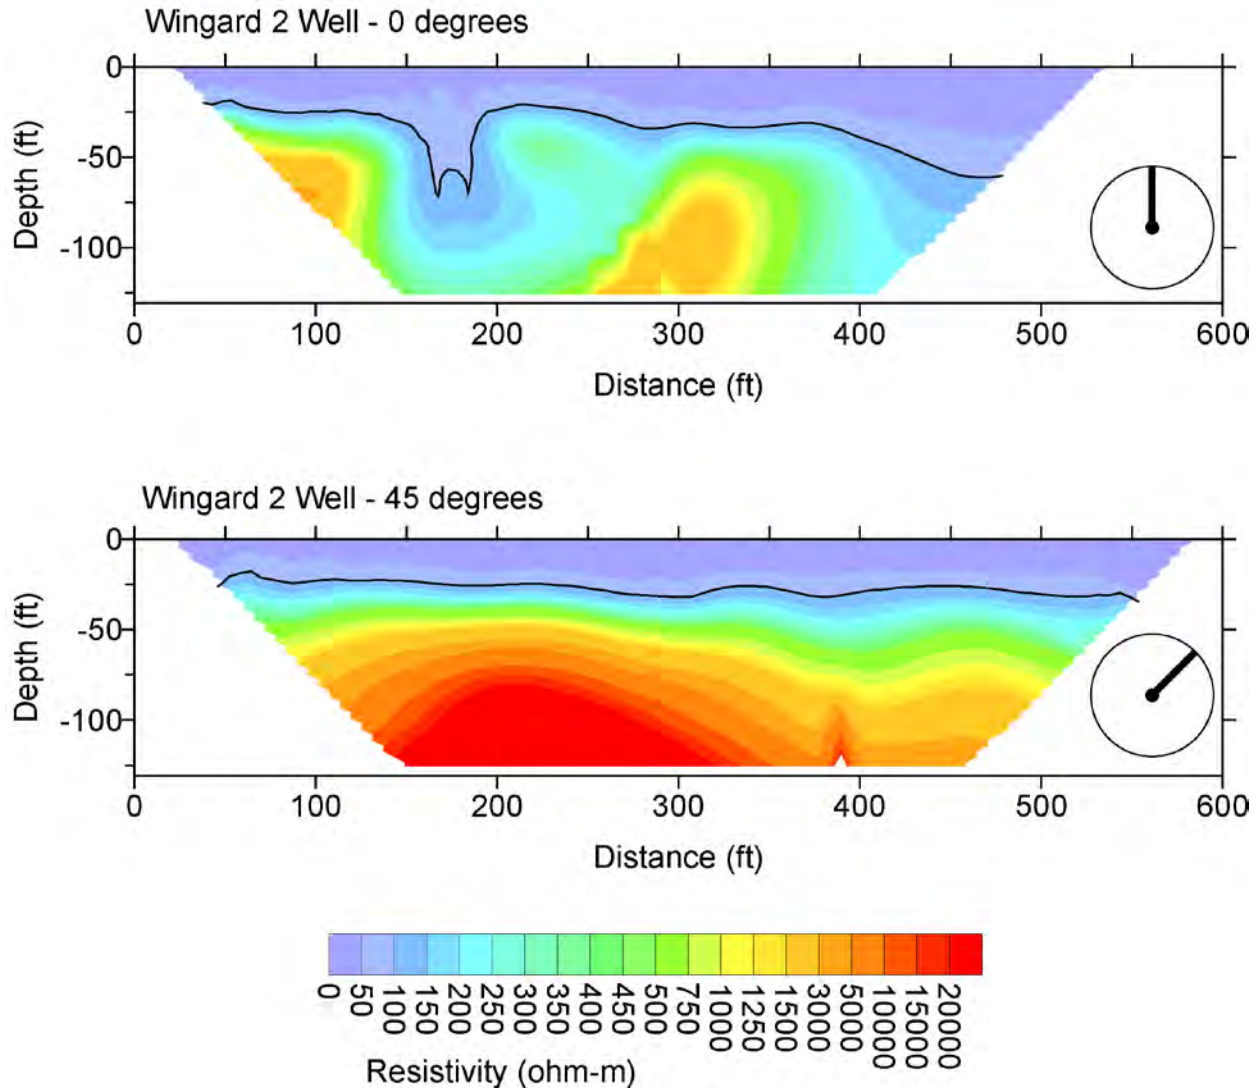
Figure 49. Surface ERI survey results at the Wingard 2 well site. The images are scaled identically and the “clock” figure at the right indicates the orientation, relative to north being up, of each image relative to the well (from Halihan et al, 2004).

Surface ERI surveys collected good quality data at the site (Figure 49). The inversions of the data provided low root mean squared (RMS) error of between 3.5% and 6.7%. The dataset had between 94.7%-95.0% of the data used in the inversions. The remaining data did not meet the data quality criteria of high signal strength and low error. Compared to other datasets at other locations, these would rank as very good.

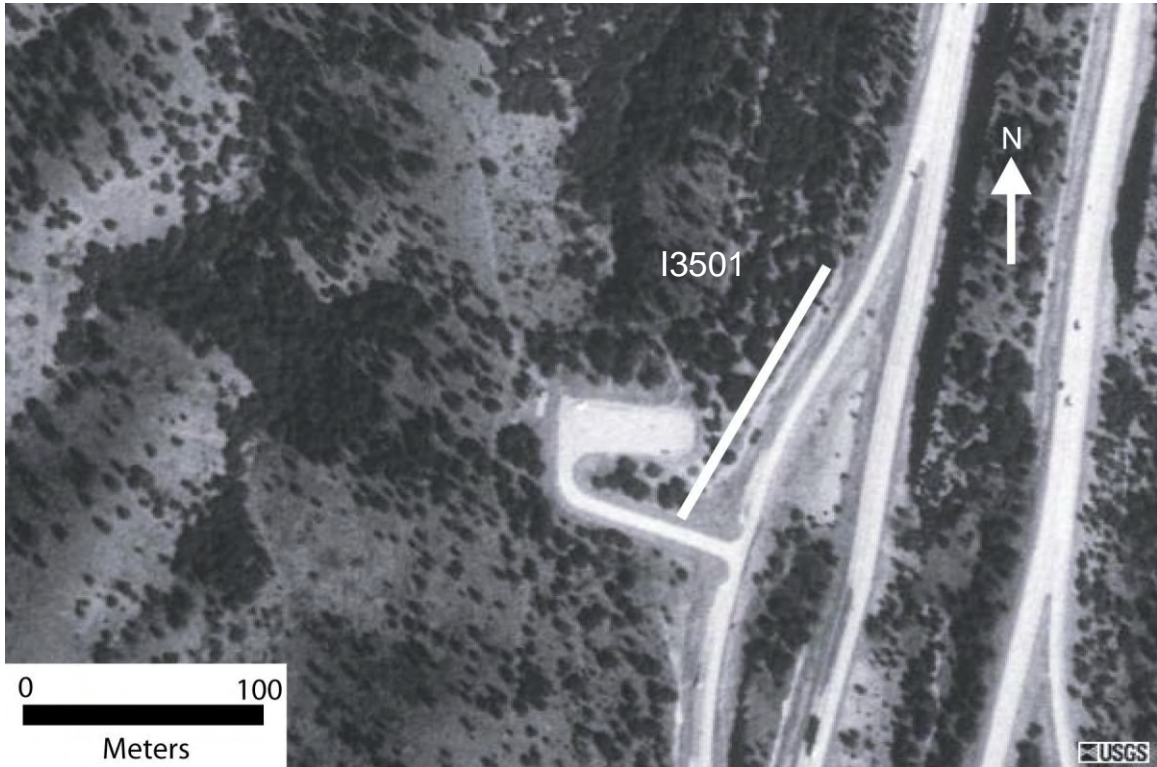
Figure A1.7. I-35 Mile Marker 49 site location showing the electrode line location (from Riley, 2007). Aerial photo courtesy of USGS.

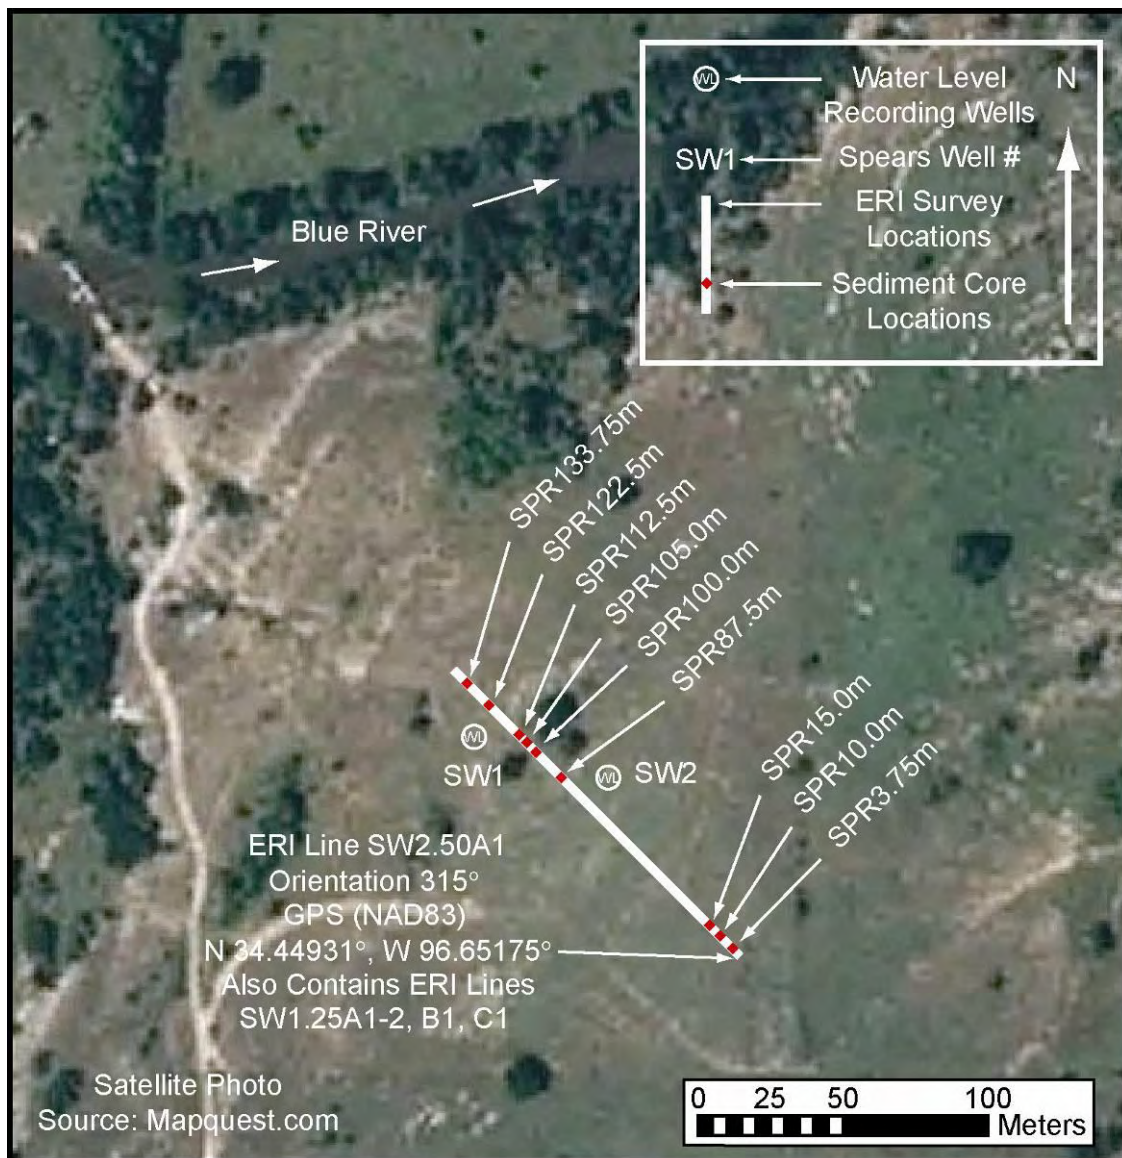
B)

Figure A1.8B. Spears Ranch site map with surface electrical resistivity and direct push locations and well locations (from Sample, 2008). Aerial photo courtesy of Mapquest.

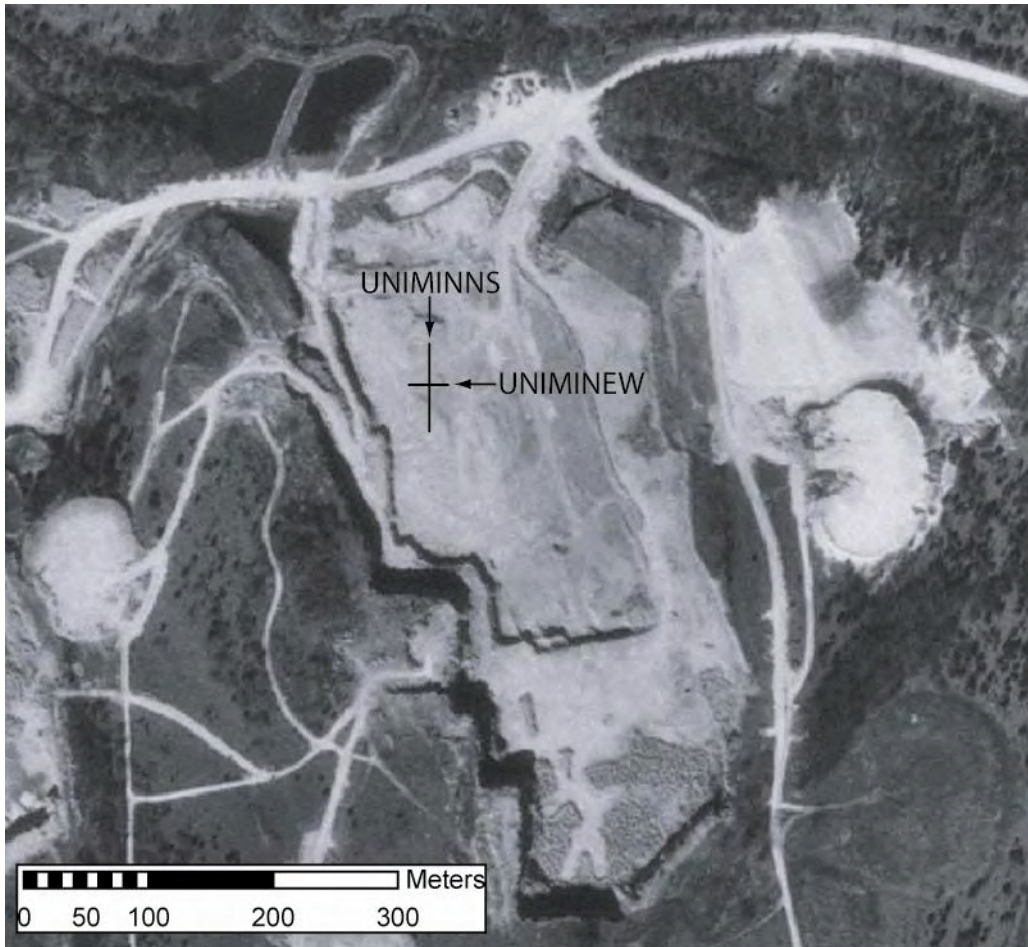
Figure A1.9. Unimin Quarry Site with location of surface electrode placement. Aerial photo courtesy of USGS.
