Demonstration and Evaluation of Artificial Recharge to the Blaine Aquifer in Southwestern Oklahoma

Oklahoma Water Resources Board
Technical Report 97-5

December 1997

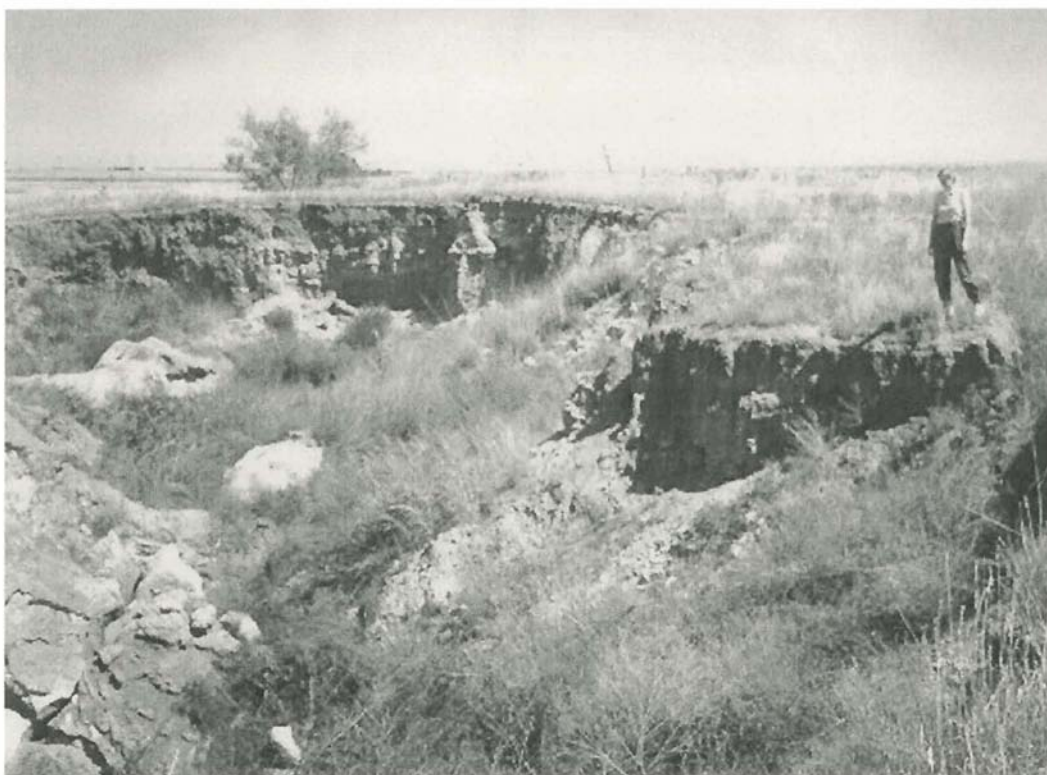
Figure 9. Sinkhole south of Hollis.

Karst features such as caves, sinkholes, disappearing streams, and springs occur within the study area. An example of a sinkhole, located south of Hollis, is shown in Figure 9. Karst features are most abundant near streams, where fresh water percolates into the gypsum. Areas where the Blaine Formation crops out, or is in the shallow subsurface beneath the Dog Creek Shale, correspond to areas where the Blaine aquifer consistently yields large quantities of water to irrigation wells (Johnson, 1990b).

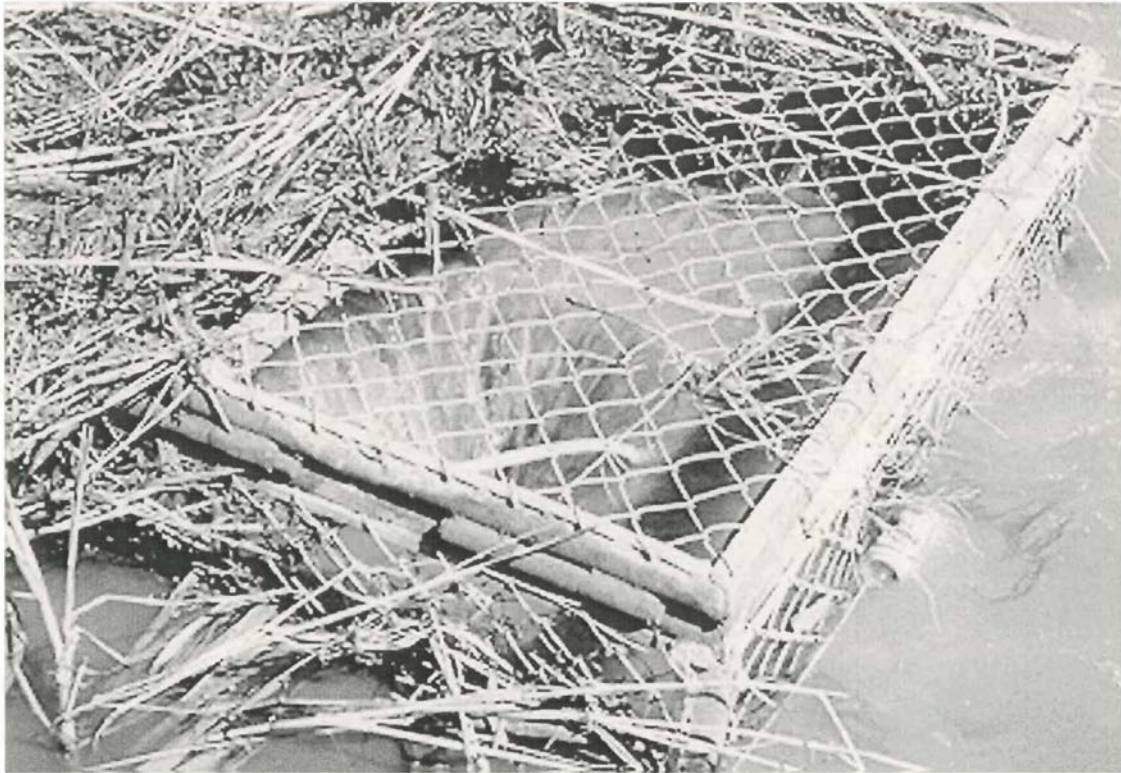
Figure 24. Photograph of the debris screen covering the drop inlet structure of a recharge well.

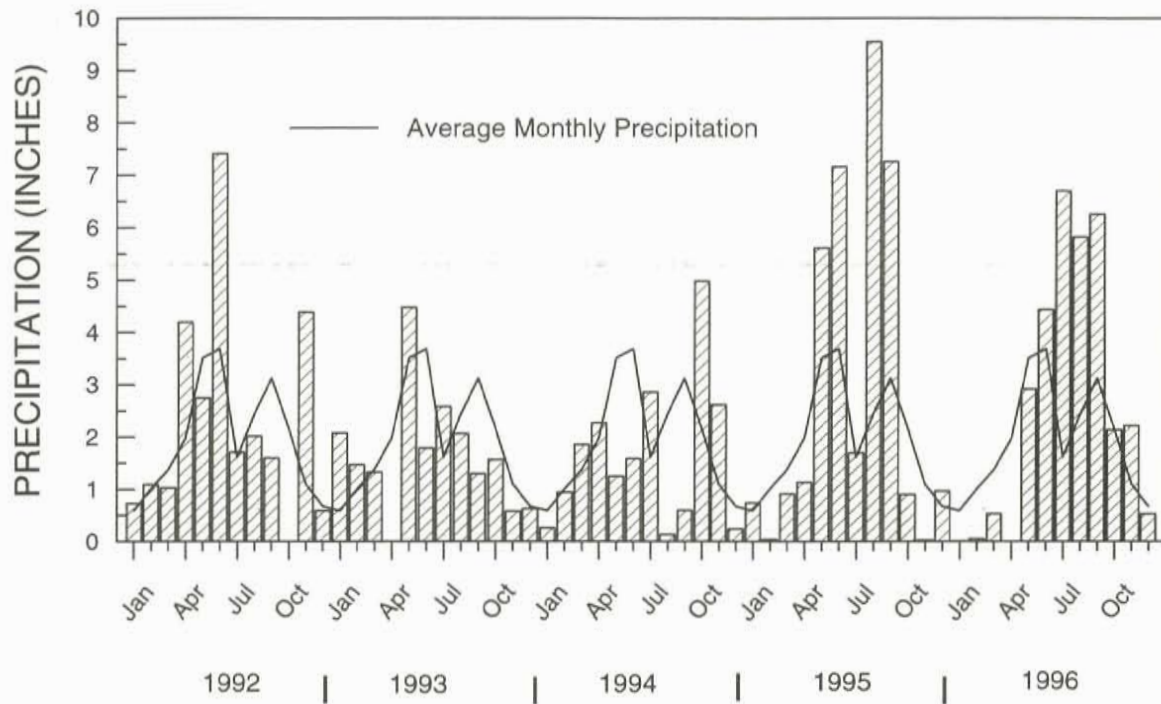
Monthly precipitation totals are shown in Figure 33, along with the average monthly precipitation. The spring and summer months of 1994 were especially dry, resulting in high irrigation pumpage. In 1995, heavy rains caused flooding in Hollis in early June, and more flooding in August and September. As much as 3.60 inches fell on June 4, and 4.36 inches fell on August 3.

Figure 33. Monthly precipitation from 1992-1996 and average monthly precipitation for the Hollis rain gauge.

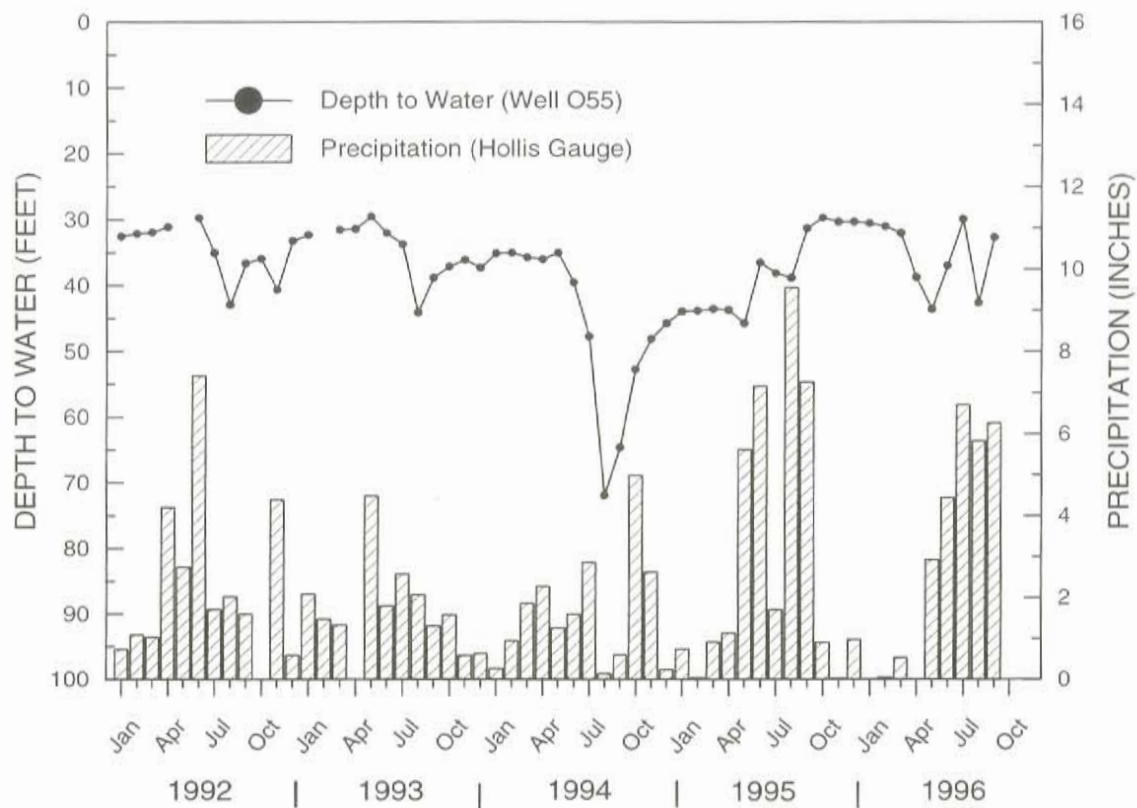
Figure 34. Monthly hydrograph of well 055 and precipitation graph of Hollis rain gauge.

The hydrograph shows a water level response similar to other wells in the pumping area, such as well O55 (see Figure 34). Prominent features are the drawdown that occurred in August 1994 in response to pumping and the sudden increase that occurred in 1995 in response to heavy rains.

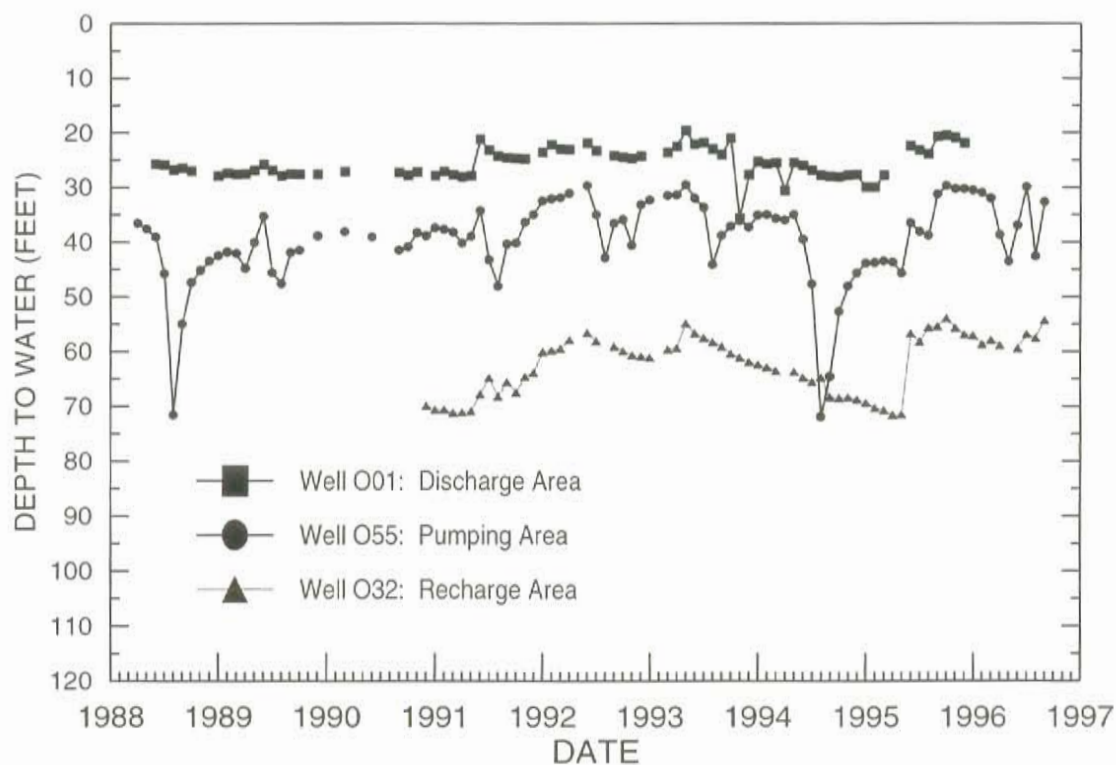
While water levels of most wells in the study area have responses similar to well O55, a few wells deviate. Figure 35 shows hydrographs of three wells representing different flow regimes. Well O32, which is located in a recharge area south of Hollis, responds most to recharge and least to pumpage. Well O01, located in the discharge area in the

Figure 35. Hydrographs of wells representing different flow regimes.

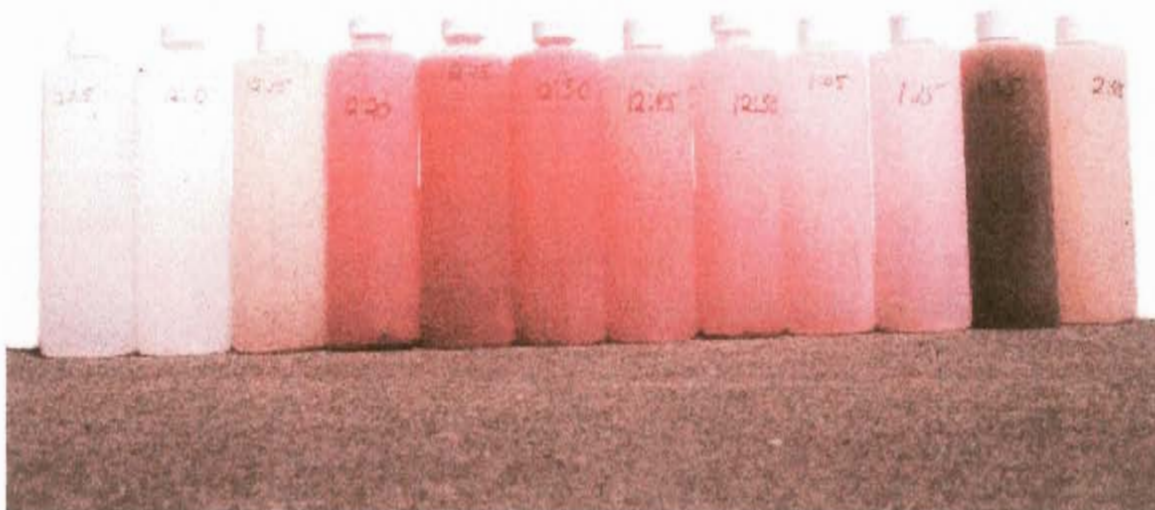
Figure 50. Grab samples from dye tracing study.

Figure 50 is a photograph of the grab samples. The first arrival of dye occurred between 10 and 15 minutes, and the peak arrival of dye occurred at approximately 25 minutes. The pink dye was readily distinguished in the samples, as illustrated in the picture. The positive dye test confirmed hydrologic connection between the recharge well and the R1M3 monitoring well. The muddy sample collected at 1:35 was collected during one of the rapid water level increases.

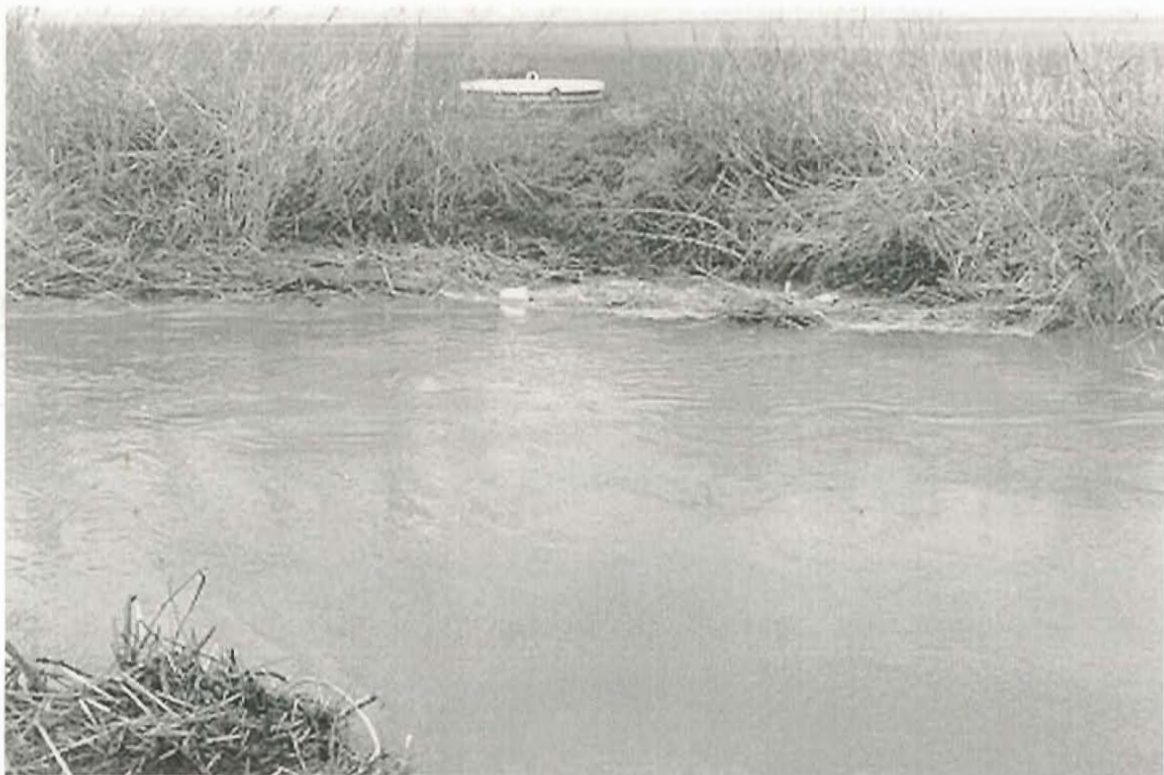
Figure 53. R02 site during recharge.

Figure 53 shows the R02 site during a recharge event. The housing for the flowmeter/sampler unit can be seen in the upper center. The inlet pipe and debris screen are under 4.7 feet of water in Figure 53, but can be seen in Figure 54. Figures 55 and 56 were taken looking north along the ditch. The housing can be seen on the left.
