Shoreline Erosion Control Plan

Lake Thunderbird, Cleveland County, Oklahoma

December 27, 2001

**Lake Thunderbird Shoreline Erosion Control
Using Bioengineering Methods
by
AllEnVironment Consulting**

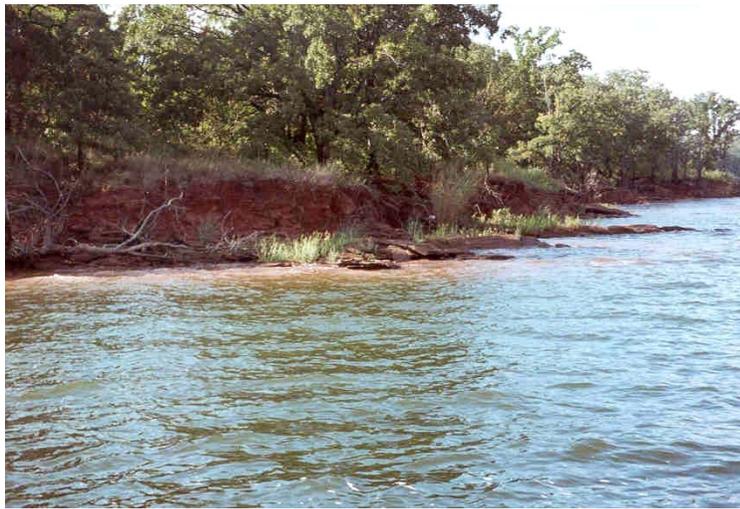
Figure 1. Rocks forming natural wave breakwater with vegetation colonizing behind the rocks

Shoreline geometry and bathymetry play a big part in determining the degree of erosion at a particular shoreline site. Sites with straight shorelines or headlands that are exposed to long wind fetches from prevailing wind directions are particularly vulnerable to more frequent and higher waves. Conversely, sites within coves or that are behind peninsulas or islands that block the wind are more protected from waves. Thus, vegetation is often present and erosion is less severe or even minimal. Bathymetry, like geometry, also plays a big part in degree of wave action. The shallower the nearshore and the wider an underwater bench, for instance, the more drag or resistance to waves there will be. Waves will subsequently be smaller in these areas in contrast to those where the water deepens abruptly and there is less resistance or bottom roughness to influence the wave. There are places where the bathymetry is shallow because rocks have dropped from an eroded shoreline bluff or soil erosion has exposed a rock strata to form a natural rock barrier or breakwater that deflects waves

(Figure 1). This improves the chances for vegetation to colonize behind the rocks and together they minimize further erosion of the bluff.

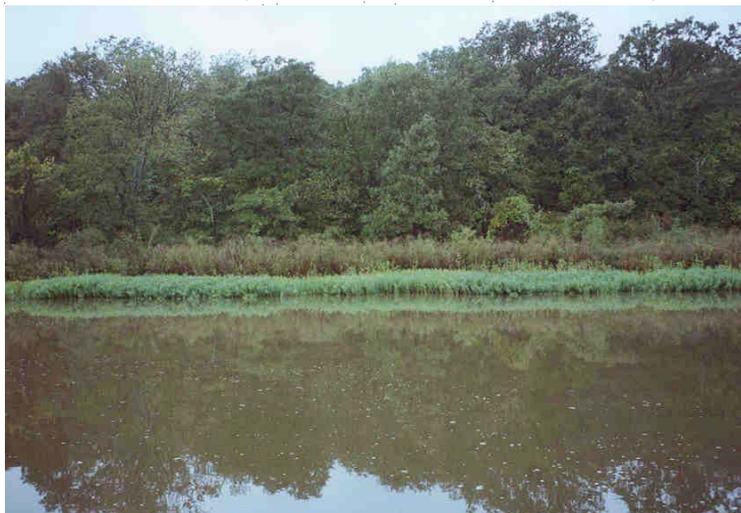
Figure 2. Category 1 of erosion; no treatment necessary; photo taken on north end of Hog Creek arm of lake

Category 1: No noticeable erosion of bank; good swath of emergent aquatic vegetation at shoreline such as water willow (*Justicia americana*) or hardstem bulrush (*Scirpus acutus*) backed by wetland facultative species, such as other herbaceous plants and willow, buttonbush (*Cephalanthus occidentalis*), and others (Figure 2)

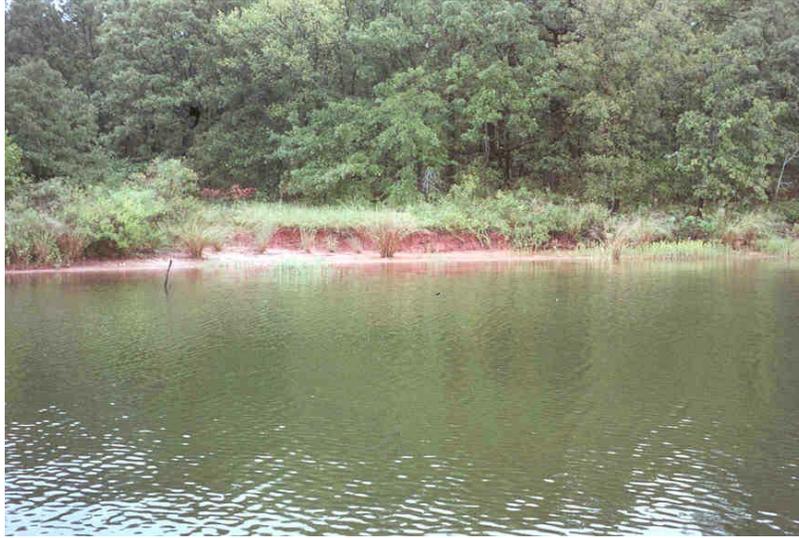
Figure 3. Category 2 of erosion; some erosion noticeable; photo taken on Hog Creek arm of lake

Category 2: some erosion noticeable; \leq 1-2' escarpment with a shallow area or bench lakeward of escarpment and covered in part with emergent aquatic plants such as water willow and/or some

other wetland facultative plants like grasses and buttonbush and willow (Figures 3-4).

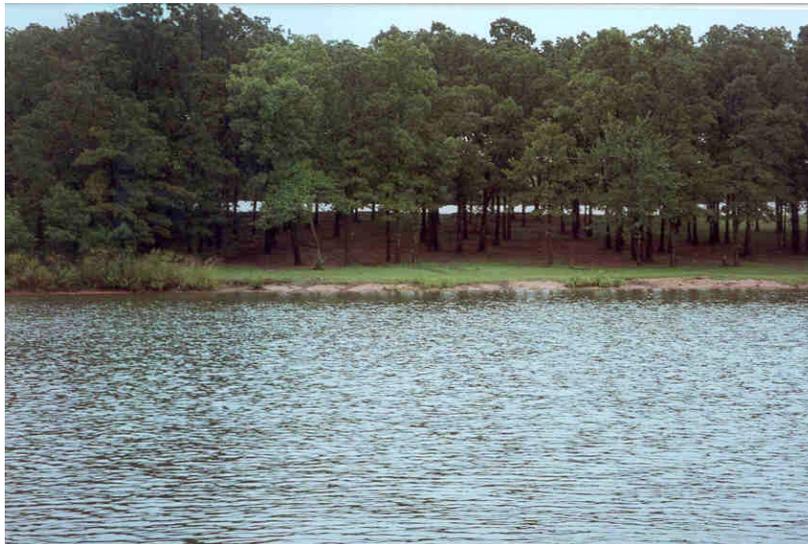
Figure 4. Category 2 erosion; \leq 1-2' escarpment with bench; photo taken at Hog Creek Camp

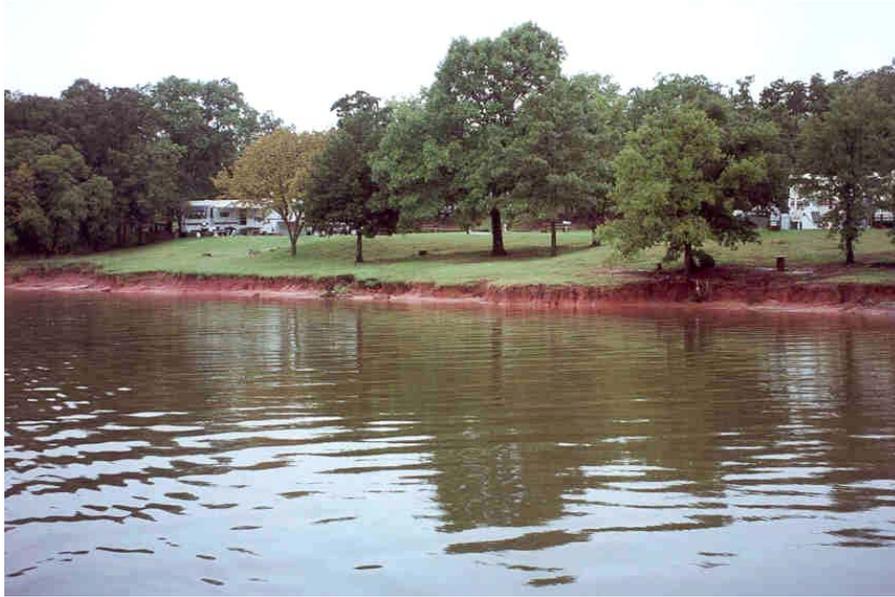
Figure 5. Category 3 eroded shoreline; photo taken at Little Sandy Campground on Hog Creek arm of lake

Category 3: eroded 2-4' escarpment present; some toe or bench lakeward of escarpment evident, but containing no plants (Figure 5)

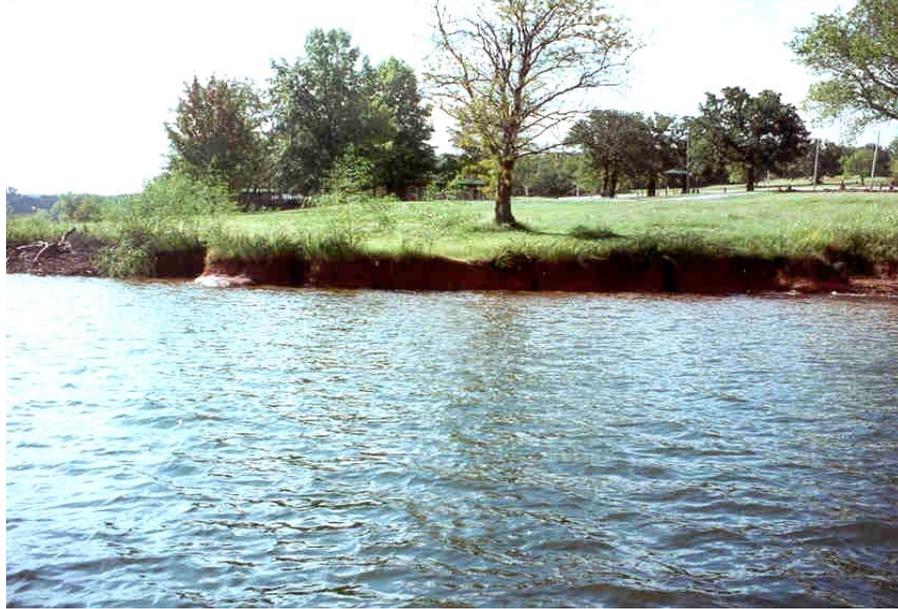
Figure 7. Category 5 erosion; about a 4-ft escarpment without a toe or bench at Clear Bay Cafe area.

Category 5: eroded \geq 4-ft escarpment present; not much, if any, toe or bench noticeable lakeward of escarpment; no vegetation noticeable in water (Figures 7 and 8)

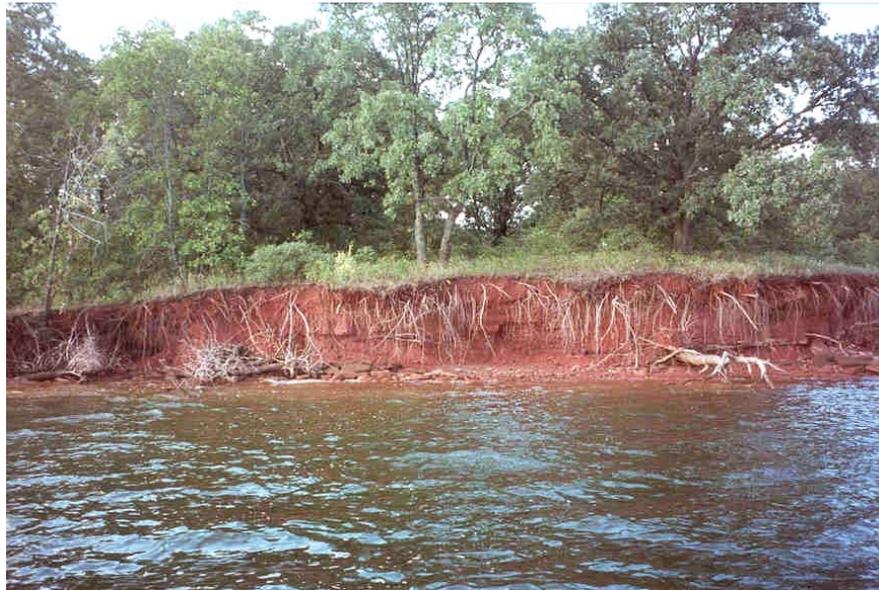
Figure 8. Category 5 erosion; $>$ 4-ft escarpment without toe or bench; exposed to $>$ 4-mile northern fetch; 1st point west of dam

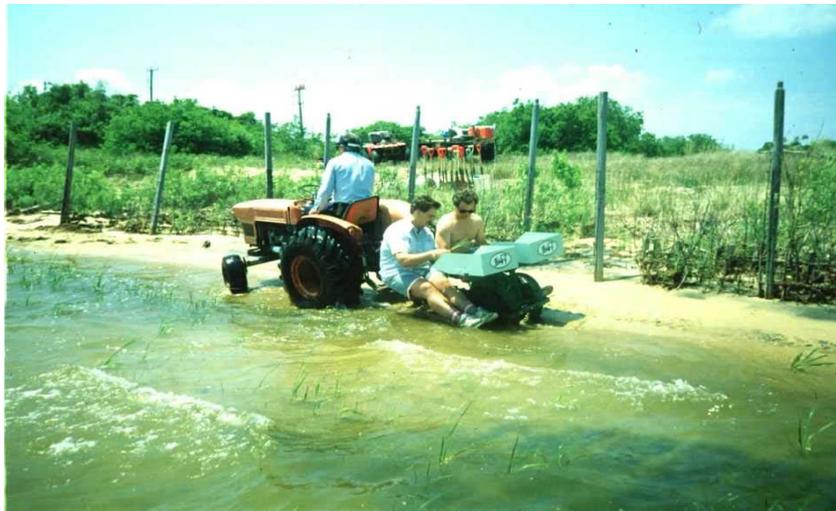
Figure 9. Planting emergent aquatic plants using a tobacco planter and tractor

Emergent aquatic plants, such as bulrush or spike rushes, can be planted as single stems by hand labor using a spade or shovel. If the bank and soil conditions will allow and access is no problem, a tractor with a tobacco planter can be used to mechanize and speed up the process (Figure 9). Woody cuttings, such as willow and buttonbush cuttings, can also be pounded in by hand using a dead-blow hammer (a hammer with shot in it so it does not damage the end of the cutting).

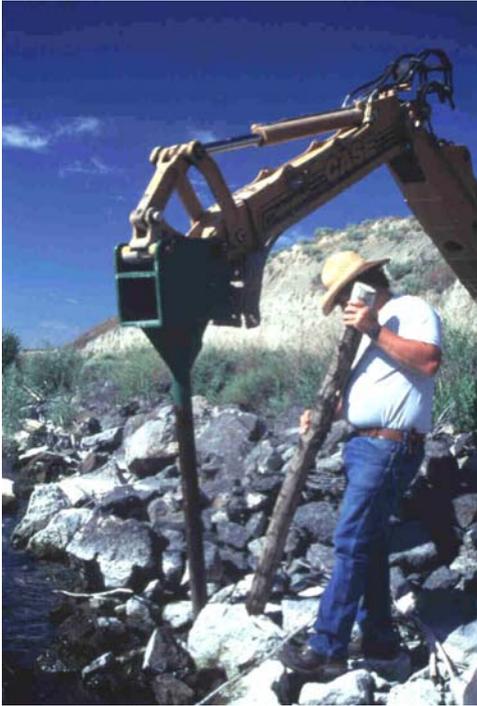
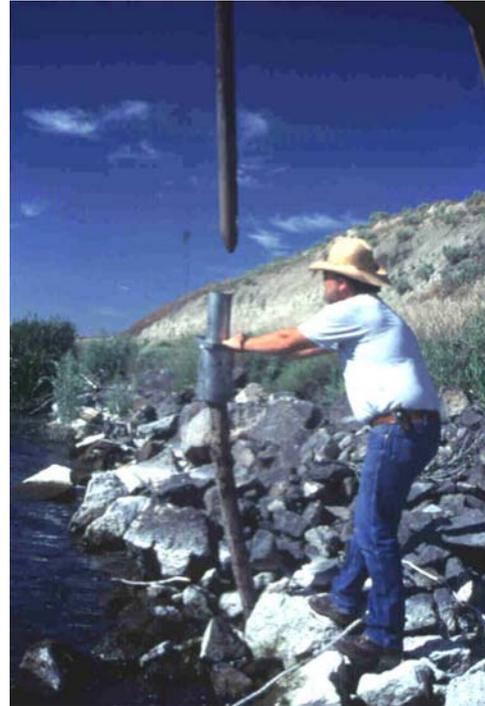
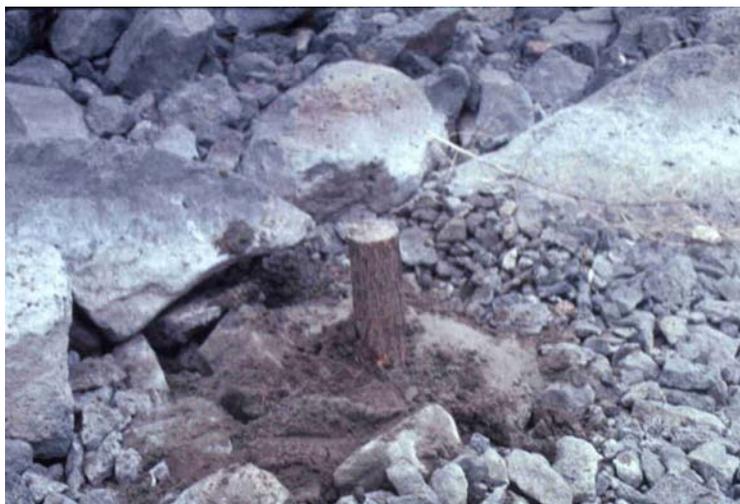
Figure 10. Cottonwood pole being inserted with aid of stinger

Figure 11. Cottonwood pole with metal cap being inserted with stinger

Figure 12. Completed installation of cottonwood pole with stinger

Dormant live poles of willow and cottonwood can be used along with the much shorter live cuttings. These can be several feet long and able to penetrate down into saturated soils and can also be used in between rocks or riprap. Figures 10 through 12 illustrate this technique. The treatment is installed using either a backhoe with a stinger device mounted on the hoe or the use of a jet pump and hose that can hydraulically insert the pole into the ground.

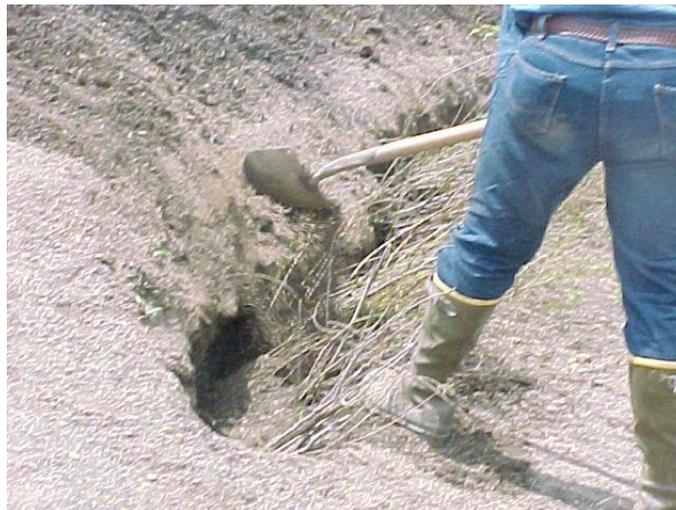
Figure 13. Brush layering

Figure 14. Brush layering; installation of willow cuttings

Woody plants such as willow can also be installed on near-vertical slopes shoreward of the emergent aquatic plants and the dormant willow cuttings/poles. They can be used in a treatment called brush layering, which is a series of trenches with live cuttings inserted into the trench perpendicular to the face of the slope as illustrated in the drawing below (Figure 13). The floor of the trench is angled down about 10 to 20°. The cuttings are criss-crossed in the trench and hang over the lip of the trench, but not to exceed about 12 inches. Figure 14 illustrates placing the branches in a trench at Lake Wister Oklahoma.

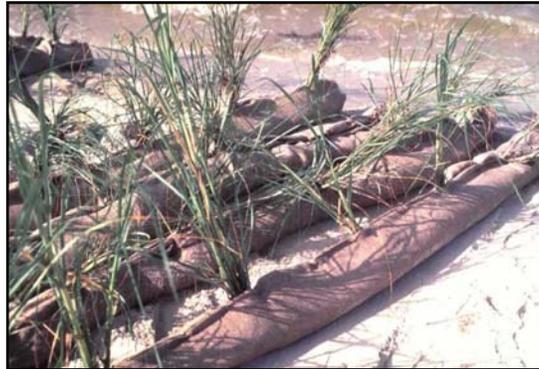
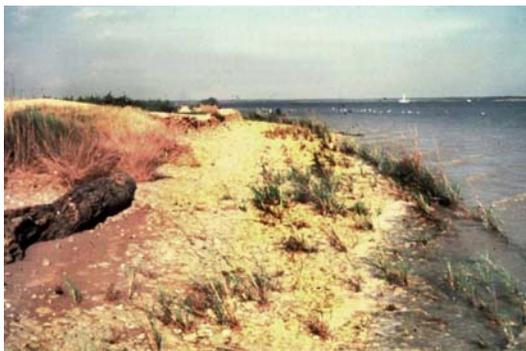
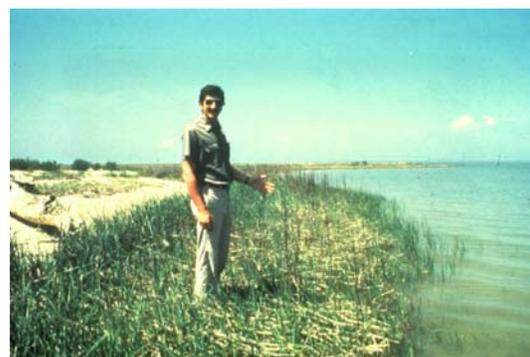
Figure 15. Plant rolls ready for installation

Figure 16. Plant roll installed in line with single plants installed shoreward

Figure 17. Same plant rolls as in Figure 16 after 2 years

Plant roll. This method places clumps of emergent aquatic plants on about 1-1/2 ft centers inside a 10-ft long burlap strip with soil that encompasses the plants. The burlap is secured around each plant clump using hog-ring wires after the burlap is folded, much in the same way as an envelope (Figure 15). Then, the roll is buried in the substrate either with shovels or by a hydraulic jet-pump. The plant roll can be placed in a long line parallel to the shoreline with single plants installed behind it as shown in Figures 16 and 17.

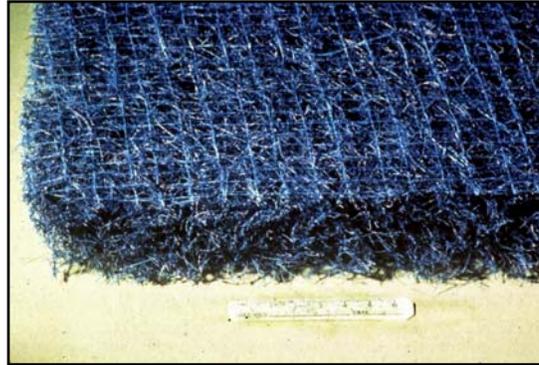
Figure 18. Erosion control mat material made of coconut and horse-hair fiber

Erosion Control Mat. Emergent aquatic plants dampen wave energy and bind the sediment. Erosion control mats aid in anchoring the plant and binding the surrounding sediment. The mats act as an instant root mat, providing the sediment with a fibrous, erosion-resistant surface and a medium in which plant roots can interlock with fibers in the mat. A type of mat found to be effective is a biodegradable fabric mat that consists of 0.1 kg/sq m of natural fibers (coconut and horse-hair, Figure 18). The mat is laid like a carpet on the shore, and single-

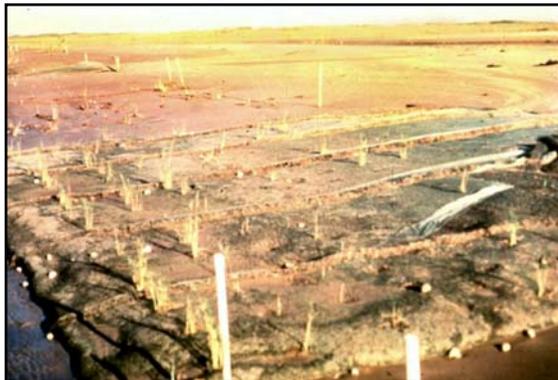
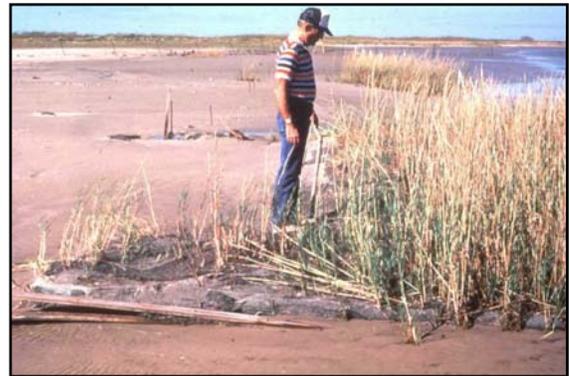
Figure 19. Erosion control mat immediately after installation

Figure 20. Same erosion control mat to left after 3 years

stemmed transplants are inserted into slits cut through the material. The edges of the mat are buried in the sediment (Figures 19 and 20) between two boards (2" X 8") or just simply keyed into a trench and staked. Although not shown in Figure 19, stakes can be inserted and wire strung from stake to stake and then all stakes are hammered until the cross-wires are firmly against the mat. Plants shown in Figure 20 were exposed to wind fetches in Galveston Bay exceeding 12 miles although they were on a fairly flat and extensive beach which allowed drag effects of the beach to dampen waves.

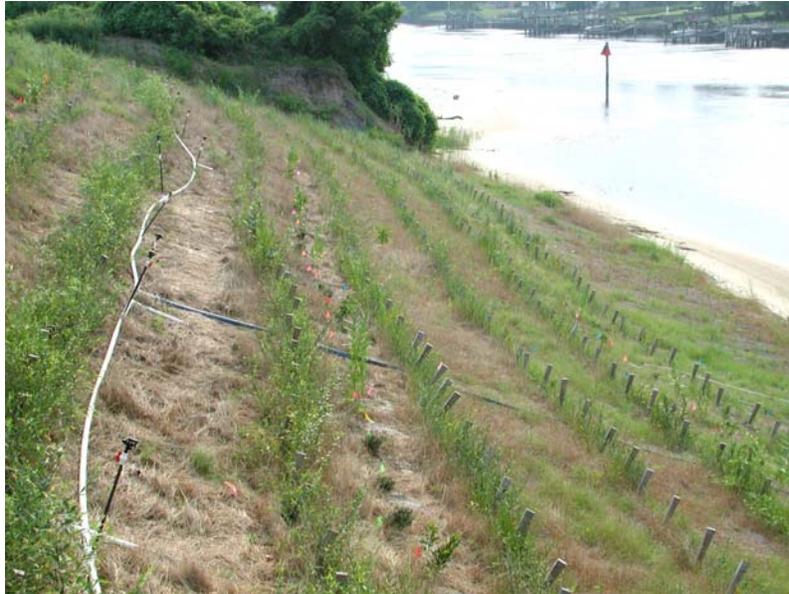
Figure 23. Series of fascines installed on very sandy soil to prevent rills and gullies from overland wash

a very sandy slope next to the Atlantic Intracoastal Waterway in South Carolina. Such an installation could be used in some of the OTRD parks landward of the lake shoreline itself where overland wash is creating rills and gullies.

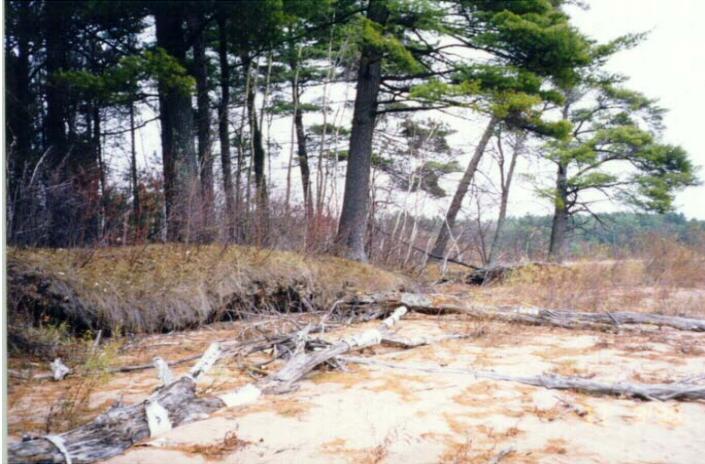
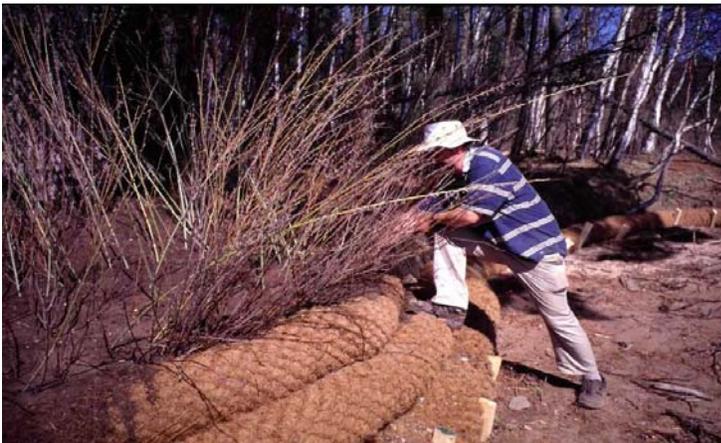
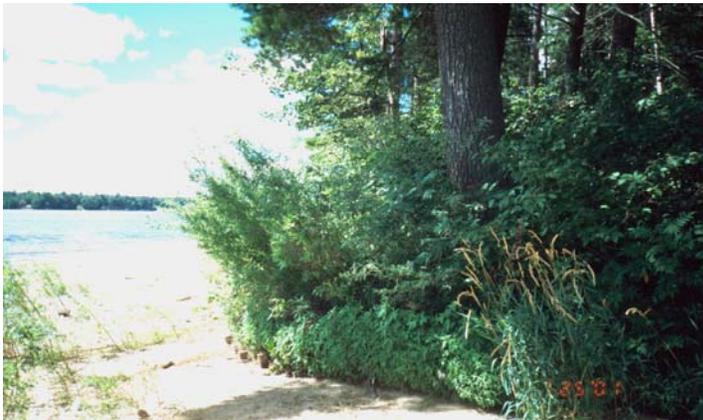
Figure 26. Undercut tree and escarpment on Rice Reservoir, Wisconsin

Figure 27. CGRs used to restore bank in figure above.

Figure 28. Restored bank at same location as shown in figure above.

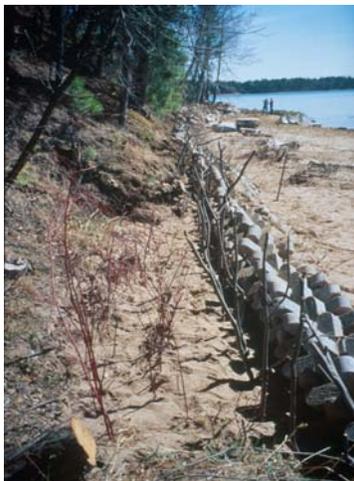
Figure 29. Schematic of A-jack and A-jacks with willow cutting

Figure 30. A-jacks immediately after installation

Figure 31. A-jacks and willow treatment during 3rd growing season

A-jacks® and willow cuttings. A-Jacks® are concrete structures that look like playing jacks and are installed in rows in combination with willow cuttings or similar woody species (Figure 29). Each A-Jacks® unit, when installed, has three 60-cm (24-in.) axes forming six 30-cm (12-in.) legs. The lowest rows of A-Jacks® are trenched in close to the base of the bank. Fibredam®, a synthetic geotextile, is placed between the rows and in the crevices to reduce soil movement and encourage root growth through the A-Jacks®. Live native willow and dogwood cuttings are hydraulically jettied into the structures. The A-Jacks® are then backfilled with a soil/rock mixture. Figure 30 shows a photograph just after installation at a Wisconsin reservoir and Figure 31 shows the same treated area almost 3 years after installation. As can be seen, the A-jacks® are almost masked by the willow and will be completely hidden as time progresses. The treatment is effective in reducing toe scour and undercutting and will allow the bank to become vegetated and heal. It is most effective where there is some bench on which to work right below the escarpment.

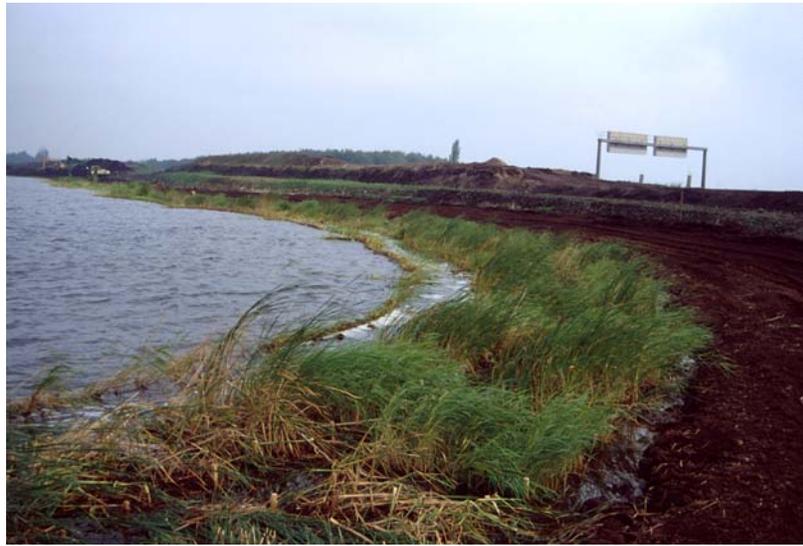
Figure 32. Drawing of CGR with single emergent aquatic plants installed shoreward of it

Figure 33. Reservoir in northern Germany with a CGR breakwater and emergent aquatic plants in erosion control mats

CGR breakwater with emergent aquatics. CGRs can also be used as a breakwater in addition to its use described above. They can be planted with sprigs of emergent aquatic plants, such as water willow, bulrushes, sedges, and rushes. Shoreward of the breakwater and in the area encompassed by it, emergent aquatics can be planted as single sprigs (Figure 32). Alternatively and as described earlier, the emergent aquatics can be planted in erosion control mats for even greater assurance of survival and development (Figures 33). Figure 33 shows plants in mats that were planted in the nursery and allowed to grow before the mats were transferred to the field site.

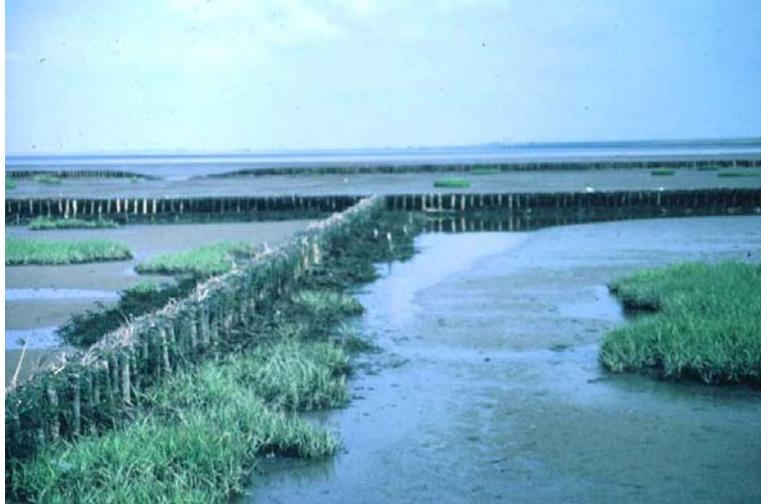
Figure 34. Schematic drawing of branchbox breakwater with emergent aquatics shoreward of it

Figure 35. Branchbox breakwaters with marsh grass employed on North Sea coast, Heidi, Germany

Branchbox breakwater. Another type of fixed breakwater is one that was developed in Europe and employed with marsh grasses shoreward of it to control erosion and develop fast land along the North Sea coast (Figure 34). A system of 100- by 100-m squares of branchbox breakwaters were used in conjunction with stone groins to protect a dike at the town of Heidi, Germany, along the North Sea coast (Figure 35).

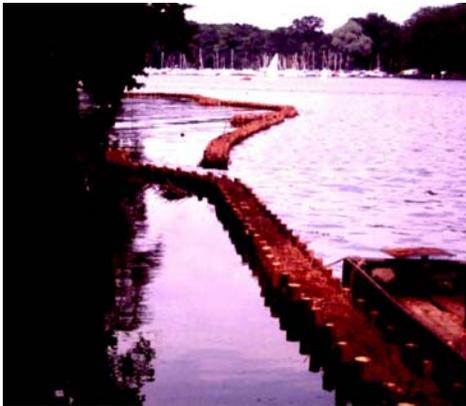
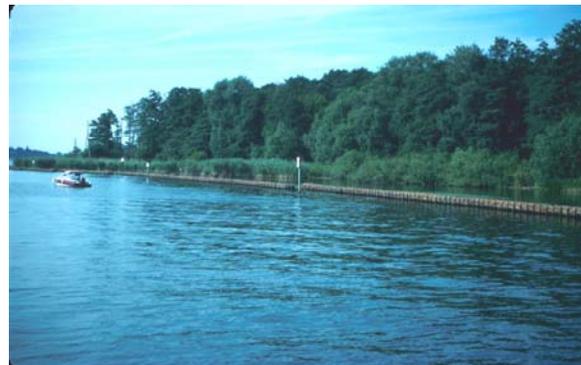
Figure 36. Branchbox breakwater at Lake Havel, Berlin, Germany.

Figure 37. Branchbox breakwater system at Lake Havel, Berlin, Germany

Lothar Bestmann, a German bioengineer, later employed similar types of breakwaters along the shoreline of Lake Havel, Berlin, Germany to control erosion (Figures 36 - 37) and clean up the water through the contaminant uptake of emergent aquatic plants. He used a series of these with gaps in them to allow access to the shore by boats and ingress and egress of aquatic organisms.

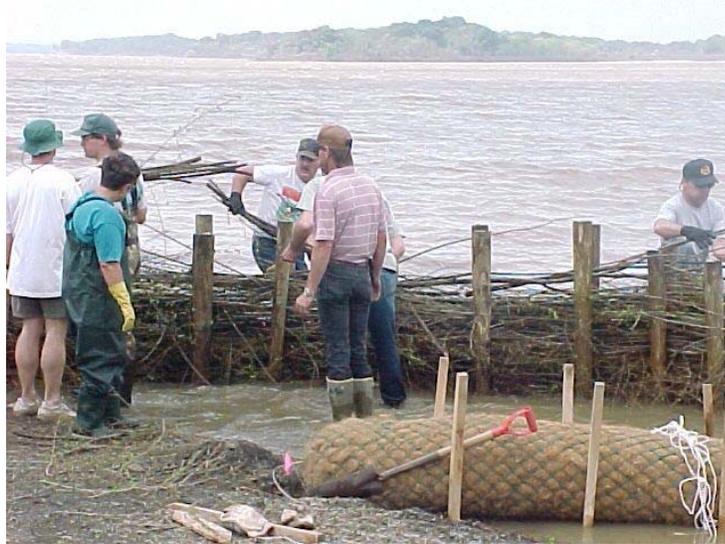
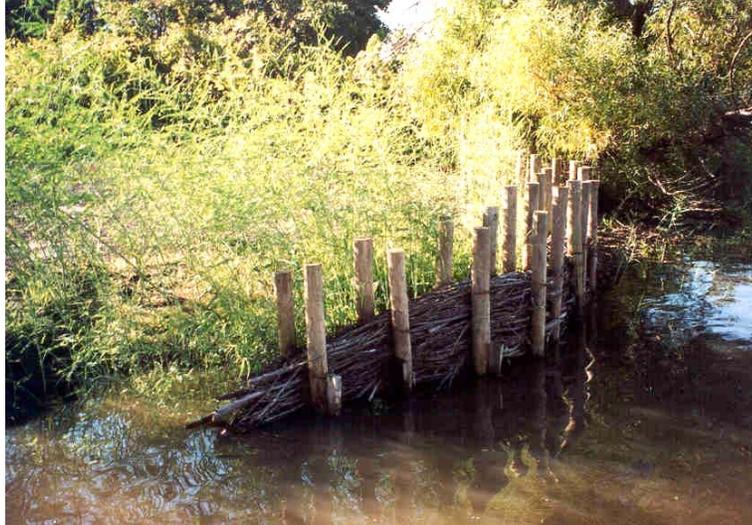
Figure 38. Branchbox breakwater being installed at a workshop/demonstration, Lake Wister, Oklahoma, April 2000

Figure 39. Branchbox breakwater at Lake Wister as viewed from a boat on September 11, 2001

A branchbox breakwater with vegetation behind it has been used successfully at several different lakes by the author in the United States. One was used at Lake Wister, Oklahoma as part of a workshop and demonstration in April 2000. The breakwater was installed on a reach of shoreline that is exposed to greater than a 2-mile fetch from the southwest (Figure 38). The area shoreward of the breakwater was

planted with both emergent aquatics, e.g., water willow, bulrush, sedges, and willow cuttings farther up on shore. The area was examined in September 2001 and was found to be functioning very well in terms of controlling erosion and providing habitat benefits (Figure 39).

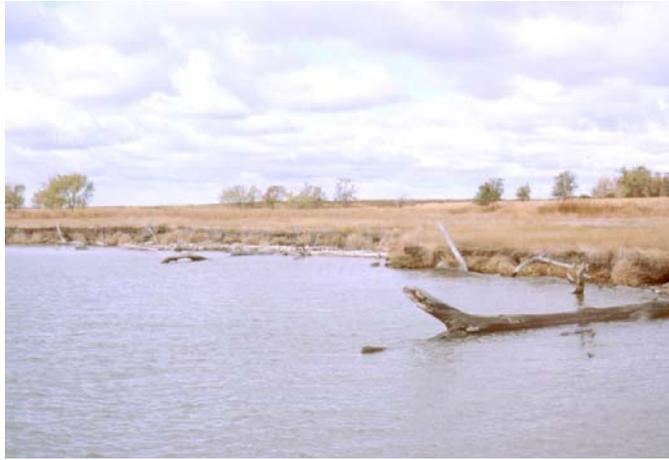
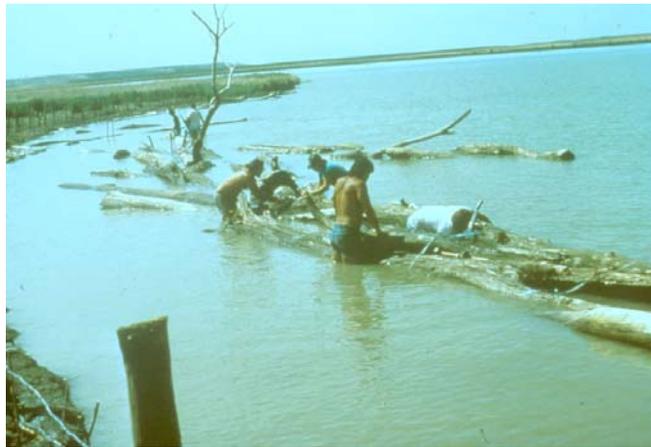
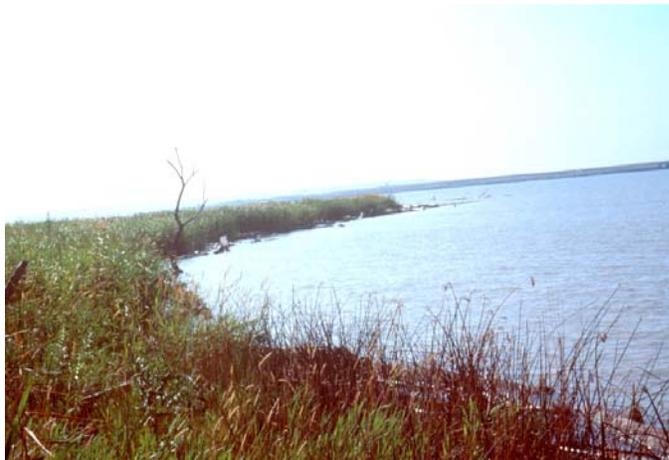
Figure 42. Shoreline erosion control site at Lake Sharpe, South Dakota, 1988

Figure 43. Log breakwater installation, Lake Sharpe, South Dakota, Summer, 1989

Figure 44. Log breakwater site 6 years after construction (August 1995)

cables and soil anchors as shown in Figures 40 - 41. Such a breakwater was used at Lake Sharpe, South Dakota, to control shoreline erosion on a reach that had 2- to 4-ft escarpments as a result of wind-driven waves from a 2- to 3-mile westerly wind (Figure 42). Figure 43 shows personnel cabling the logs together that were floated over to the site. Emergent aquatic plants, such as bulrush and cattail were planted shoreward of the breakwater. Within a growing season, the area was covered with marsh vegetation. The breakwater withstood several years of ice action and the vegetation healed the bank (Figure 44).
