# **Implementation of Non-Point Source BMPs**

## **In the Fourche Maline Arm of Lake Wister**

**(C9-996100-05, Task 700)**

### **FINAL REPORT**

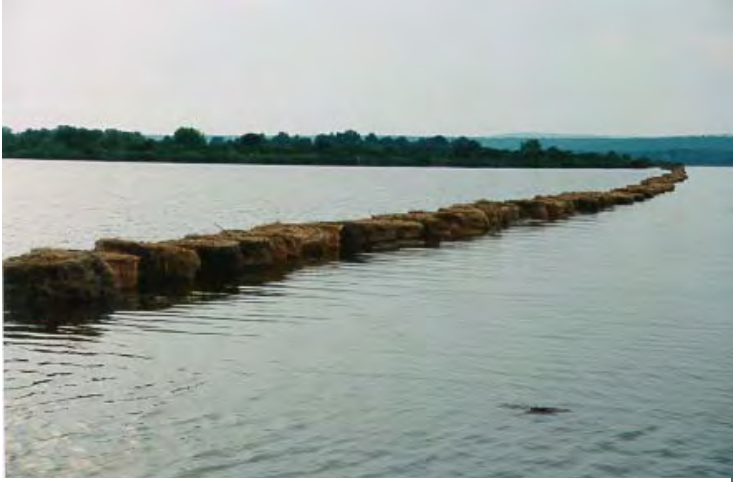
**Completed barrier in the Lewis Creek arm.**

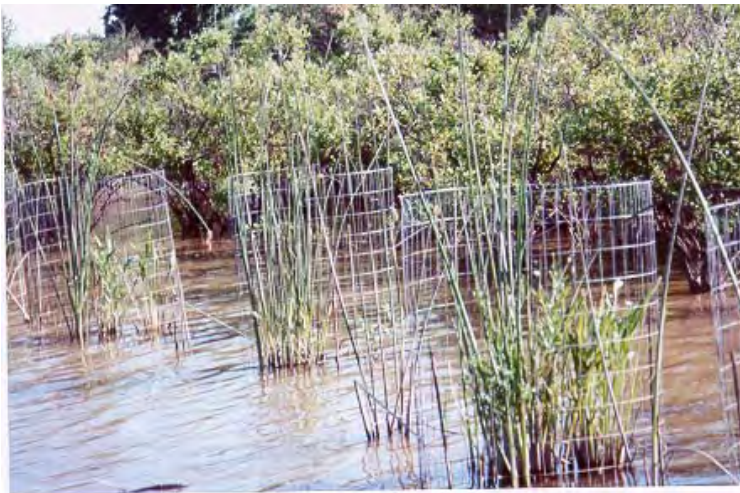
**Aquatic plant community transplanted into Lake Wister.**

around the state. Herbivore control, such as the wire cages seen at left, is recommended to allow the transplants to establish. Once established, herbivore control would no longer be needed. Plant establishment in Lake Wister has already shown that this remediation device can be successful long-term. The water benefit of established plants is evidenced by the sediment accumulation around the root systems of growing transplants in the lake.

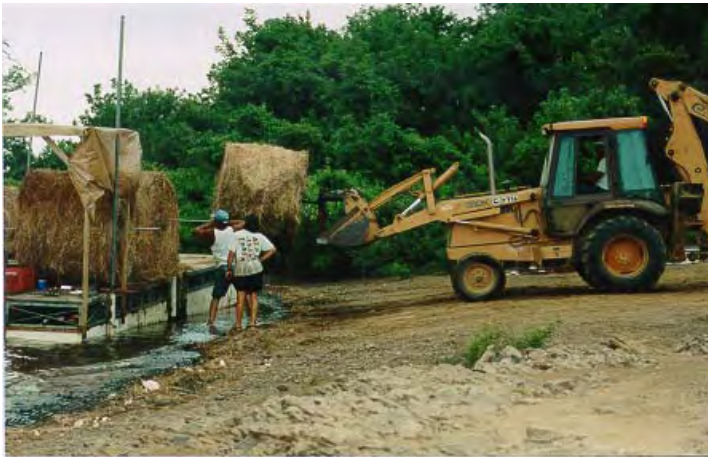
**Figure 3.1. PVIA loading the hay onto the barge**

The marine installation was awarded to Recon Marine out of McAlester, OK for a total cost of \$18,000. The PVIA provided the manpower and equipment to load the round bales onto Recon’s barge (Figure 3.1). Recon then floated the hay to the

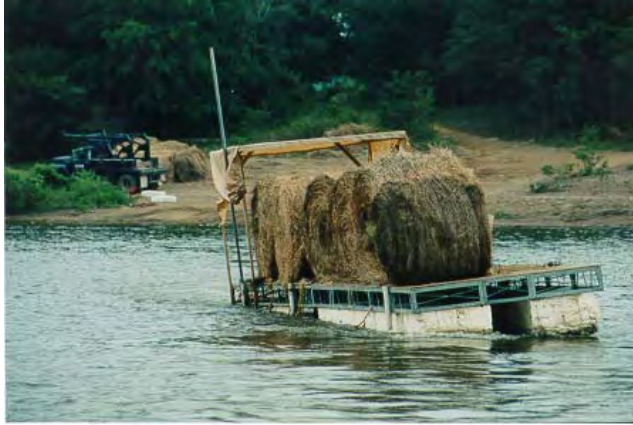
**Figure 3.2. Transport across Lake Wister to the installation site**

installation site (Figure 3.2). Recon Marine developed a method of anchoring the bales to the lakebed using a combination of steel t-post, 9-gauge wire and a scrap piece of 2x4. The steel post was driven into the lakebed while the wire was attached to the top of the post. The wire was then threaded through the bale. As the bales flooded with water the wire was wrapped around the 2x4 (Figure 3.3).

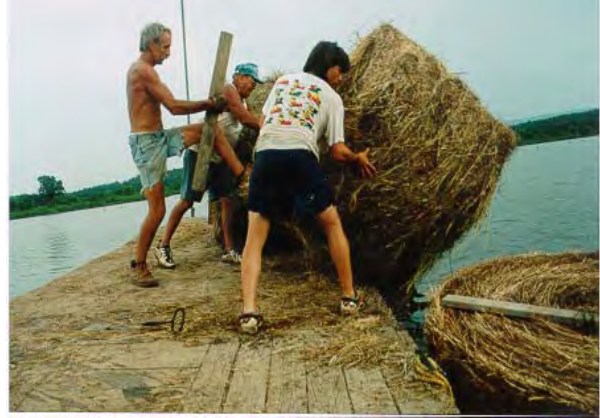
**Figure 3.3. The installation process**

When the bale settled onto the lakebed the 2x4 was snug to the top of the bale. This helped keep bales from floating off when the pool elevation rose above conservation pool. The OWRB furnished steel t-posts from a local business at a cost of approximately \$650. Figure 3.4 shows the installed barrier in the Lewis Creek arm of Lake Wister.

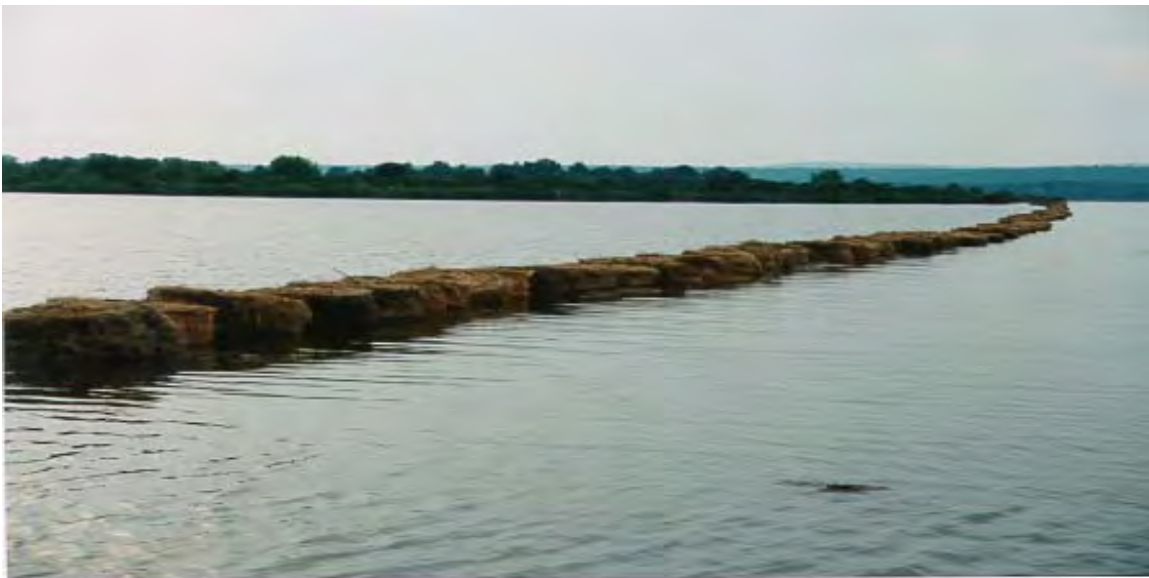
**Figure 3.4. Completed installation**

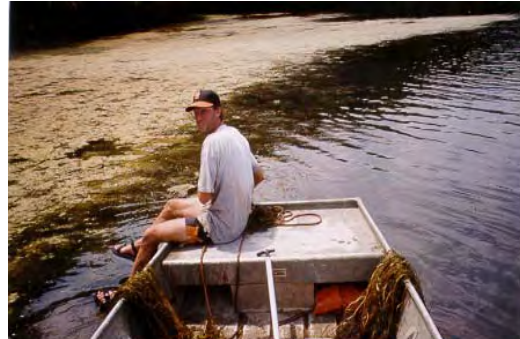
**Figure 3.7. Harvesting Water Stargrass from Spavinaw Lake**

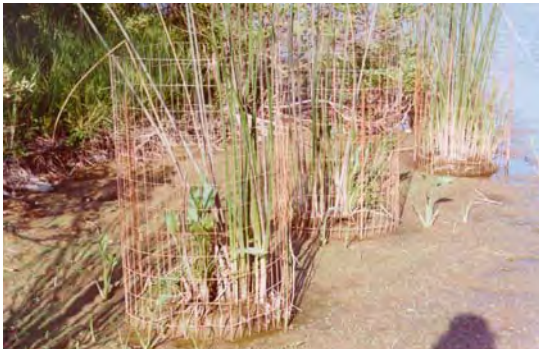
**Figure 4.14. High transplant protection.**

Approximately 1.75 miles of shoreline were planted with softstem bulrush transplants. These plants were placed approximately four feet apart with a water depth ranging from 3 to 12 inches below conservation pool. Three levels of protection from herbivory were used -- high, low and none. High protection consisted of placing a "tomato" cage constructed of 2-inch by 4-inch galvanized wire around the transplant (Figure 4.14). To prevent entry from the top as well as the sides, some cages were "bent" over the top to completely enclose the cage. A low level of protection was given by placing 24-inch by 24-inch pieces of 2-inch by 4-inch galvanized wire mesh flat on the ground over the transplant (Figure 4.15). This measure protected the root mass from disturbance but not the above ground growth. Finally, a portion of the transplants was given no cage protection at all. Monitored parameters included number of living shoots, depth of the water at which the plant was growing, height of the tallest shoot, presence or absence of reproductive structures, caged status and type of cage, other species growing with the bulrush, and whether or not herbivory had occurred.

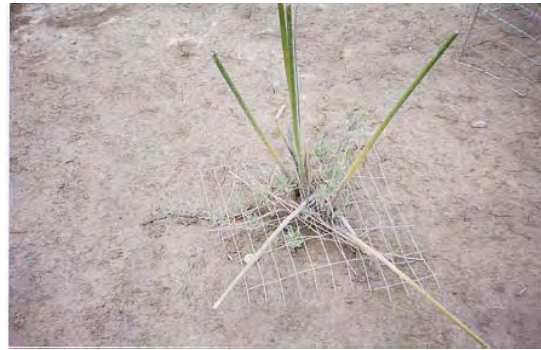
**Figure 4.15. Low transplant protection.**

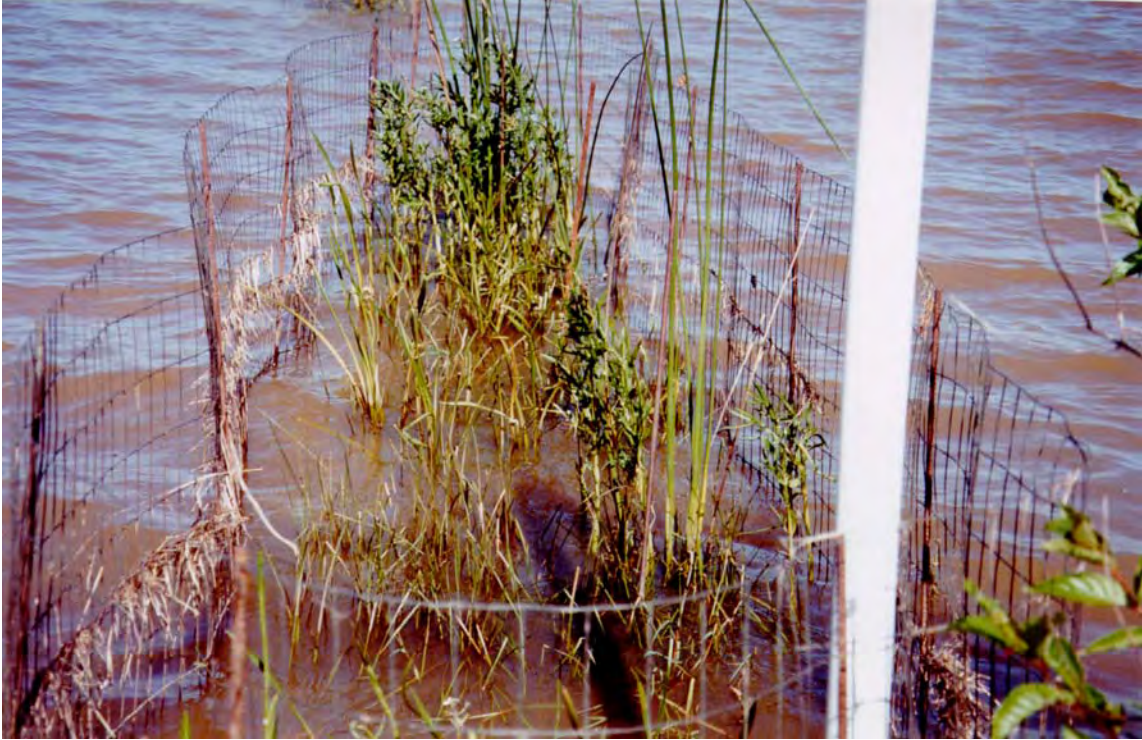
**Figure 4.16. June 9, 2000 - Transect 1 showing growth of water willow, bulrush, smartweed and arrowhead. Some aquatic grasses also were noted here.**

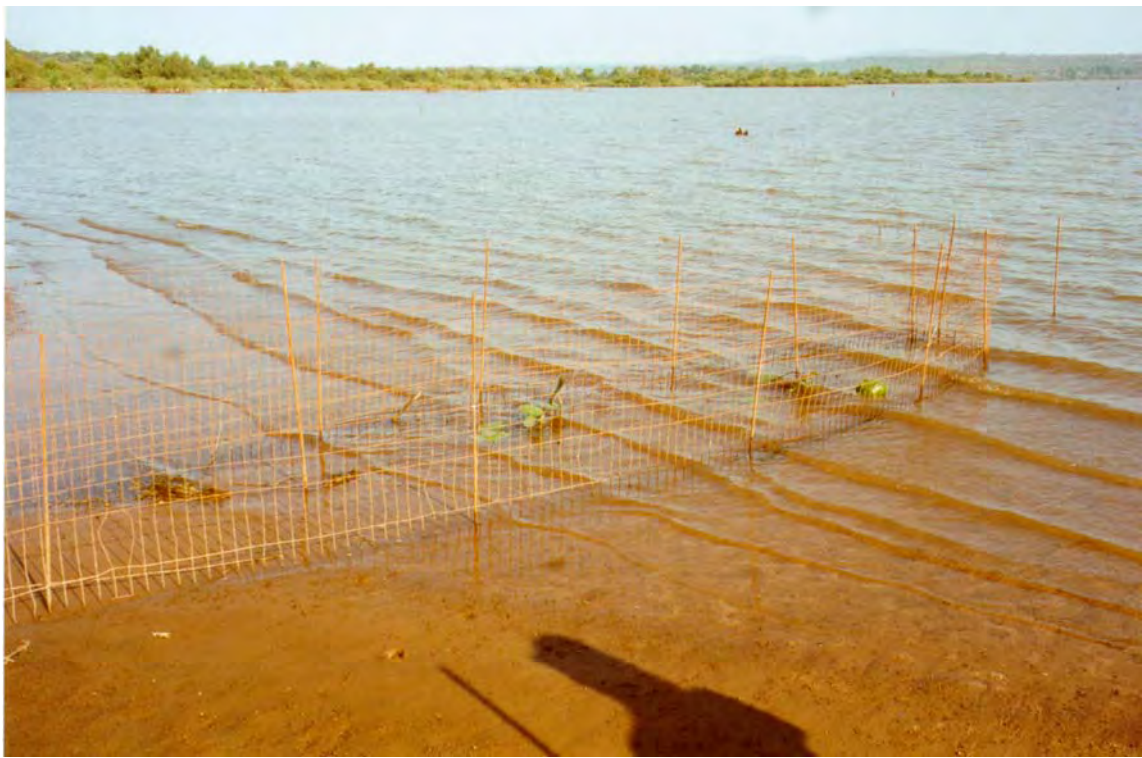
**Figure 4.17. June 9, 2000 - Transect 3. There was little survival except for cow lily (*Nuphar luteum*) in caged area.**

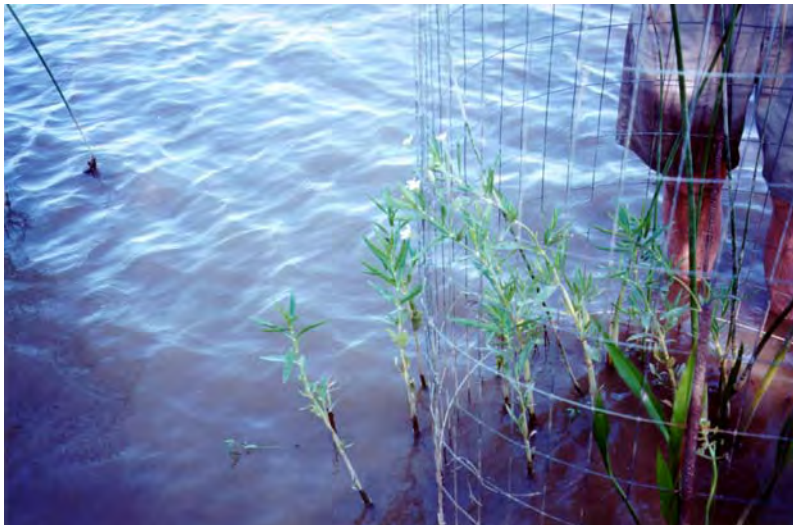
**Figure 4.18. Water willow and arrowhead plants transplanted with the bulrush.**

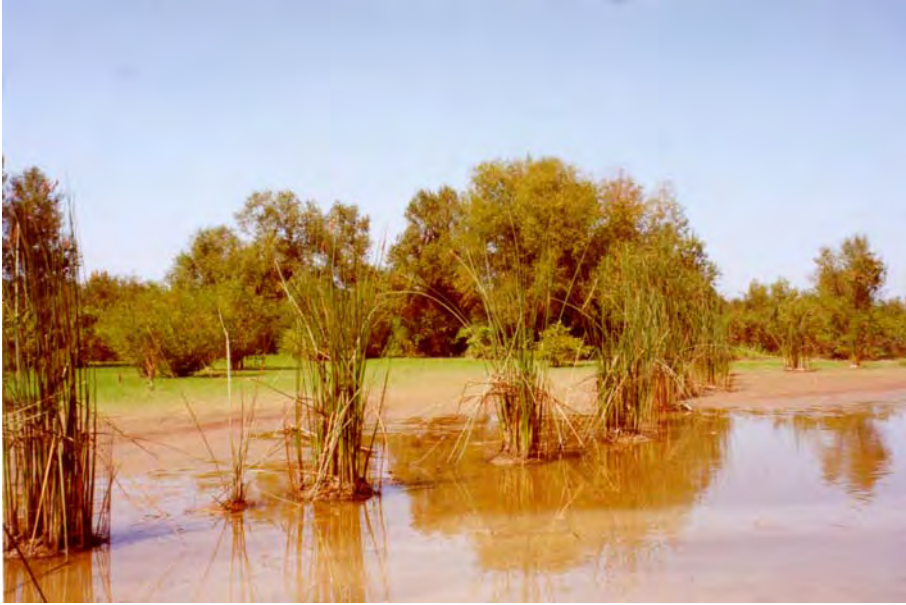
**Figure 4.19. Transplanted bulrush in September 2000. The second plant from the left represents a transplant that received a low level of protection. All other plants in the picture received high level of protection.**

Analysis of the data revealed that the caged plants had a far better survival rate than those not caged. Those not caged showed considerable loss to herbivory and also some loss by wave action. The plants that were protected in standing cages (high level of protection) showed considerably less herbivory than those afforded a low level of protection (covered with flat cages) (Figure 4.19). Standing cages also revealed a greater percentage of the plants that had other species growing with them. Comparison of the data also revealed that considerably more of the plants protected in the standing cages had reproductive structures (Figure 4.20). These show that the plants with a high level of protection were the most robust transplants and most viable for establishment in Wister Lake.

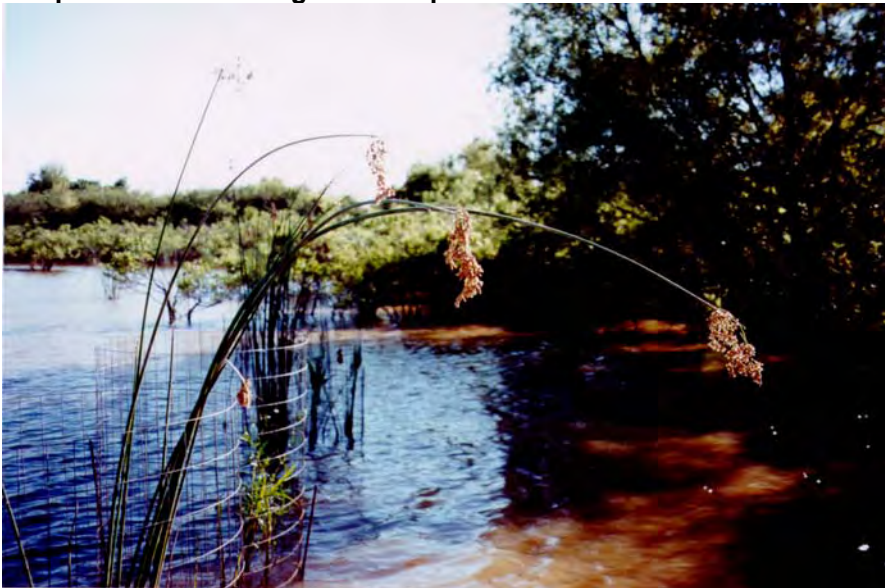
**Figure 4.20. Sexual reproductive structures on bulrush.**

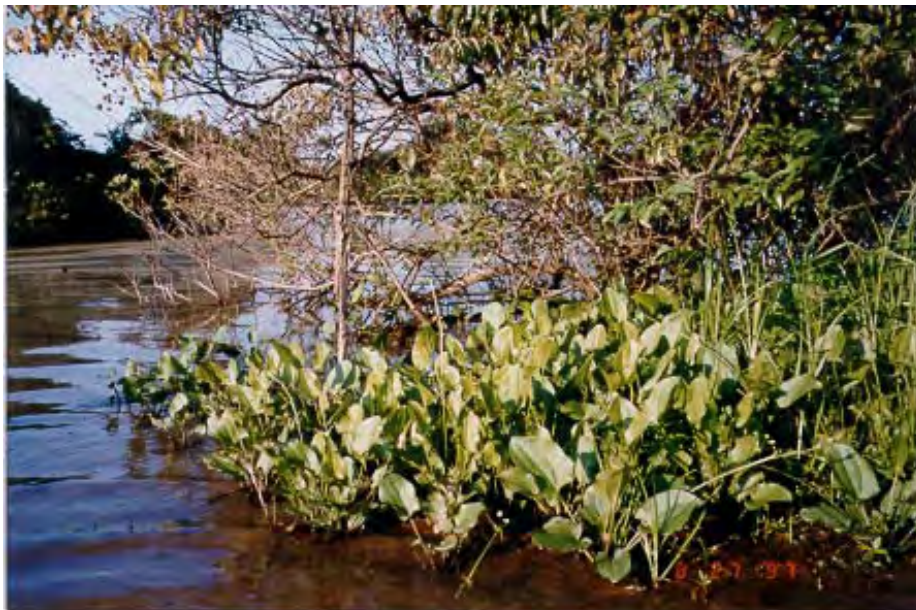
Figure 5.1. Patch of mud plantain, *Echinodurus rostratum*, in Lake Wister.

Table 5.1. Plant species noted to grow and reproduce in Lake Wister. Highlighted names show the greatest potential for long-term establishment in Wister Lake. Planting considerations are also noted.

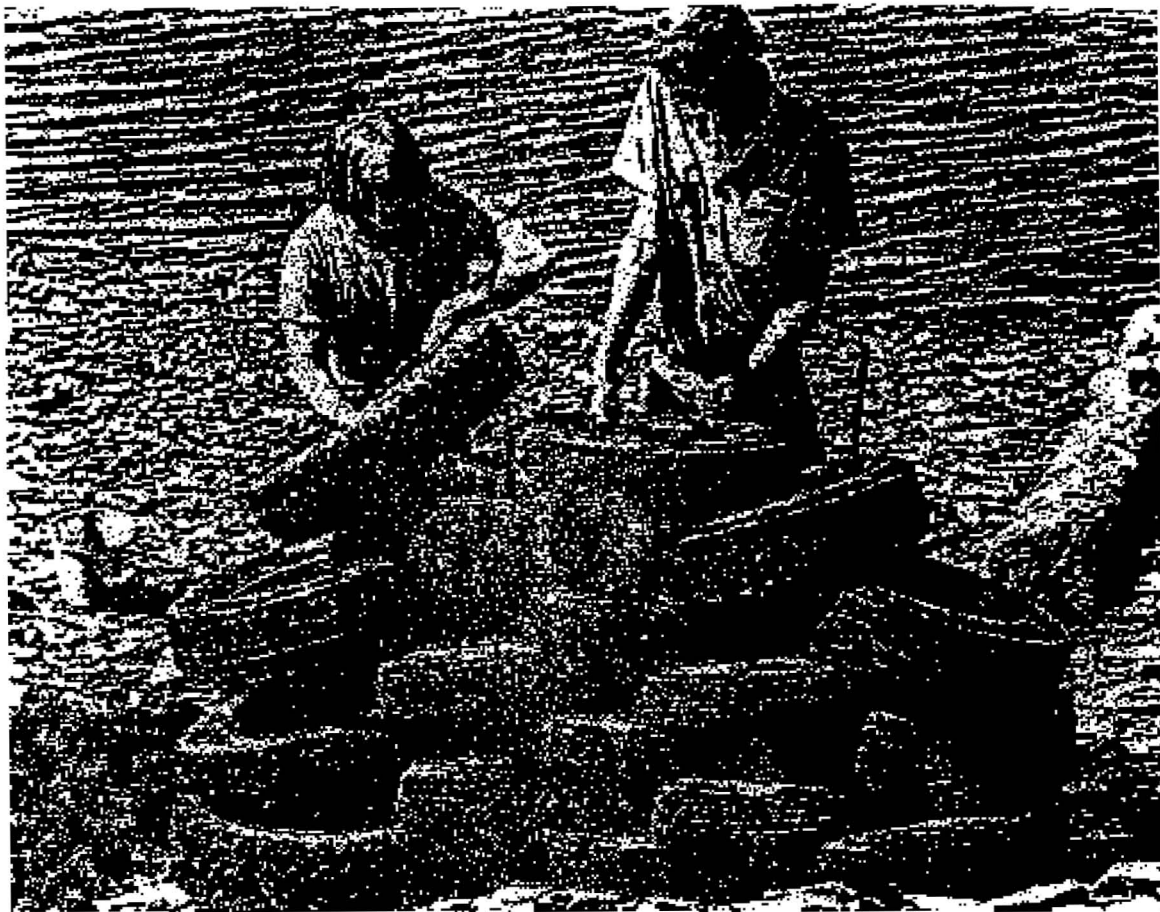
FIGURE NO. 3

Tire bundles are constructed by stacking the tires flat in a 3-2-3-2-3-2 3 configuration. Binding material -- in this case, conveyor belt edging -- is woven through the tires as they are stacked to secure the bundle.
