DEMONSTRATION PROJECT: MITIGATION OF NON-POINT SOURCE IMPACT TO LITTORAL ZONE OF LAKE CARL BLACKWELL, PAYNE COUNTY, OKLAHOMA

FY-01 319(h) Task #01-003
CA # C9-996100-07 Project 3

Subtask 5.1.2 Bioengineering Demonstration
And
Subtask 5.1.3 Erosion Control Monitoring

September 2006

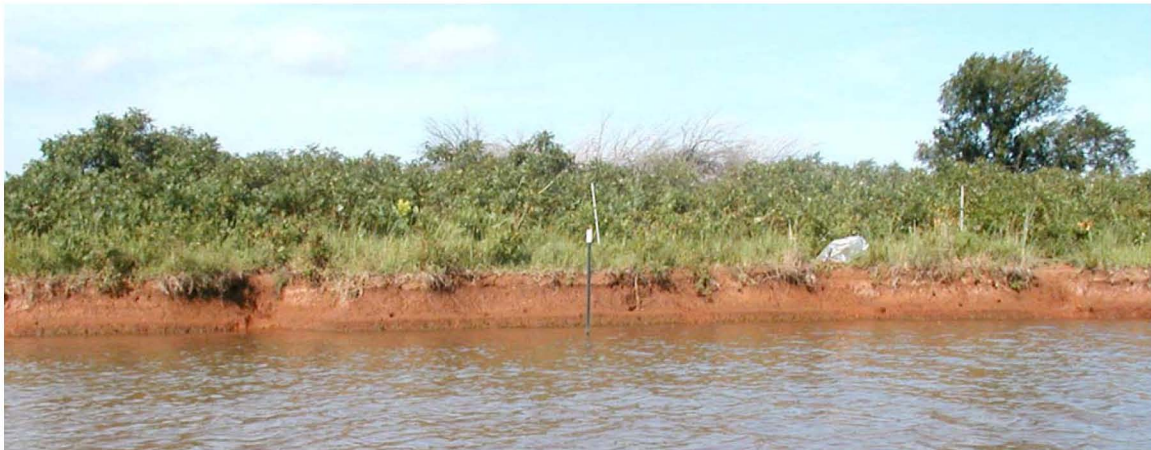
Site 1 is a very typical shoreline found surrounding the lake. It is a hard clay vertical 4-foot escarpment over a softer clay shallow flat. The maximum fetch is 3 ½ miles from the east however the prominent fetch would be one-half mile from the north. Cattle graze the site and have made ruts in the escarpment to reach the water. The site was protected on the shore by installing a solar powered electric fence. There was never any evidence of cattle entering the site over the duration of this project. This site was protected lakeward with a cedar tree breakwater and planted with a broad band of herbaceous plants that once established would protect the shoreline. This remote site was chosen in part because of its proximity to a large source area of cut cedar trees. It later determined that these trees were too old and decayed to be used for this project. Ultimately newly cut cedar trees were used for this site.

Figure 2: Site 1 (specifically Transect 4) before implementation, hard clay vertical escarpment with shallow flat bench

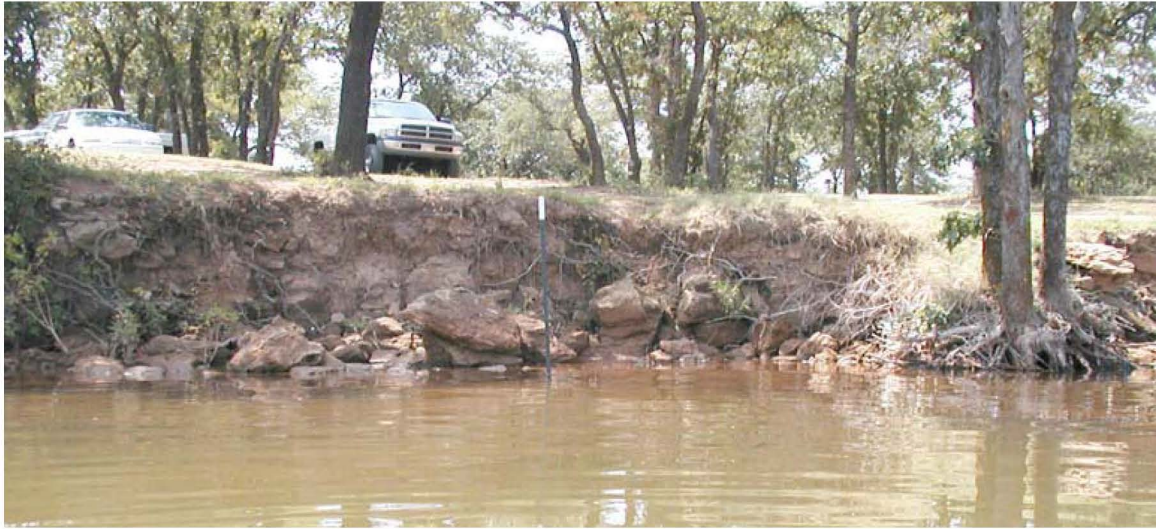
Site 2 is a highly eroded sandstone escarpment with large rocks in the planting zone mixed with an excellent substrate for plants. It has a fetch of 1½ mile. This is a campground site that is quickly eroding away. This would be an excellent point to establish an herbaceous buffer zone to halt this erosion.

Figure 3: Site 2 (specifically Transect 2) before implementation, sandstone vertical escarpment with silt and clay bottom.

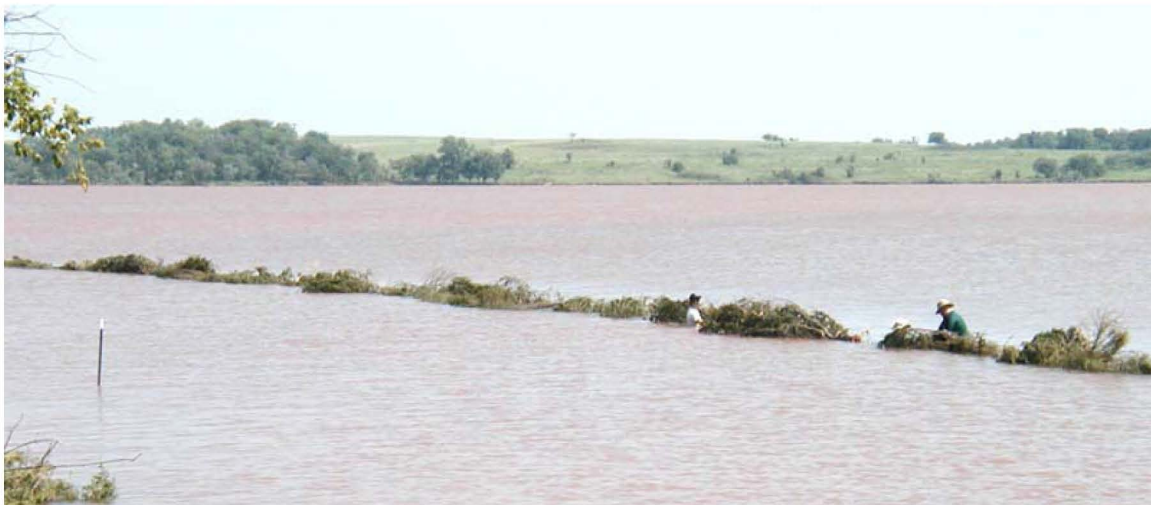
Cedar trees cut by Carl Blackwell staff were pulled into the water by hand to a line roughly 60 ft. from the shore and attached to t-posts set on 8-10 foot spacing. The trees were tied to the t-posts using coated 16-gauge cable. Trees were configured into two rows in opposing direction (top to bottom) with t-post between. This breakwater was 525 feet long. Water depth at the time of construction was 3.5 - 4 feet.

Figure 10: Site 1: Installation of Cedar Tree Breakwater

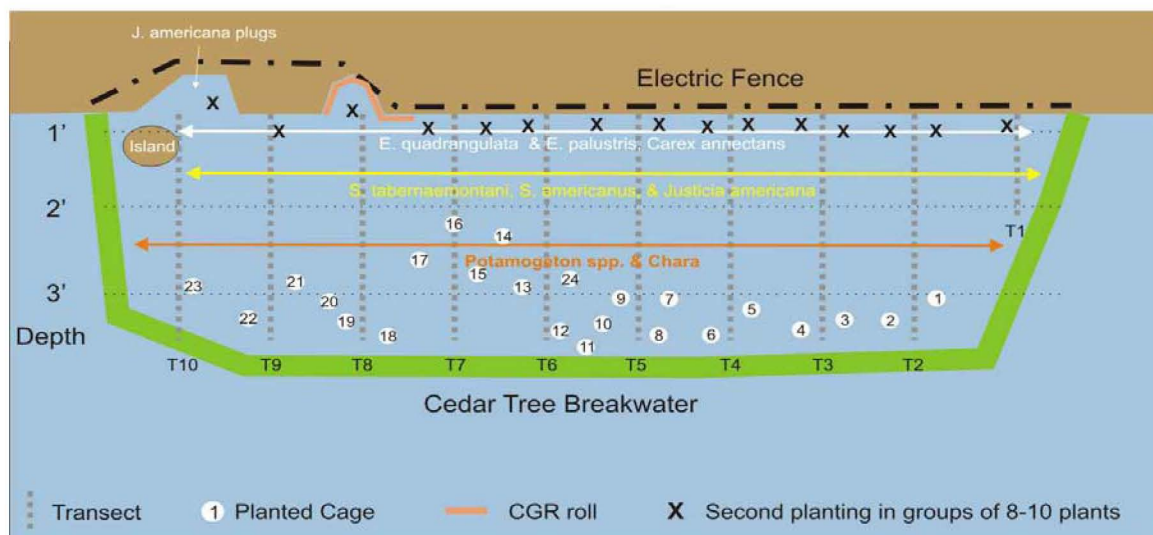
Figure 11: Site 1 Initial Planting Layout as of Summer 2005

An initial assessment of the plantings was made on September 7, 2005. At that time it was discovered that most of the Site 1 plants were gone except for the 6" potted plants in the ring cages which appeared to be fine. We suspect this was due to either herbivory or more likely that the small 2" plugs and bare root transplants were washed out by wave action before they had a chance to root in. Several floating plugs found at the site evidenced this.

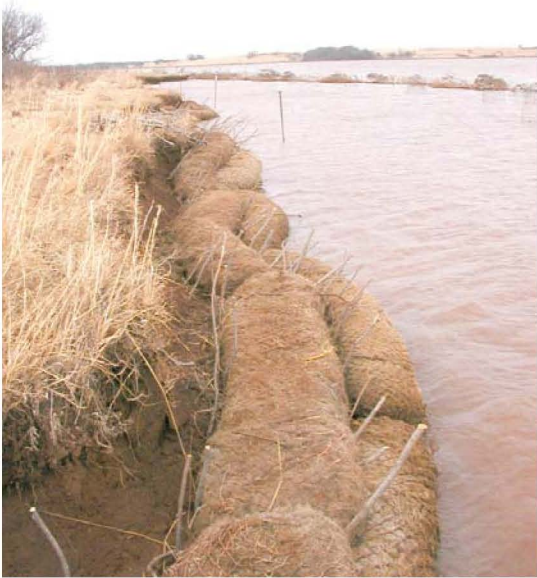
CGRs were planted with dormant black willow (*Salix nigra*) cuttings, a/k/a "live stakes" above and between rolls (Figure 12). The live stakes were cut on the same morning from a drainage ditch in Edmond, OK and transported to the site for planting. Using a steel drive rod and sledge, 1 foot deep holes were driven into the bank (Figure 13). Cuttings soaked in a bucket of root promoting solution before planting. Minimum stem diameter was ½ inch. Planting density was roughly one foot. Holes were tamped closed with a drive rod.

Figure 12: Newly installed CGRs at Site 1 with dormant willow cuttings at 16 inch intervals

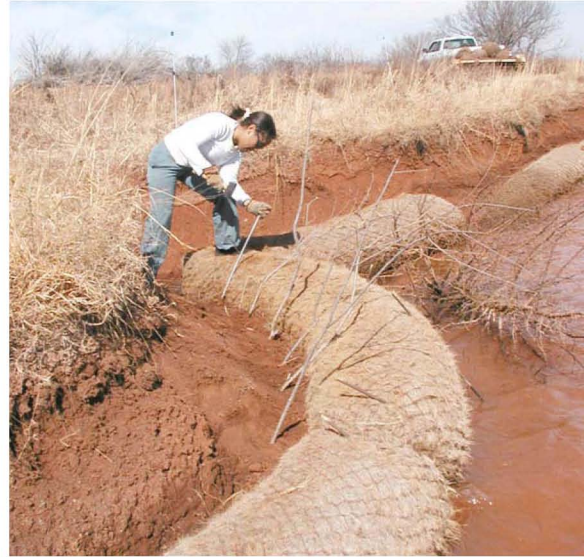
Figure 13: Driving one-foot deep holes for willow cuttings

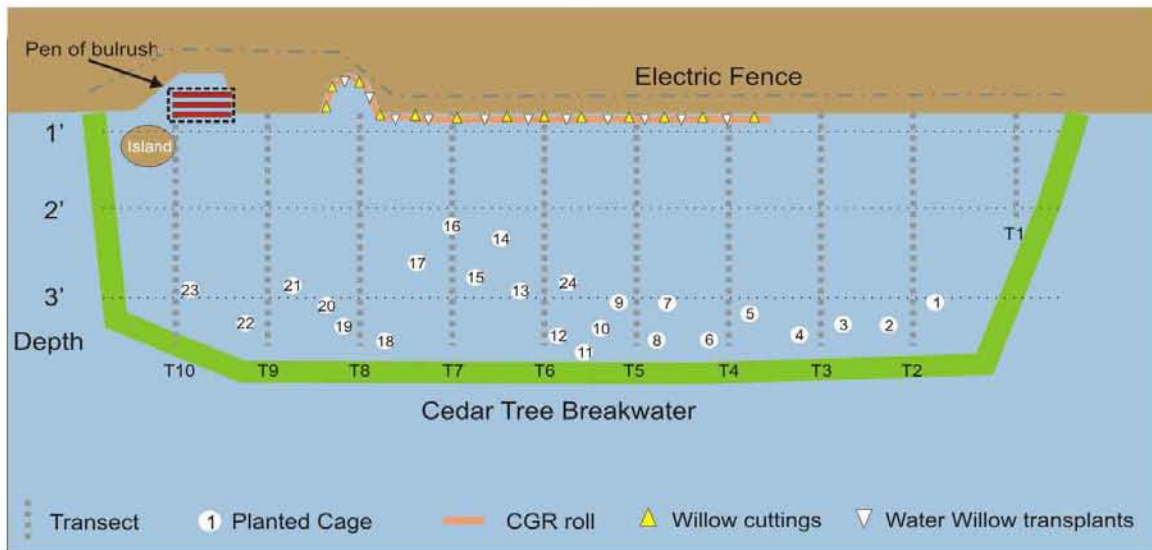
Figure 15: Site 1 Final planting layout as of Spring 2006

The most promising results of this project are to be found in the CGR plantings at Site 1. The black willow trees are fully expected to establish as they are well protected by the CGRs. It will likely take three or more growing seasons before the willows are rooted in well enough to provide substantial protection to the bank. The CGRs are rated to last seven seasons and for that reason should adequately sustain the trees. The waterwillows there are also expected to spread well within the CGR medium since they were kept wet through most of the summer. Once established they can handle drought conditions should it come about.

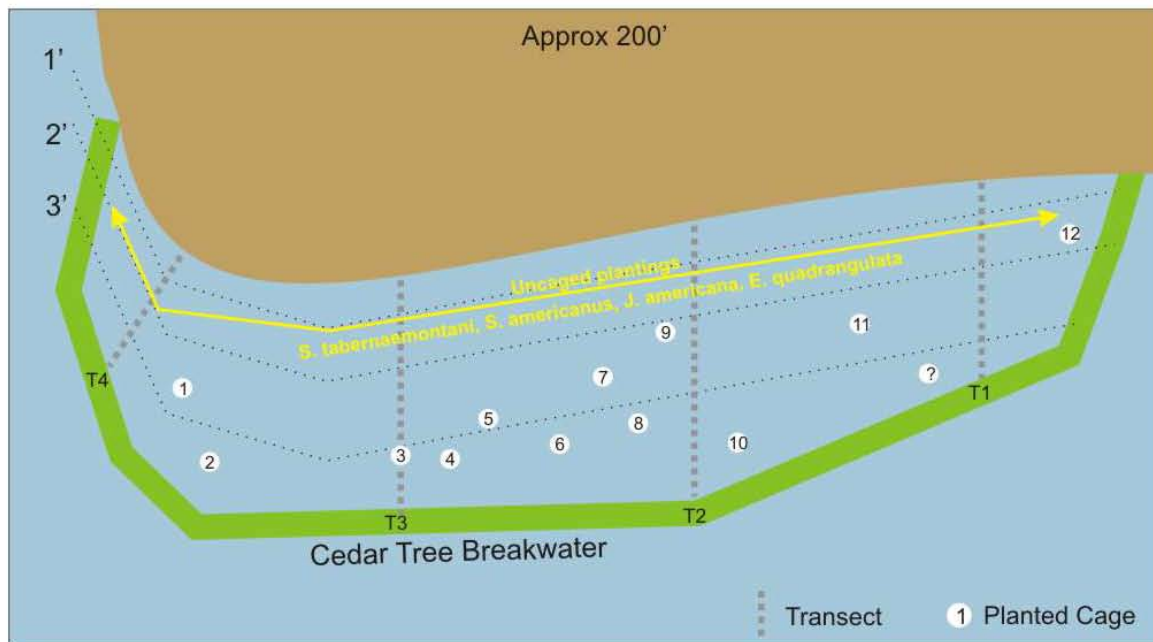
Figure 17: Site 2 planted layout as of Summer of 2005

This site's poor plant survival, 1.4% overall, can be attributed to wave action since even the caged plants did not survive well. One cage of American pondweed did survive with expanded growth within the cage. The 50% coverage is credited as 2 plants out of the 7 planted for a survival of 28.6%. Six cages had been turned over during the spring with no surviving plants to be found. The remaining 6 cages were empty as well. Two individual waterwillow plants survived but did not send out rhizomes to make new plants. The breakwaters were not visibly effective at reducing the high-energy waves coming into the site. No further efforts were made to replant.

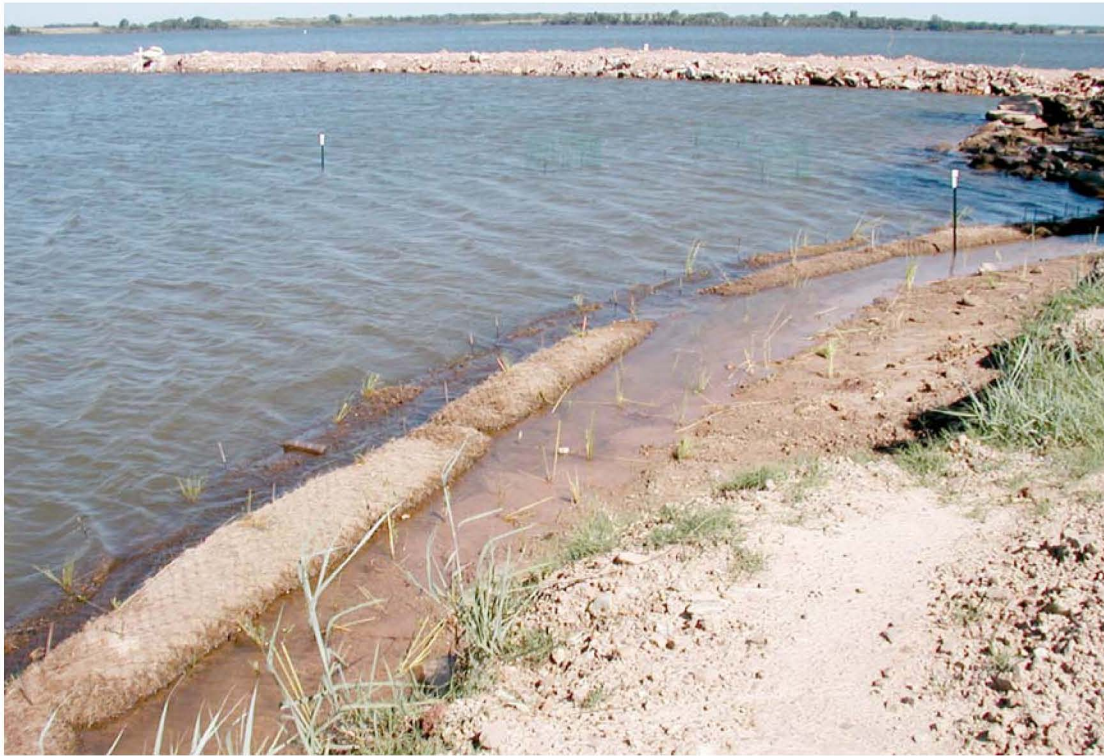
Figure 18: Site 3 looking north - Plantings in and behind CGRs. Green cages of submersed species in background.

High energy wave action continuously loosened the CGRs at the site. It was eventually decided to pull the CGRs and move them to Site 1. (See Sections 5.2 and 5.3.6 "Third Planting").

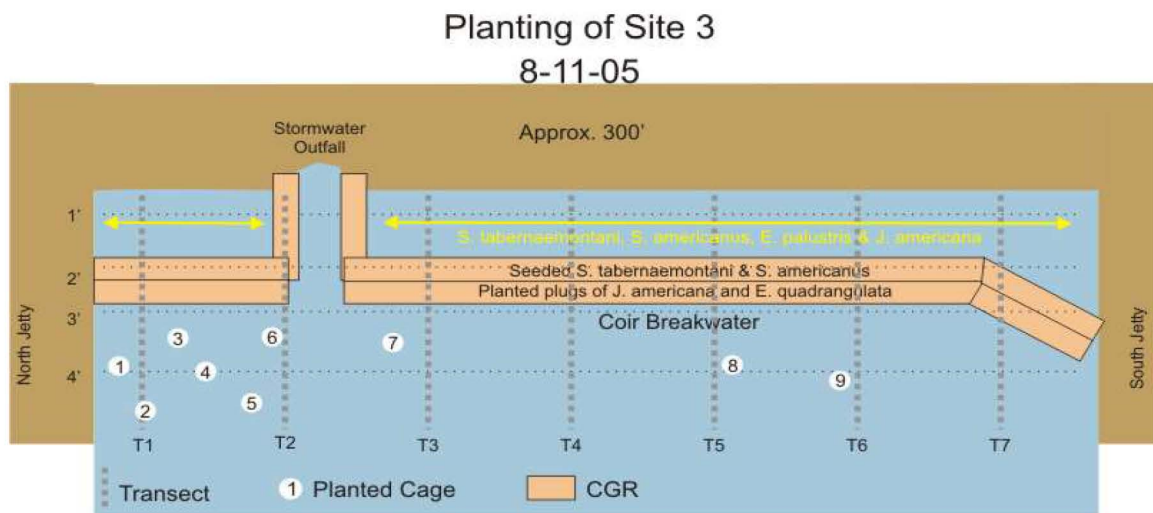
Figure 19: Site 3 planting layout

This site also had problems with herbivory and wave action. The only surviving plants were those out of the water or in a single cage protected further by its proximity to the north jetty. The surviving caged plants were American pondweed at 100% coverage. Surviving emergent plants were small clumps of squarestem spikerush, softstem bulrush and common bulrush found above the waterline and thus protected from wave action and aquatic herbivory. While this site was planted initially into and behind the CGR, the breakwater was unstable killing most of the site plants. The breakwater was eventually abandoned and CGRs moved to Site 1 to abut the bank there.

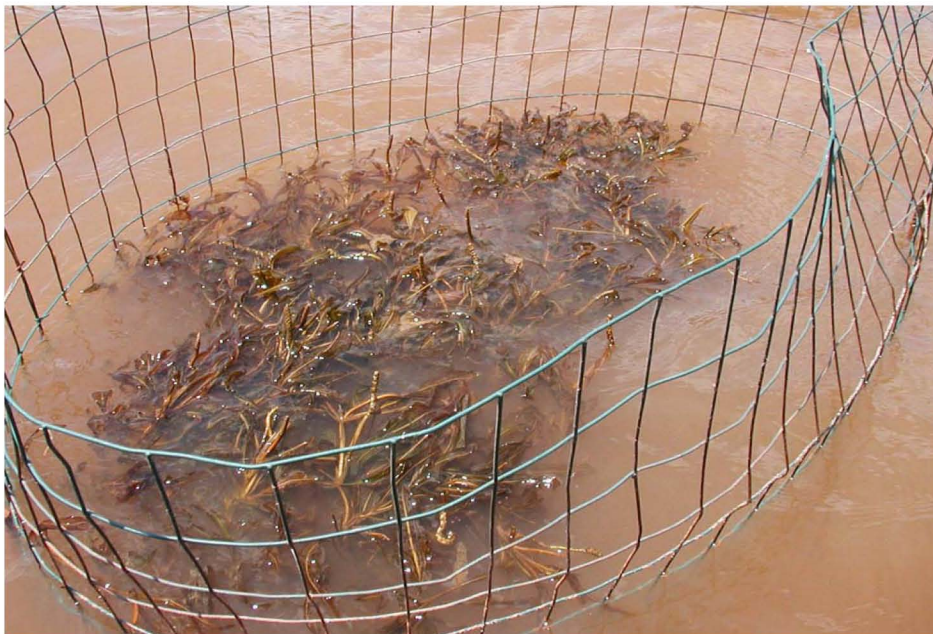
Of the submersed species, Illinois pondweed (Figure 21) had the highest survival rating at 660% due to the exceptional growth both inside and out of the cages. All of its cages filled to capacity and extended to plants two feet beyond their cages. At one point there was a thick ring of pondweed for 5'-10' beyond the cages. Much of this was found washed against the embankment two weeks later when we returned with a camera. Most likely broken up by a storm and some herbivory. American pondweed and water stargrass maintained and survived without significant expansion. We can conclude for this time period that wave action and herbivory was within tolerable limits for Illinois pondweed.

Figure 21: Illinois pondweed filling cage at Site 1.

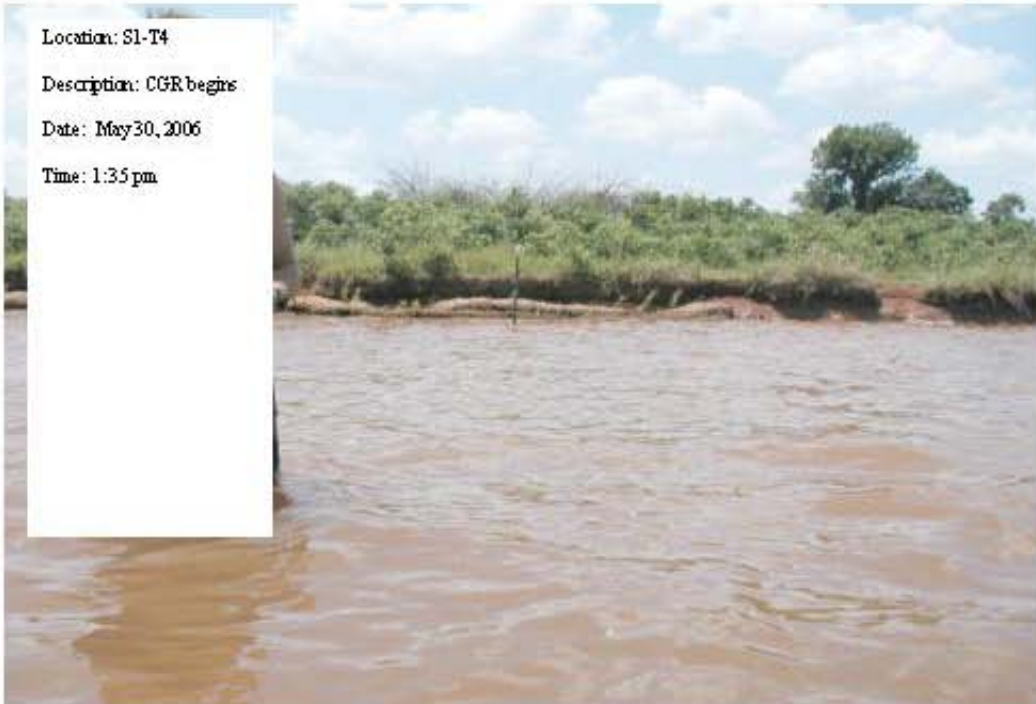
Location: S1-T4

Description: CGR begins

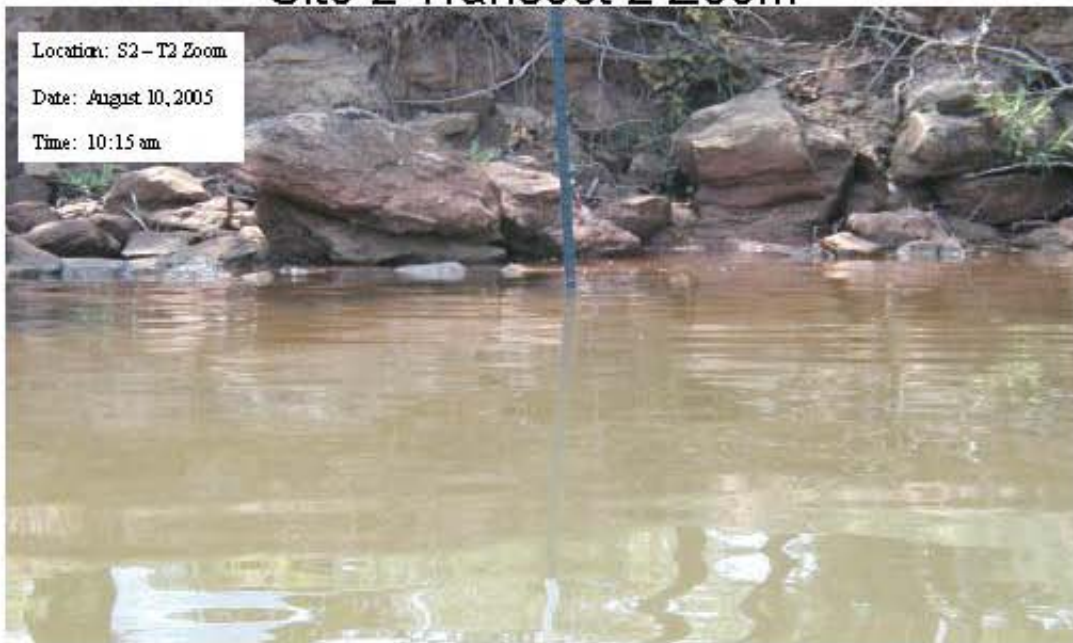
Site 2 Transect 2 Zoom

Description: Large Cedar
broken away from
breakwater lodged in
transect 2

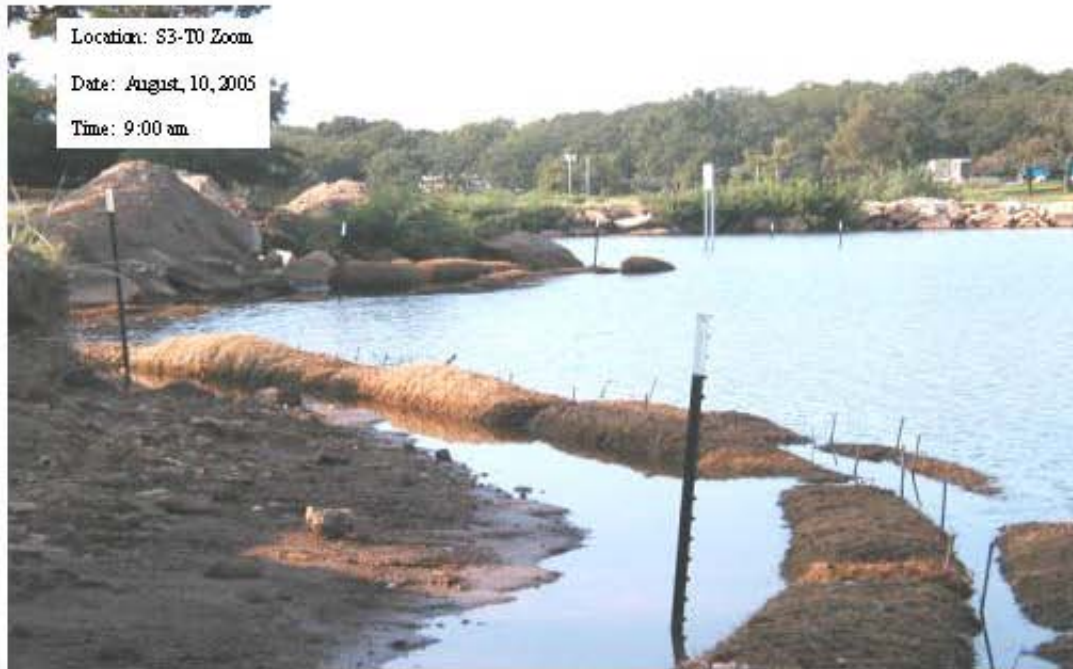
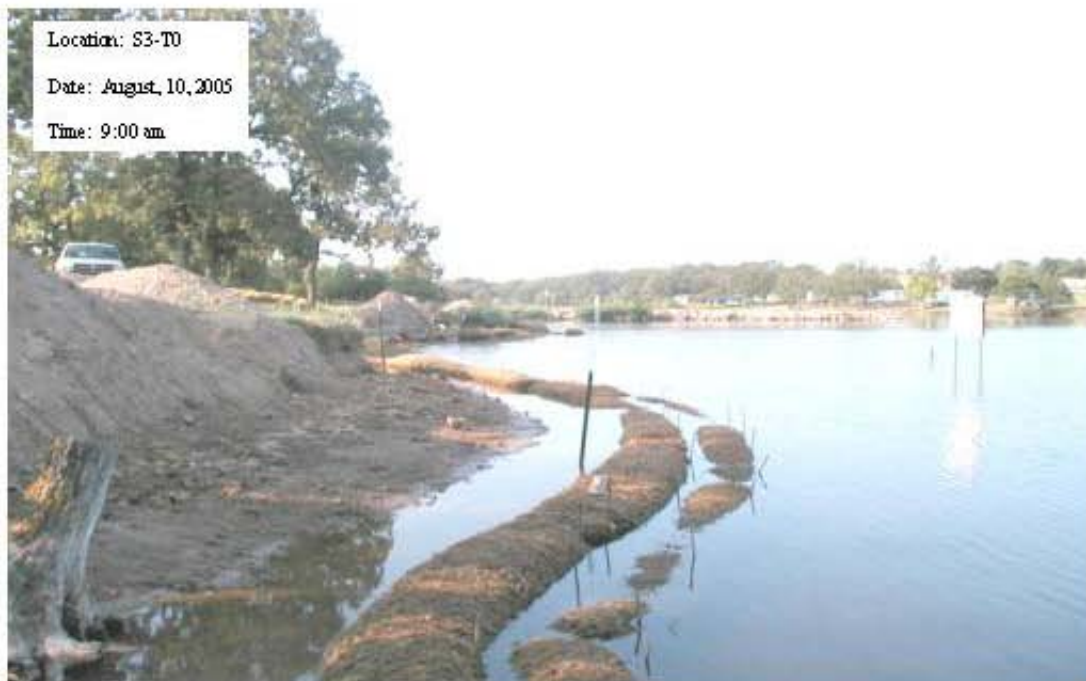
Site 3 Transect 0

Site 3 was dismantled months before the spring assessment. In January 2006 a backhoe was used in the lake to remove the CGRs for use at Site 1. This greatly disturbed the sediment at the site and resulted in knocking down two t-posts. Given two stakes were down and no plants were evident at or near the photo points, photos were not taken of the transects but were taken of the few plants at the site. These were mostly from a replanting effort initiated by LCB staff in May of 2006. These replanted bulrushes were *not* included in the planting results table but photos of them have been included here. Bulrushes were trimmed to < 1 ft. to help stimulate growth and reduce wave impact on the transplants.

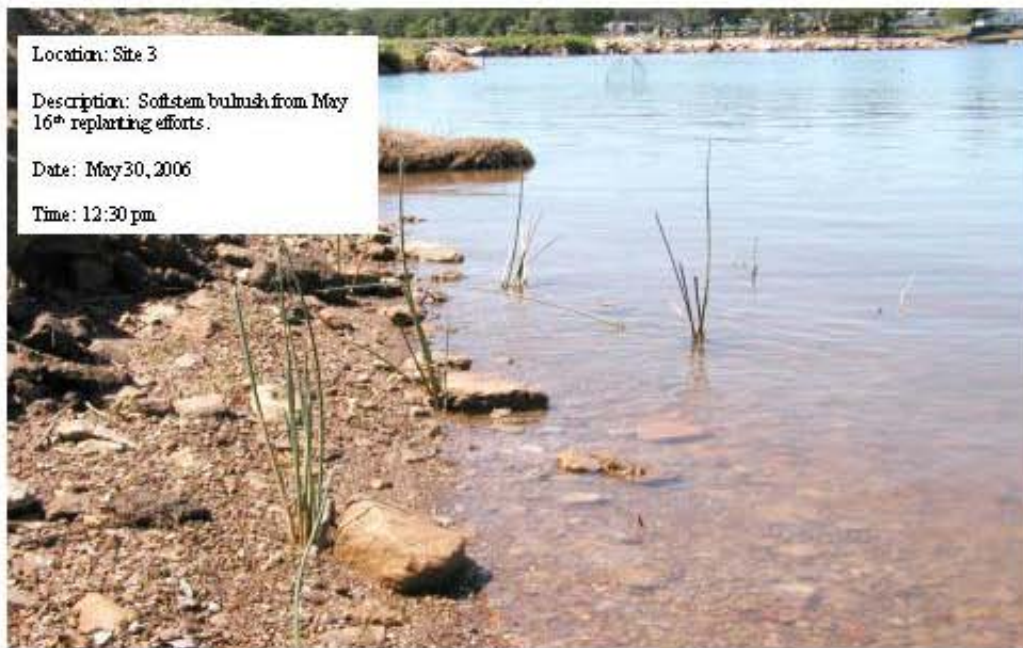
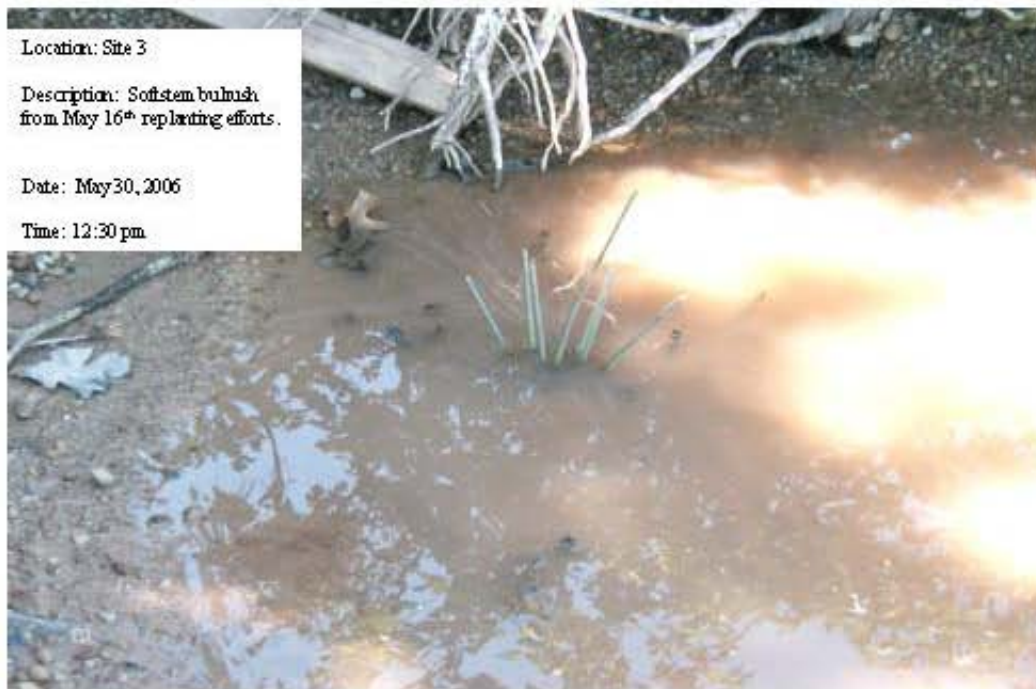
Site 3 - Bulrush Replanted May 16, 2006

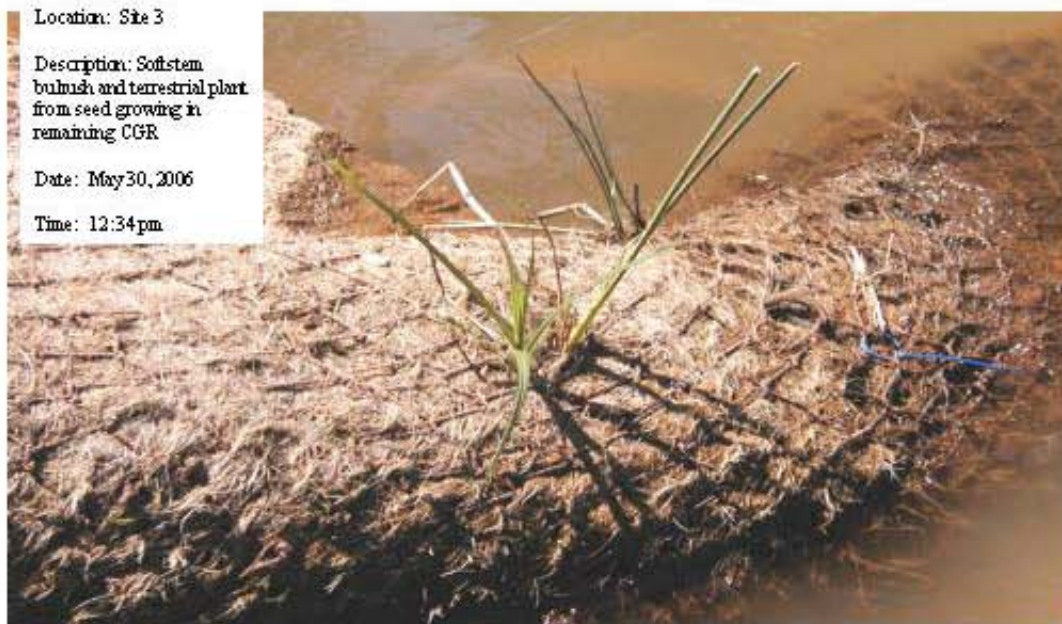
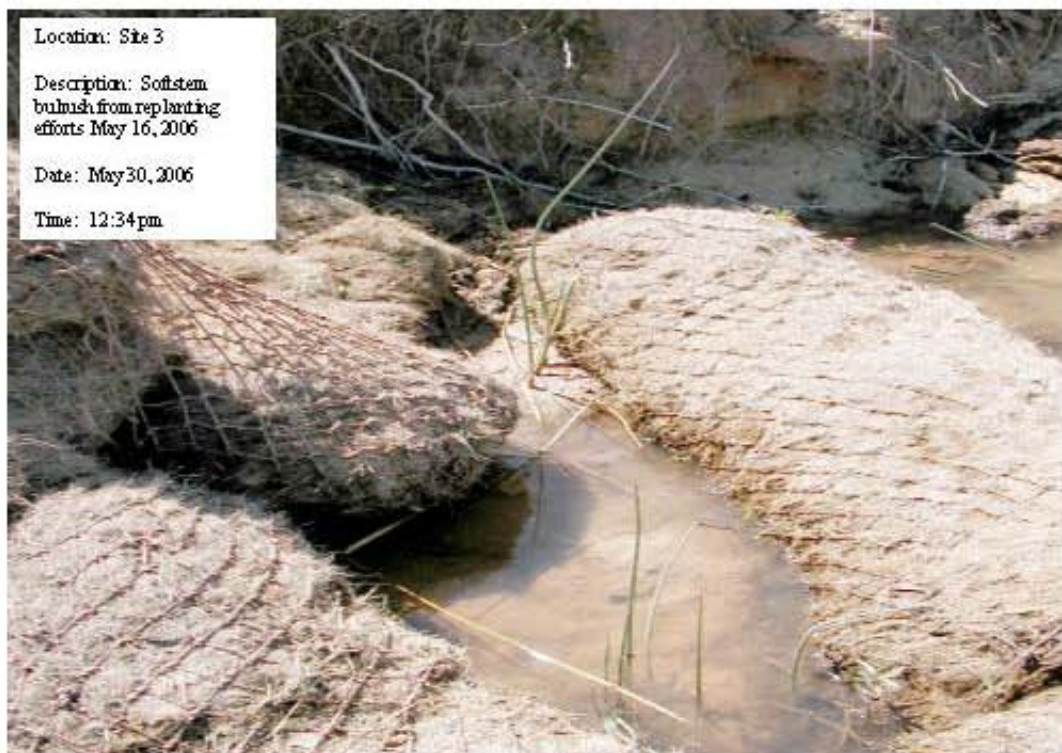
Site 3 Bulrush in Coir

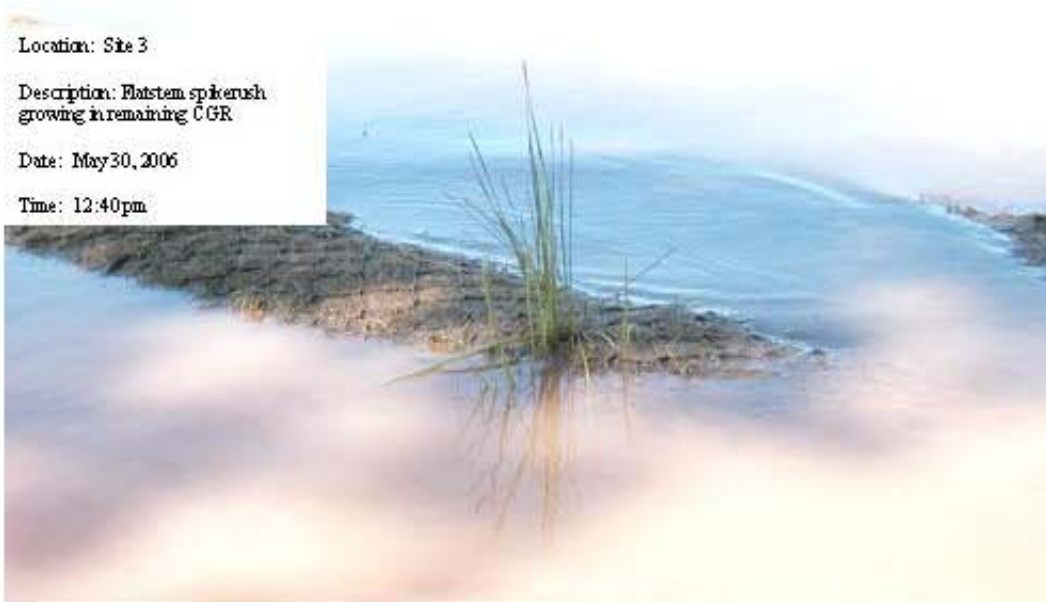
Location: Site 3

Site 3 Spikerush and Common Bulrush

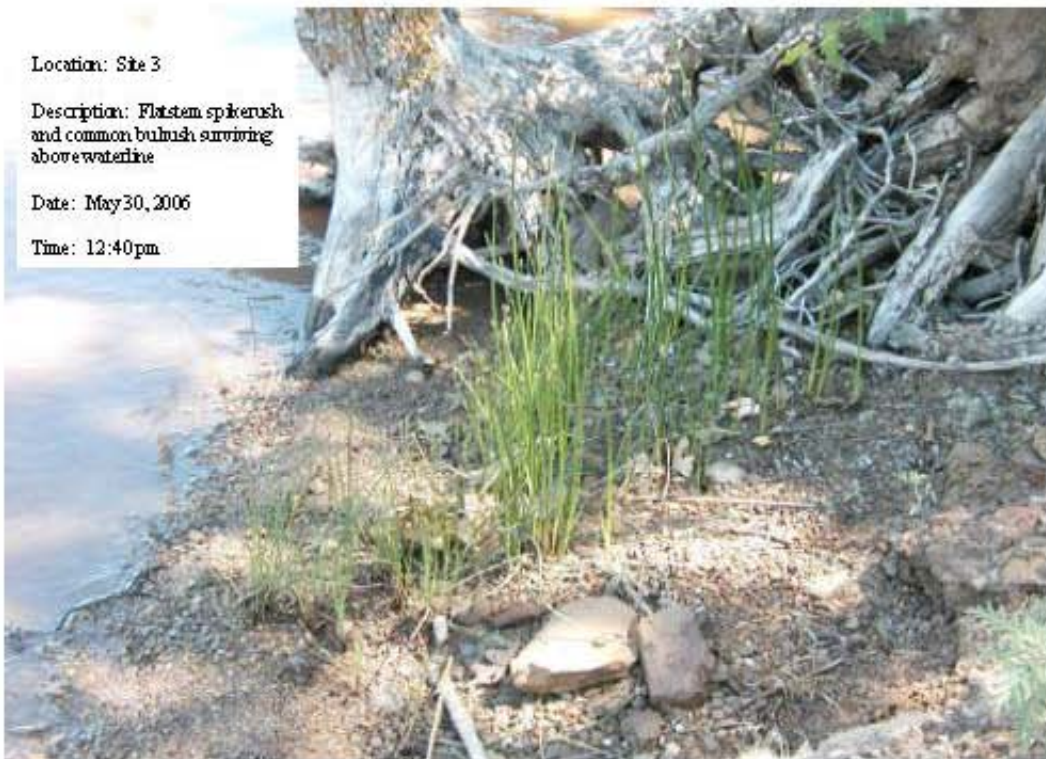
Location: Site 3

Description: Flatstem spikerush
and common bulrush surviving
above waterline
