**AN INVESTIGATION OF
SOURCE OF GASOLINE
CONTAMINATION OF
WATER WELLS IN
RENFROW, OKLAHOMA**

OKLAHOMA WATER RESOURCES BOARD

March 1978

Publication #85

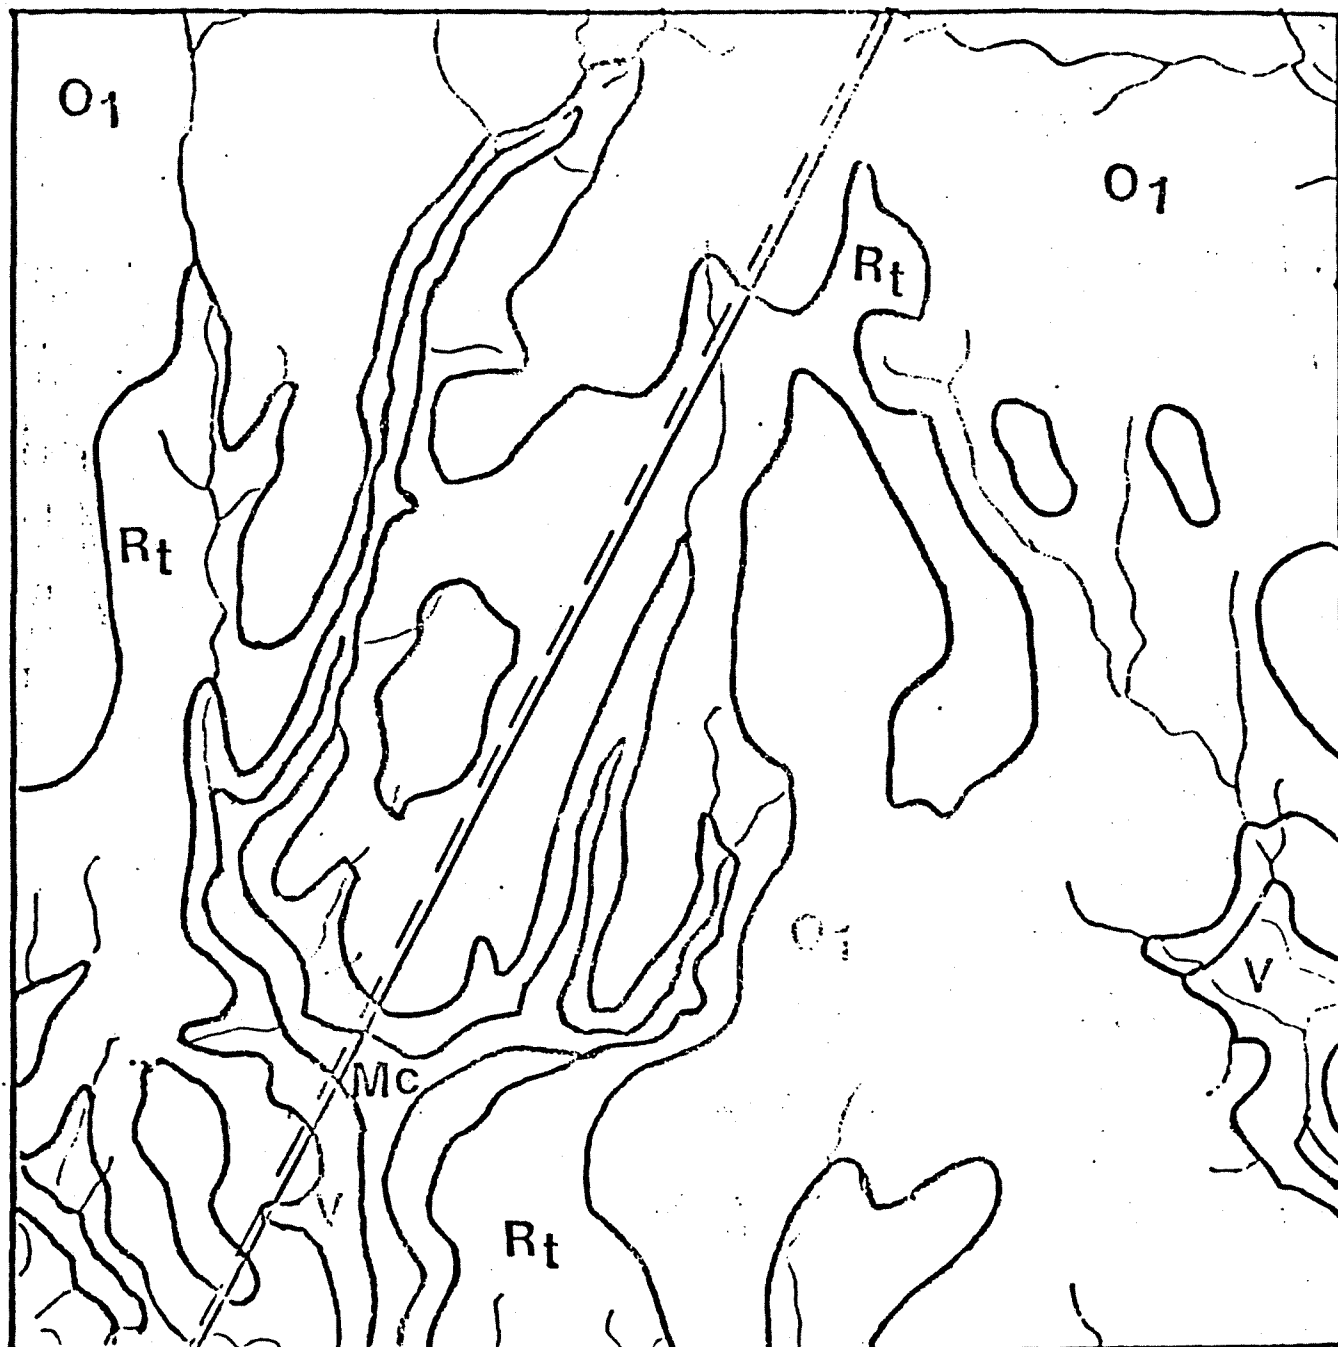
FIGURE 3

The soils in the area are generally loam or clay and are shown in Fig. 3. The major portion of the area in question is composed of Oswego silt loam (O1) while the Renfrow silt loam (Rt) is extensively distributed in the vicinity of Renfrow. The valleys and low lying areas are covered with the Miller Clay loam and Vernon Clay loam. A detail description of the soil type is as follows:

Soil Classification Map of the Renfrow Area
Showing the Distribution of Major Soil Series

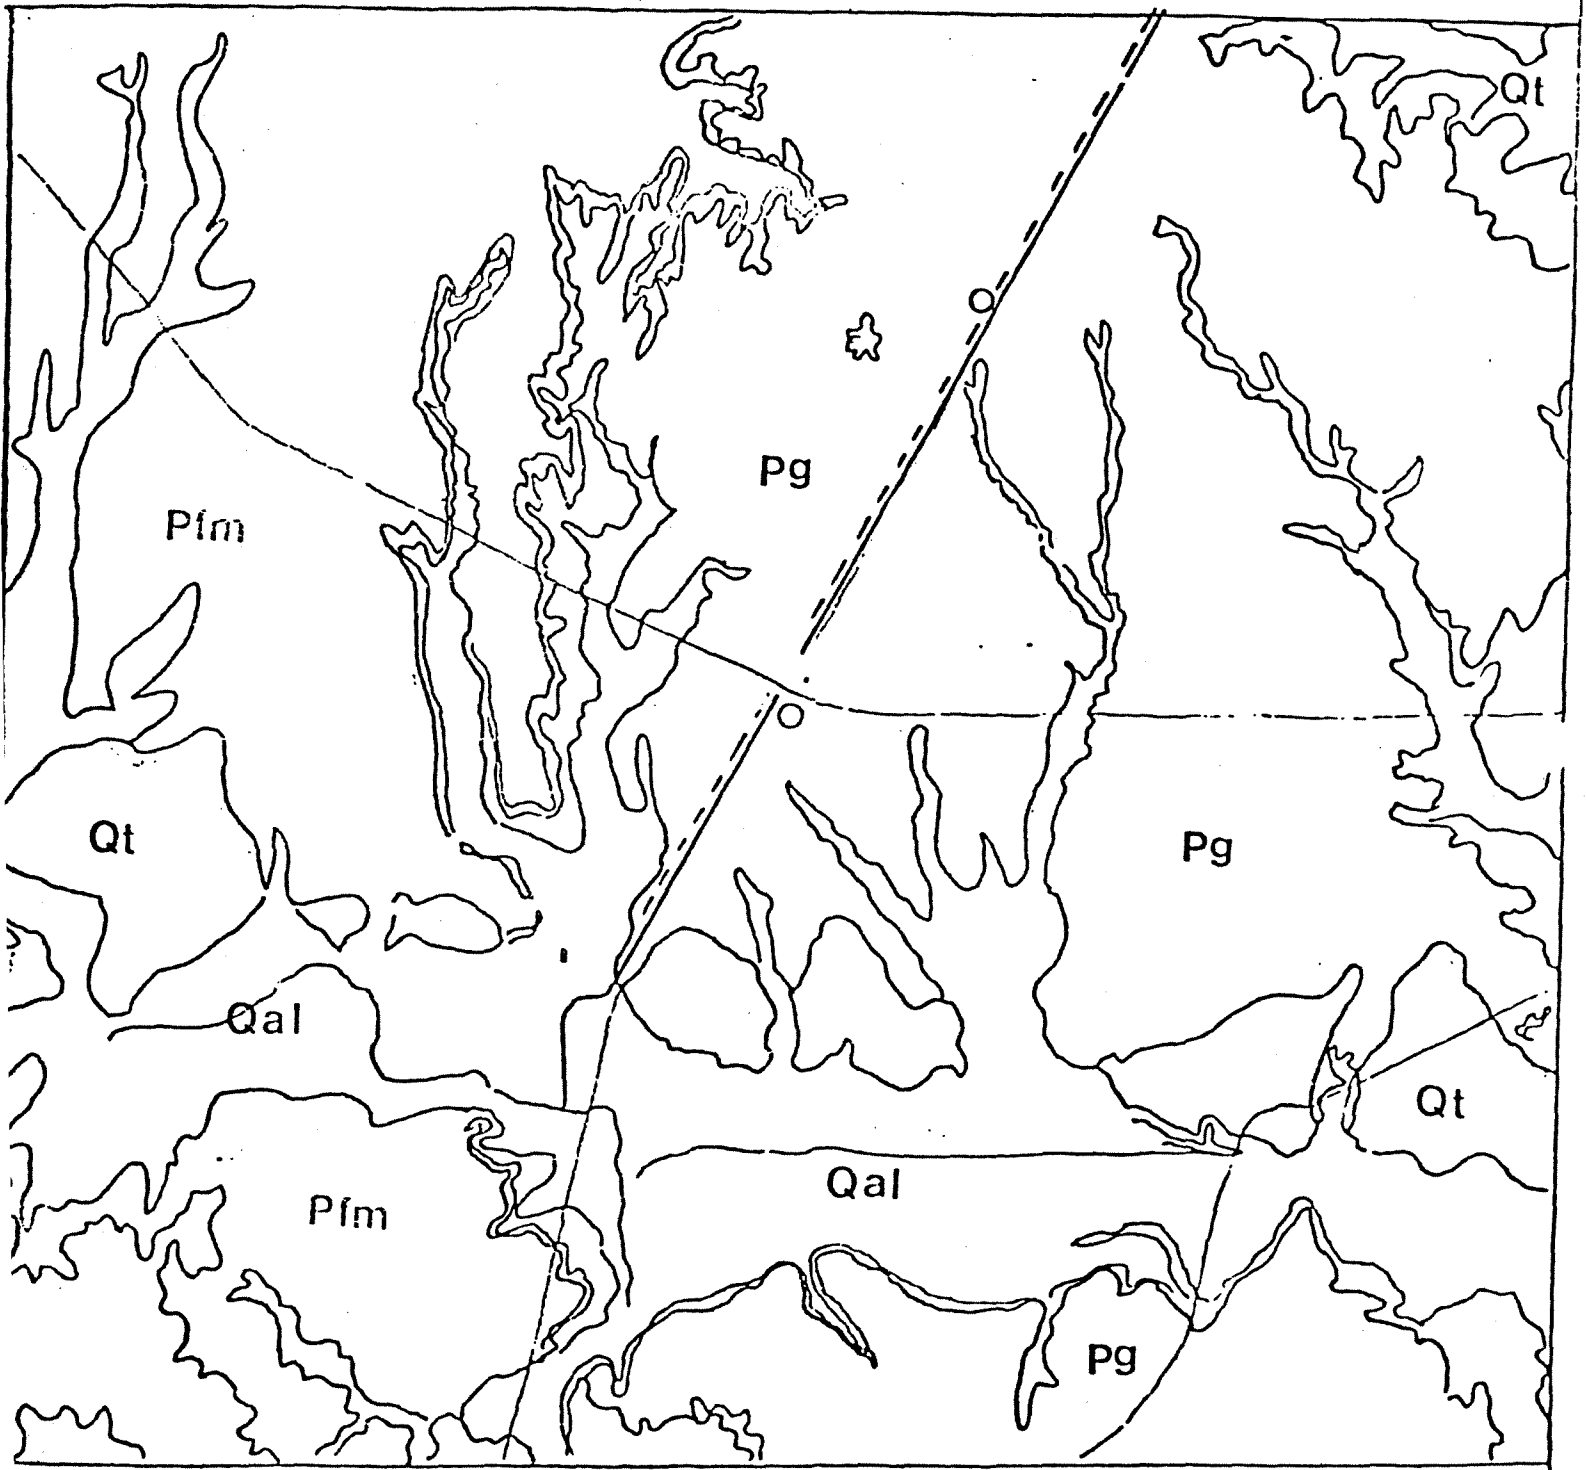
FIGURE 4

The study area is situated in the eastern half of Grant County, Oklahoma. It is underlain by sandstone, shale and siltstone. Generally, the shale layers are thicker northward and the sandstone layers thicken southward. The area of investigation overlies the Garber Sandstone and Wellington Formation, (see Fig. 4 and Table 1). The Garber Sandstone (Pg) is mostly fine-to-medium-grained quartzose sandstone gradational northward into shale, calcitic siltstone, and conglomerate. The Wellington Formation is mostly shale to the north, gradational into fine-grained sandstone and mudstone.

Geological Map of the Renfrow Area Showing the
Distribution of Major Geological Formations

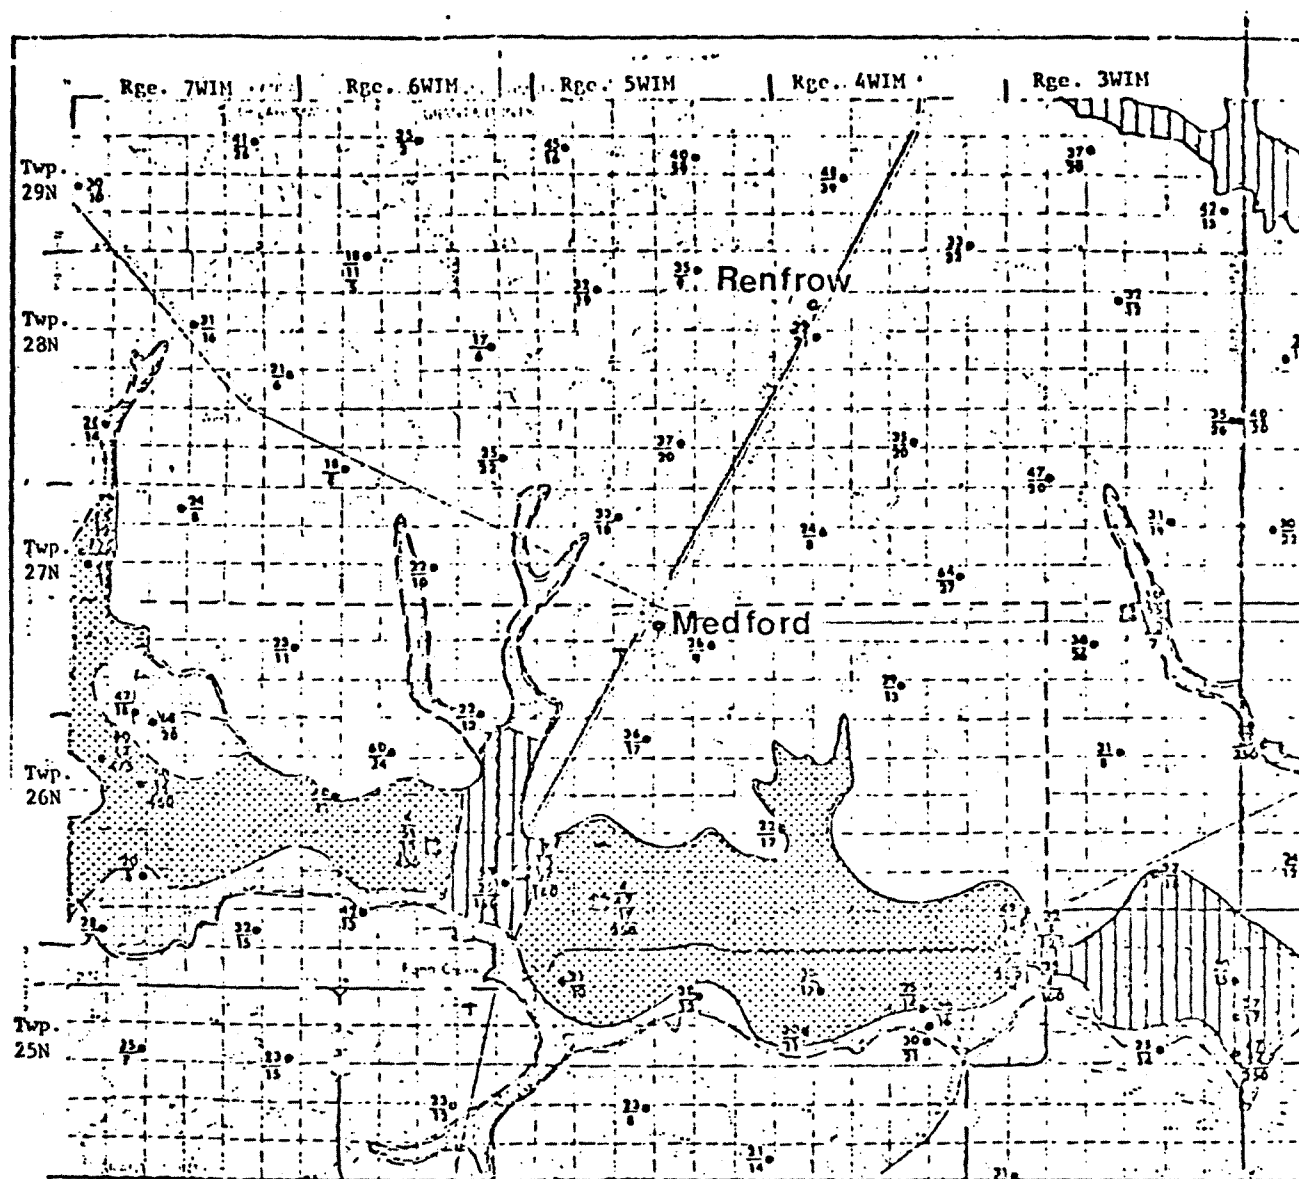
FIGURE 5

A detailed hydrological study of this area is underway. A preliminary ground water availability map, (Fig. 5), indicates that in the Renfrow area most wells are shallow and water stands at about 21 ft. below the surface. The water quality was measured to be from moderate to poor with respect to total dissolved solids.

Preliminary Ground Water Availability Map
East half of Grant County, Oklahoma
