## EPA Grant CA# CD-966618-01 Project 2

# Initiating a Vegetated Wetland throughout the Littoral Zone of Atoka Lake, Atoka County, Oklahoma

## FINAL REPORT

Agency: Oklahoma Water Resources Board (OWRB)

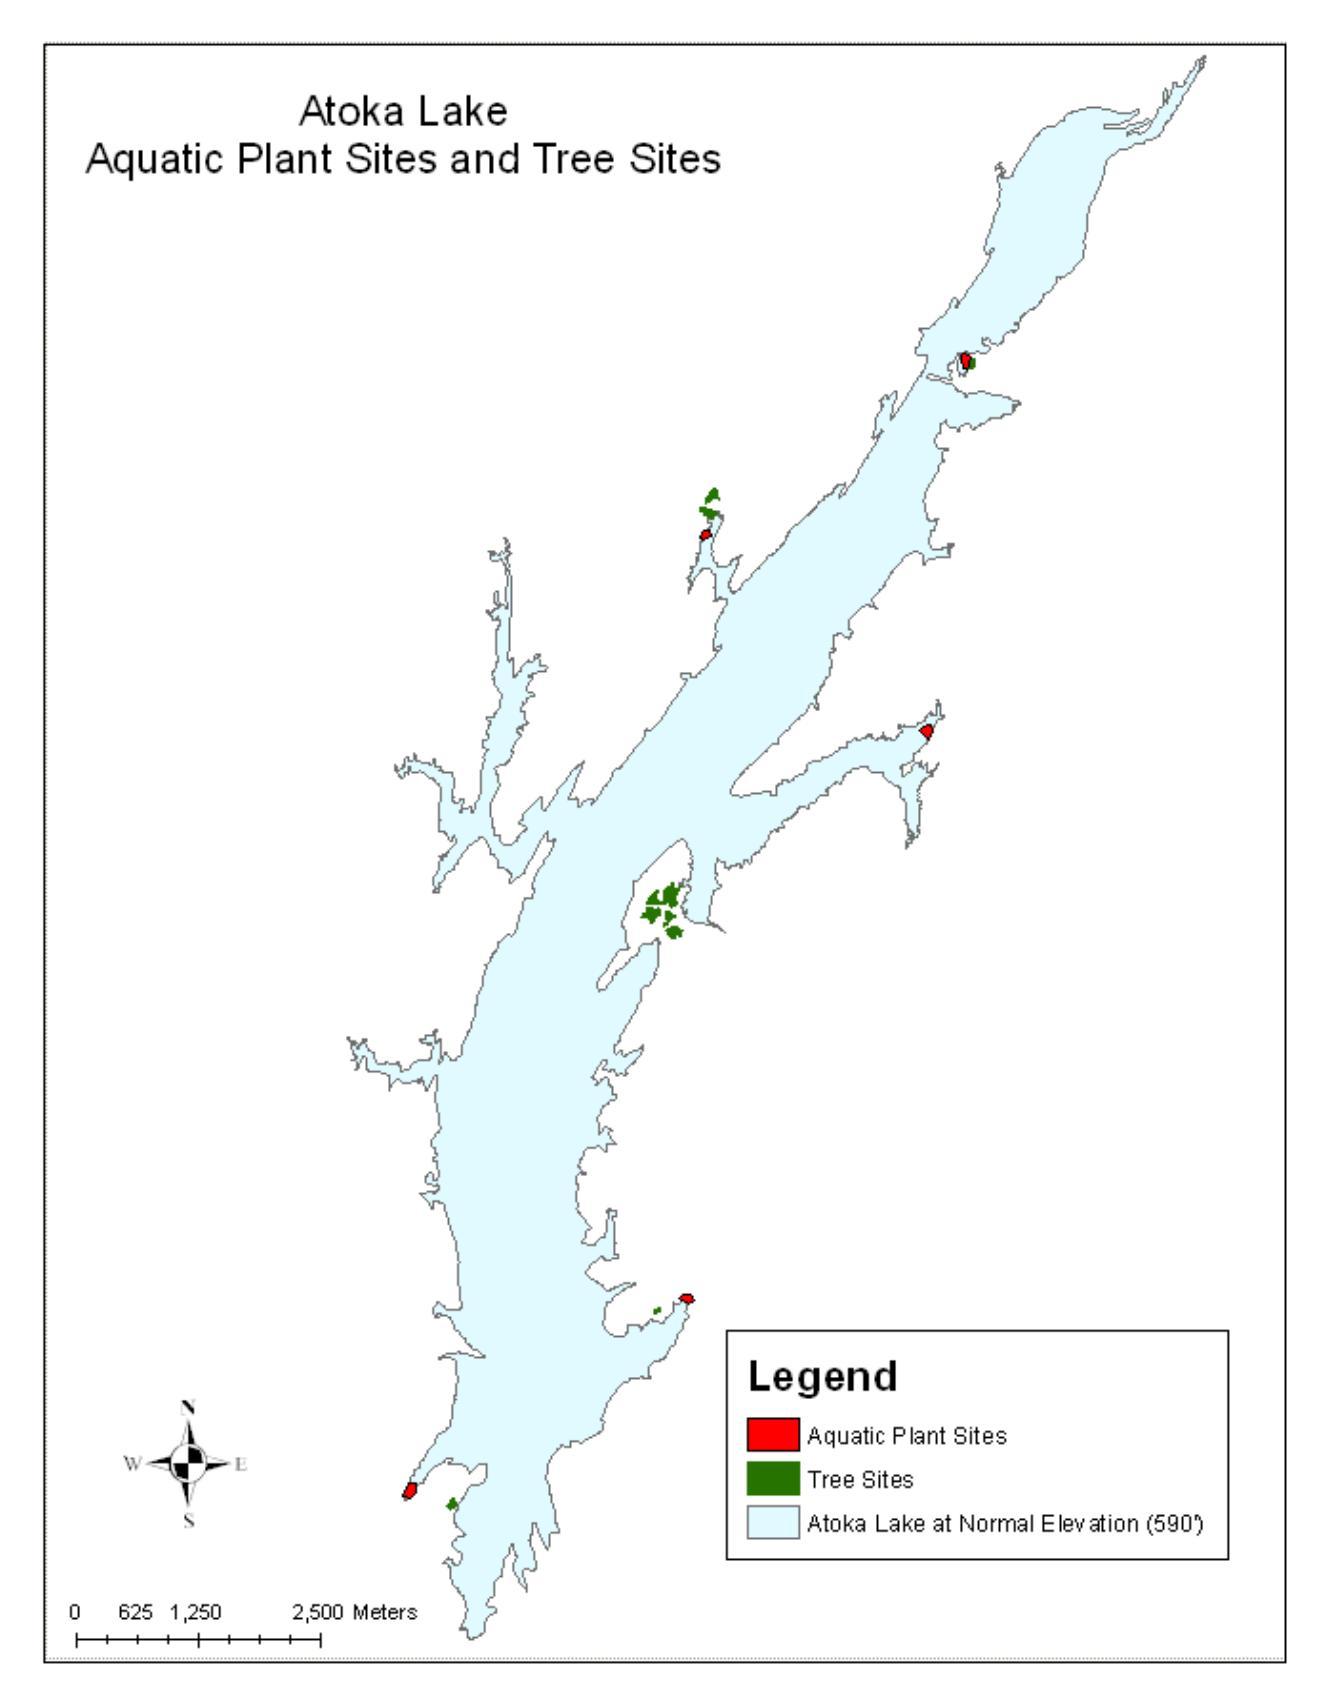
Figure 4: Atoka Lake Site Map as of Final Assessment – fall 2010

Outcome: 5 aquatic plant sites (Figure 4) were planted with 1,311 plants from 22 species over three seasons (Maps of each planted site can be found in Appendix C – Site Maps).

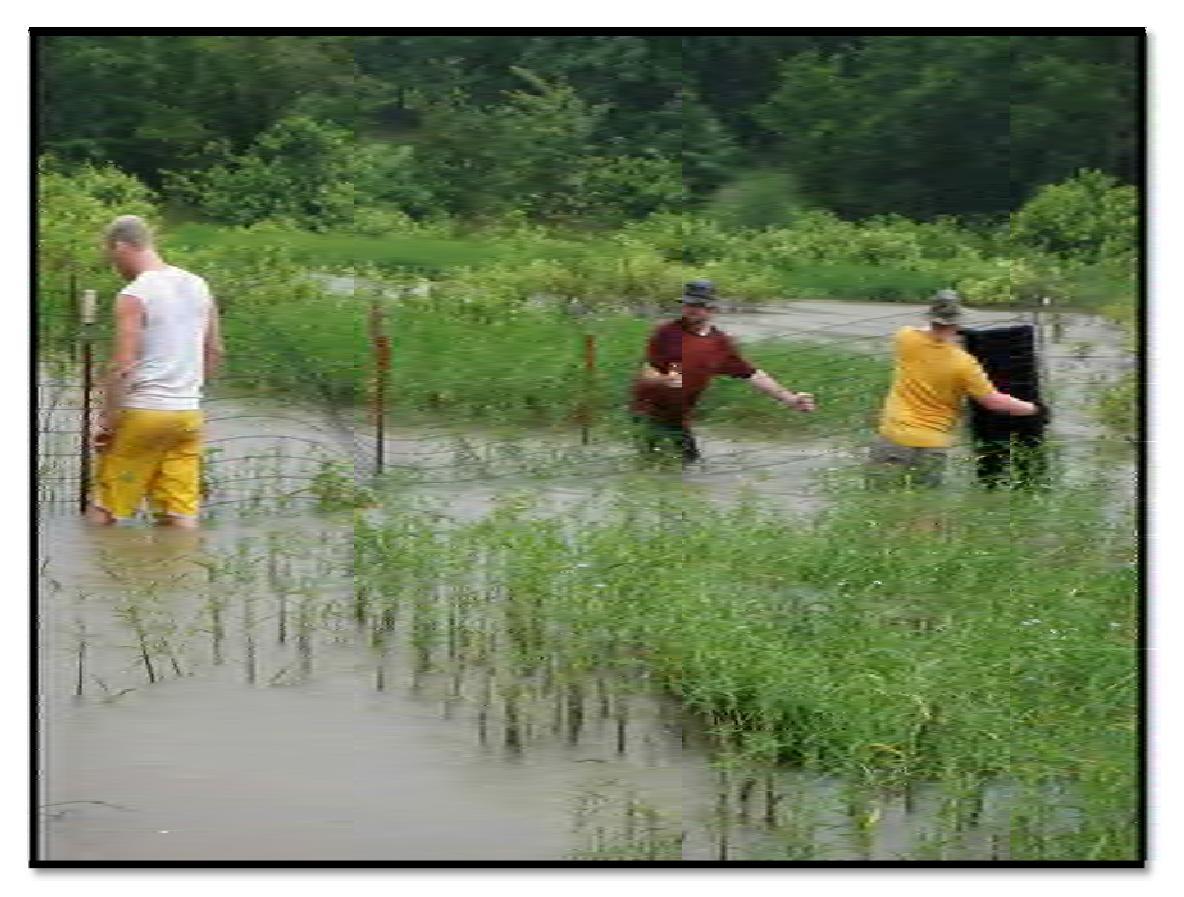
In the large area a pen provides, plant populations and their seeds can multiply beyond ring cage plantings by one or two orders of magnitude. The pen methodology was incorporated into this project due to the success of this method witnessed during previous founder colony projects including the EPA 104(b)(3) Lake Stanley Draper project and planting work done at Grand Lake. Figure 6 shows the installation of a pen in the summer of 2010.

Figure 6: Construction and planting of a new pen in July, 2010

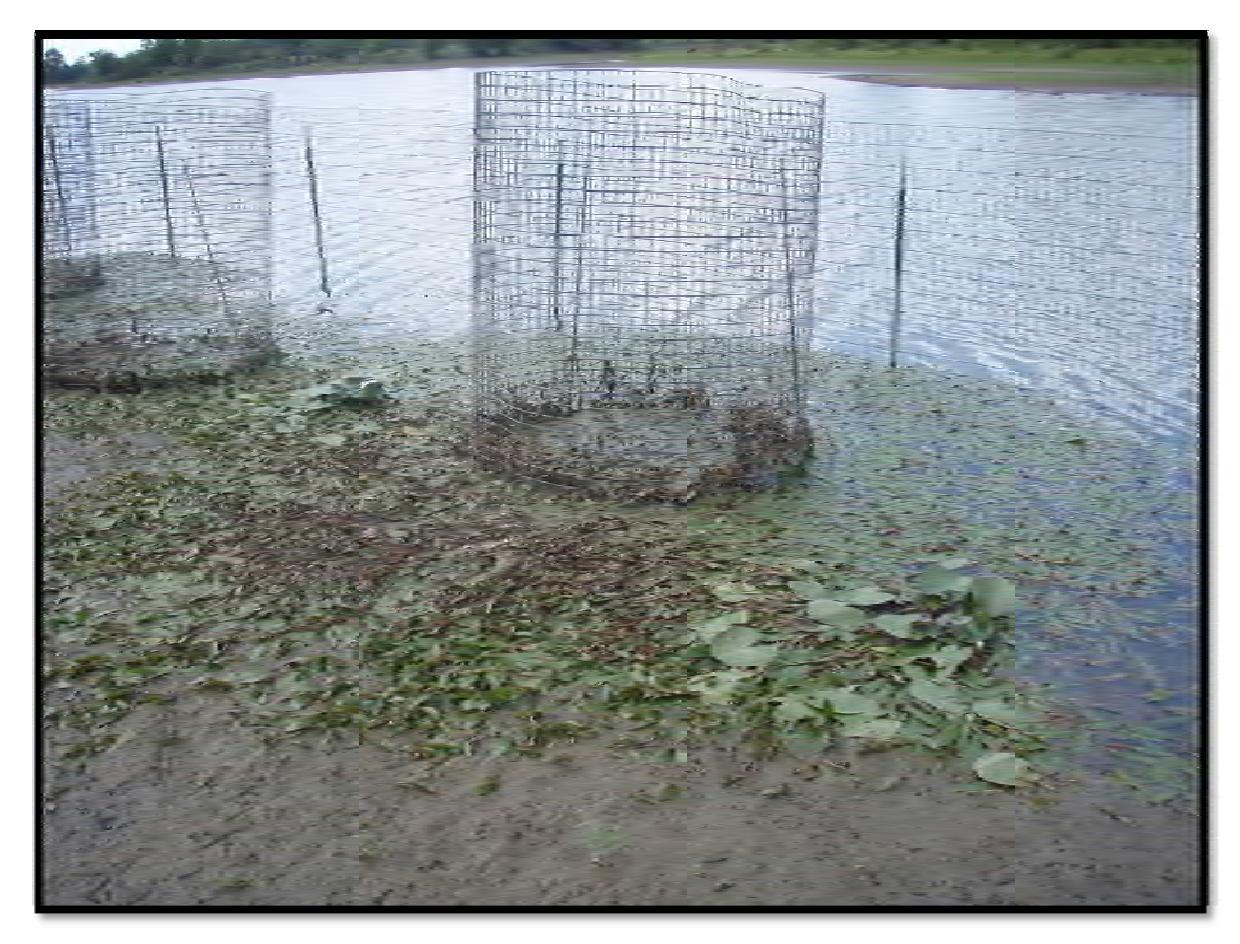
Diverse plant communities can develop as well as habitat for younger age classes of fish. While not caught on camera, project staff witnessed on multiple occasions young fish darting in and out of the 2"x 4" mesh pens as staff approached. Pens have an outstanding ability to provide multiple levels of habitat and protection for younger age class fish (Figure 7).

Figure 7: A canopy of *Potamogeton nodosus* (American Pondweed), *Nymphea Odorata* (White Water-Lily) and wire mesh provide outstanding cover for young age-class fish, fall assessment 2008

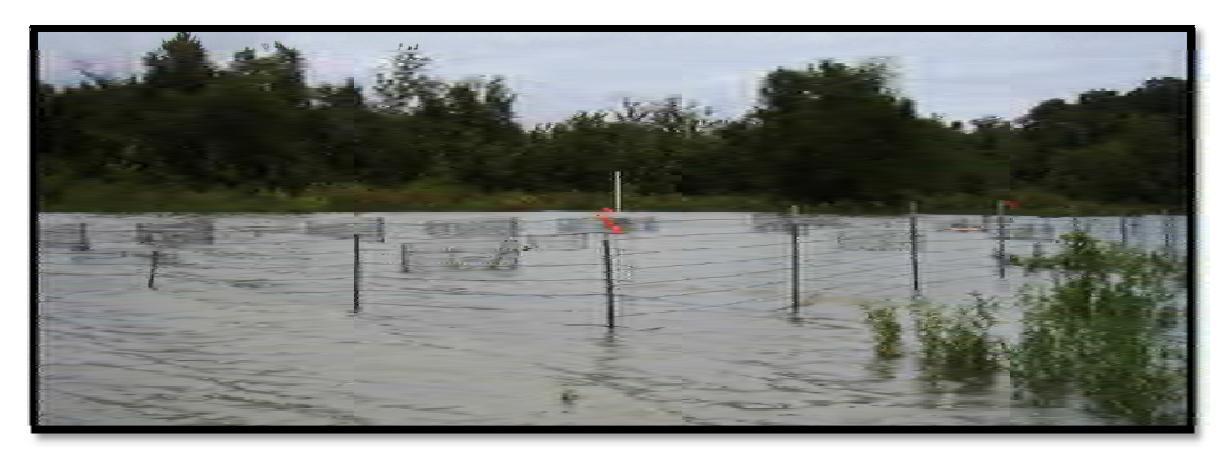
In general, the pens did as expected; creating a mixed community of aquatic macrophytes. The caged and uncaged plants generally spread well, filling both their ring cages and the pen (Figure 8, Figure 9, Figure 10 and Figure 11).

Figure 8: "Deeper" pen at site 4; September 2008

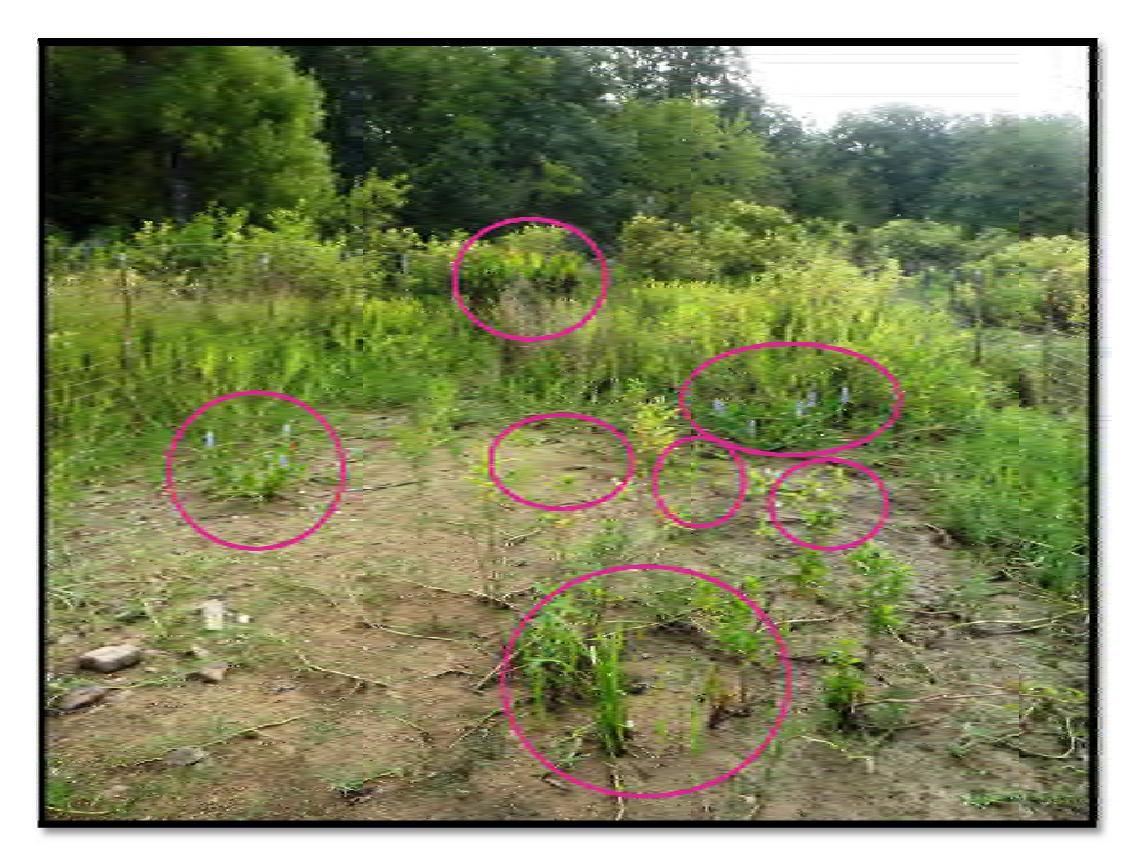
Figure 11: "Shallow" pen at Site 4, has new sprouts of several different species *including sagittaria graminea, nuphar lutea, pontederia cordata,* and *sagittaria latifolia*. September 2010

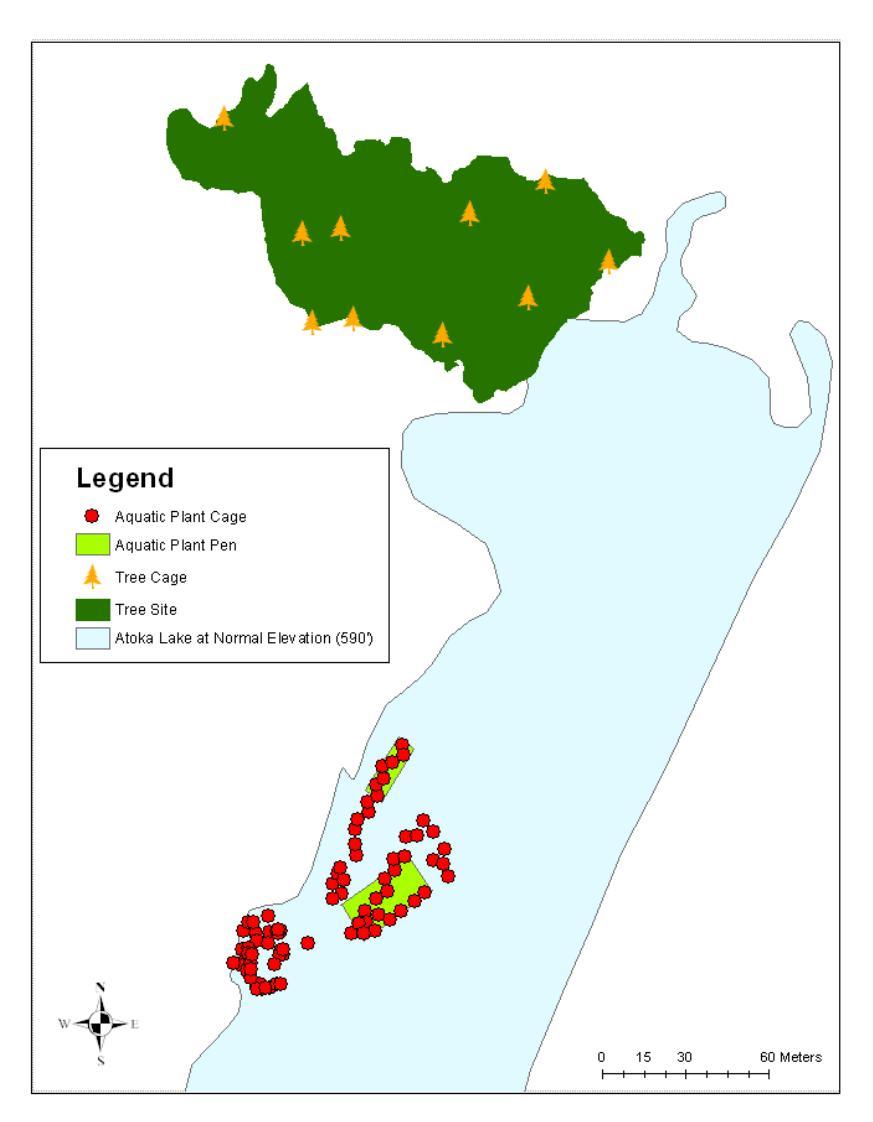
A typical site consisted of aquatic plant cages and deep and/or shallow pens. Often times, tree sites were in close proximity to the aquatic plant sites. The initial plantings were done May through July of 2008 with both caged and pen plantings. A representative format is illustrated in Figure 12.

Figure 12: Typical site layout by 2010 consisted of aquatic plant cages and pens, with tree cages and plots nearby

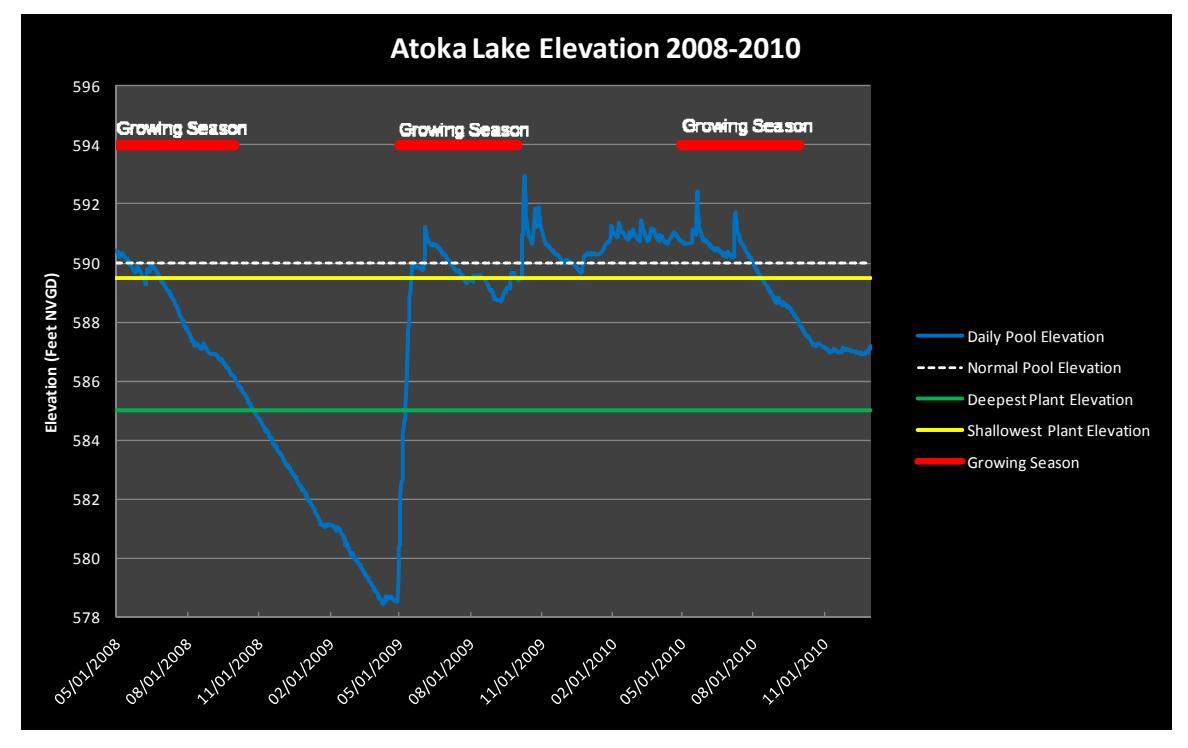
more water available to Oklahoma City as the pipeline repairs were being made. As a result, Atoka Lake was pumped down lower than normal in order to fill up Stanley Draper. When work began on the pipeline in 2009, Atoka Lake levels stayed above normal because there was not the usual drawdown from water being sent to Lake Stanley Draper due to the pipeline repairs. The water levels in Atoka Lake remained above the expected norm through the summer of 2010 as a result of the pipeline work. This was, at first, a very positive development for the emergent macrophytes, because the slow drawdown allowed them to follow the water. However, by the second season, as water levels during the growing season averaged 589.2' mean sea level (msl) the plants suffered from herbivory and inundation, with many of the cages and pen constructed in season one being overtopped and no longer providing protection. Planting elevations can be seen in Figure 13.

Figure 13: Plant Elevations in relation to Water Level elevations over project timeframe and growing seasons.

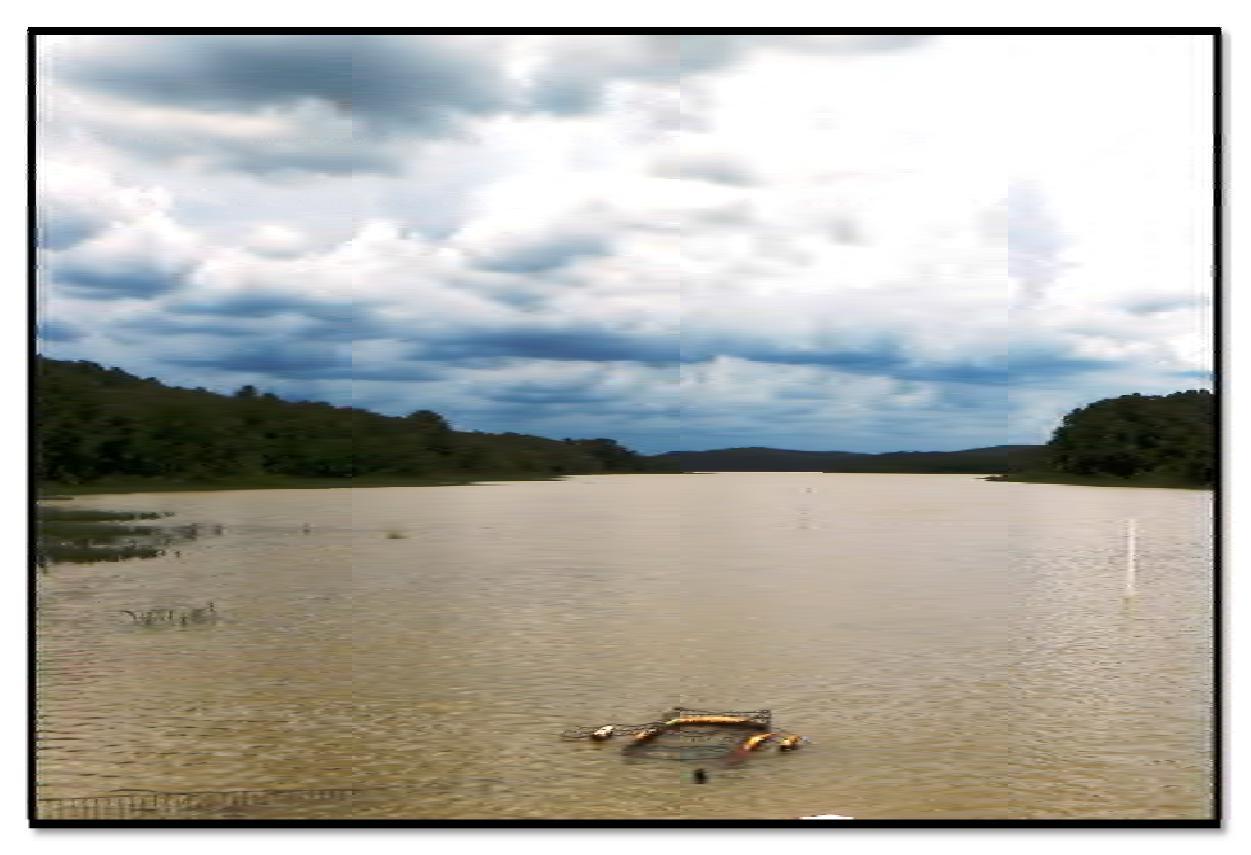
By the second season, many of the sites were transformed; placing a few deep cages inside the pen, placing tops on deeper cages that had surviving plants to prevent herbivory and add an extra level of protection, and moving the majority of the deep cages that had experienced mortality to higher elevations. Eventually a "topper" was added to the "Deeper" pens (raising the top of the pen 1 ½ to 4 feet depending on the pen and elevation) to avoid overtopping by high water (Figure 14).

Figure 14: "Deeper" pen at Site 1, July 2010. More than half of the pen is under water. Later a "topper" was added to prevent the water from overtopping the "Deeper" pens.

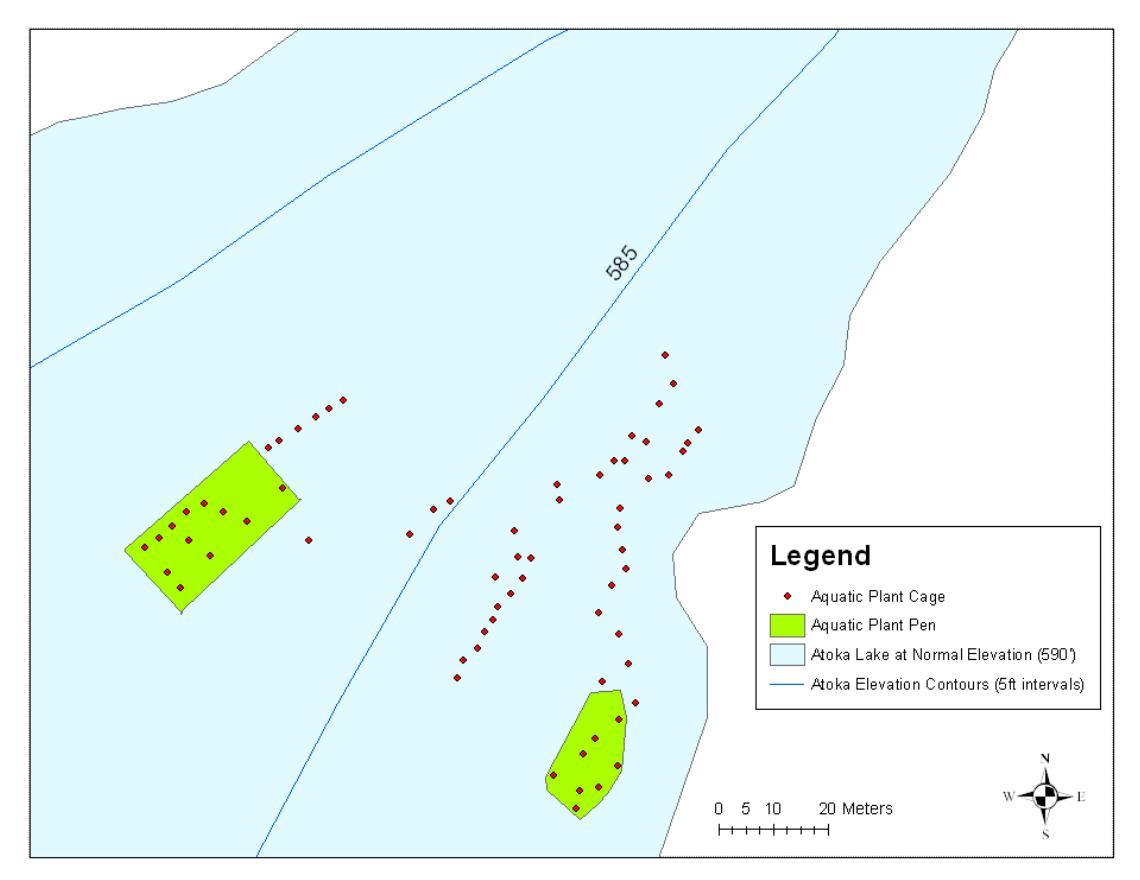
By year three, "Shallow" pens had been constructed at four of the five sites to offer another area for founder colony development. The expectation was that the plants had a better chance of surviving the upper elevations and eventual drought conditions than lower elevations where they may be inundated for longer periods of time. Deep waters can lead to plants expending their energy on elongation rather than expansive growth. Therefore the majority of plantings were on higher ground with only submersed or floating leaved species planted at deep elevations. Figure 15 depicts what the typical site looked like by the end of 2010.

Figure 15: Typical 2010 site layout with fewer deep cages and the addition of a Shallow pen at a higher elevation.

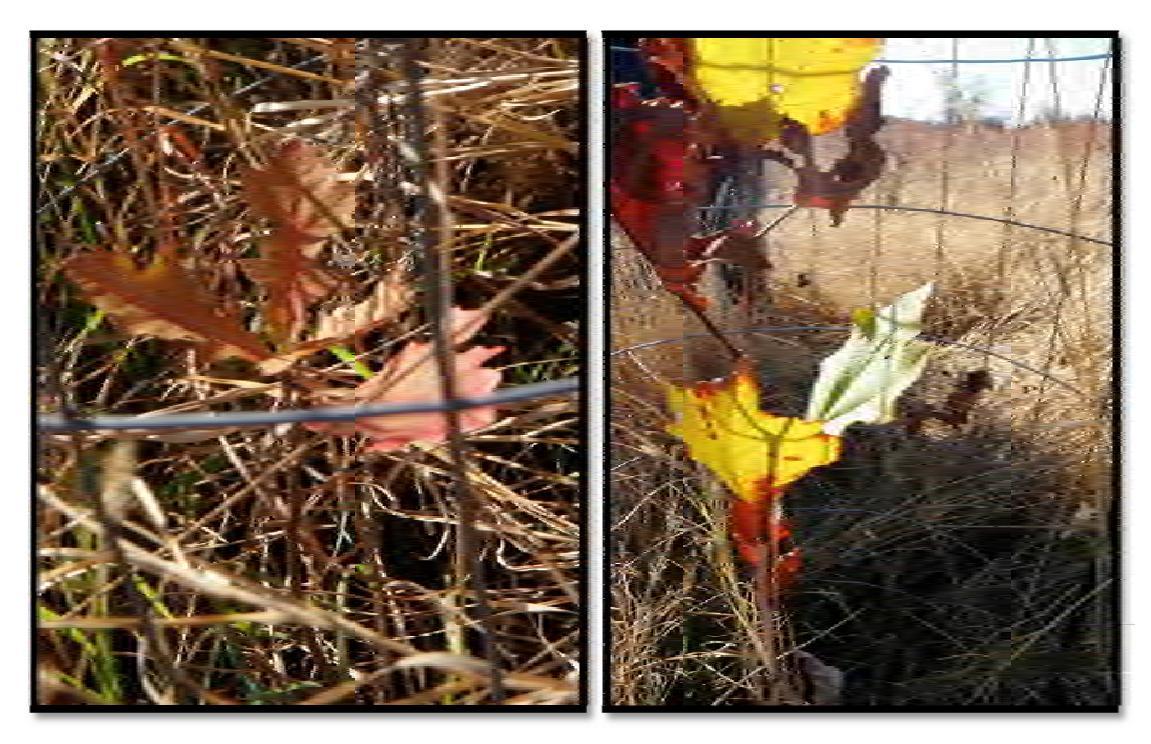
Figure 17 shows two seedlings approximately 8 and 20 months after initial planting.

Figure 17: A *Quercus macrocarpa* (Bur Oak) sapling approximately 20 months after planting; and a *Platanus occidentalis* (American Sycamore) sapling approximately 8 months after planting, October 2010

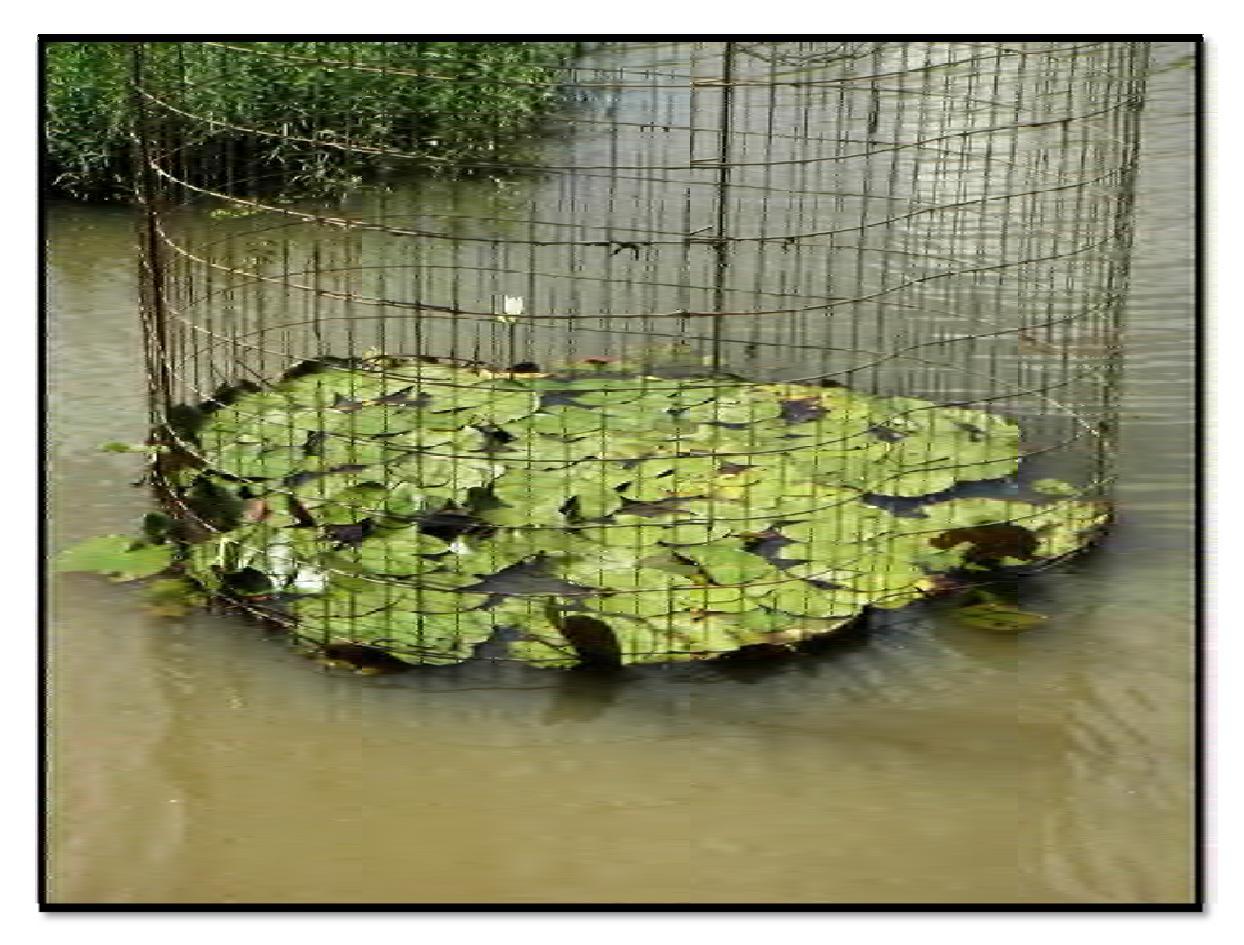
Figure 22: *Nymphaea odorata* completely filling its cage at site 2; 100% coverage (September 2010)

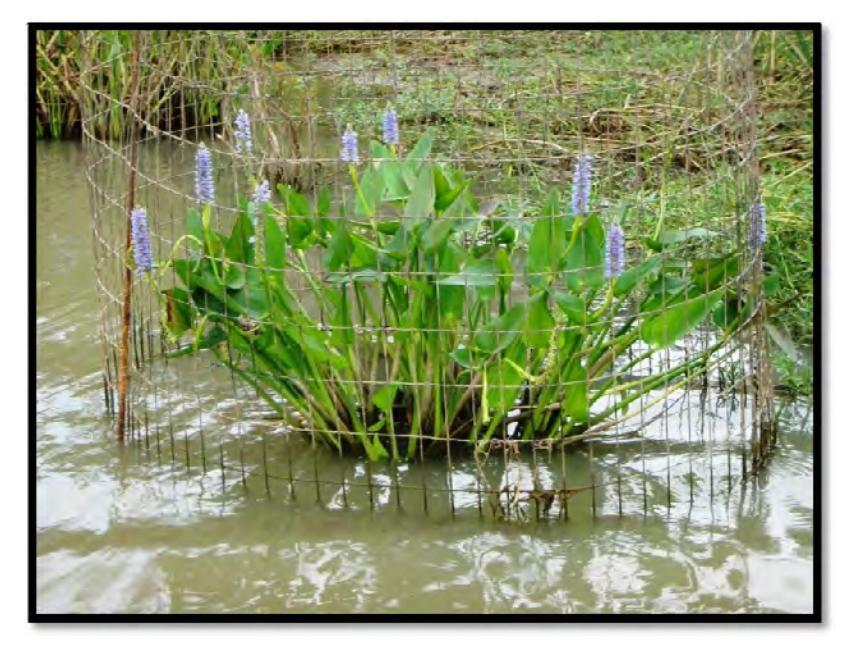
survived and was determined to have 75% average coverage (*exceptional growth*) at the final assessment

Figure 23: A cage of *Pontederia cordata* with *exceptional growth* (75% coverage) at final assessment - fall 2010

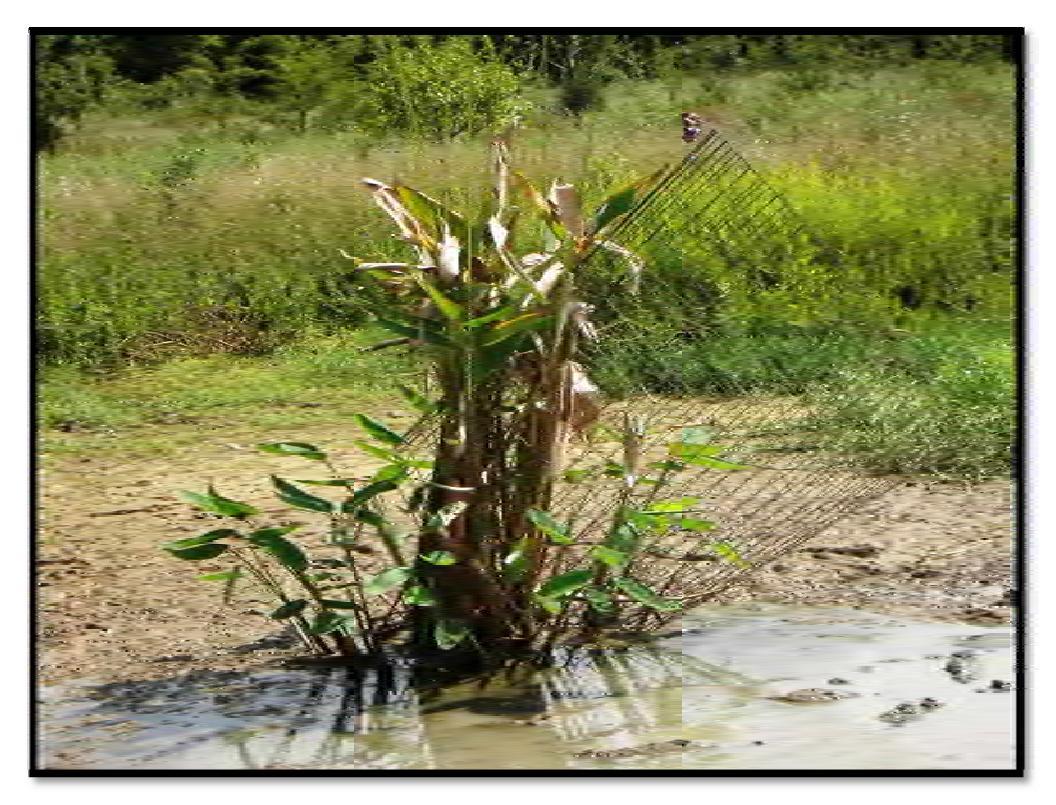
Figure 24 shows a *Thalia dealbata* plant with the cage tipped over, but the plant continuing to grow well with new shoots, growing completely unprotected.

Figure 24: Thalia dealbata causing its cage to tip over. (September 2010)

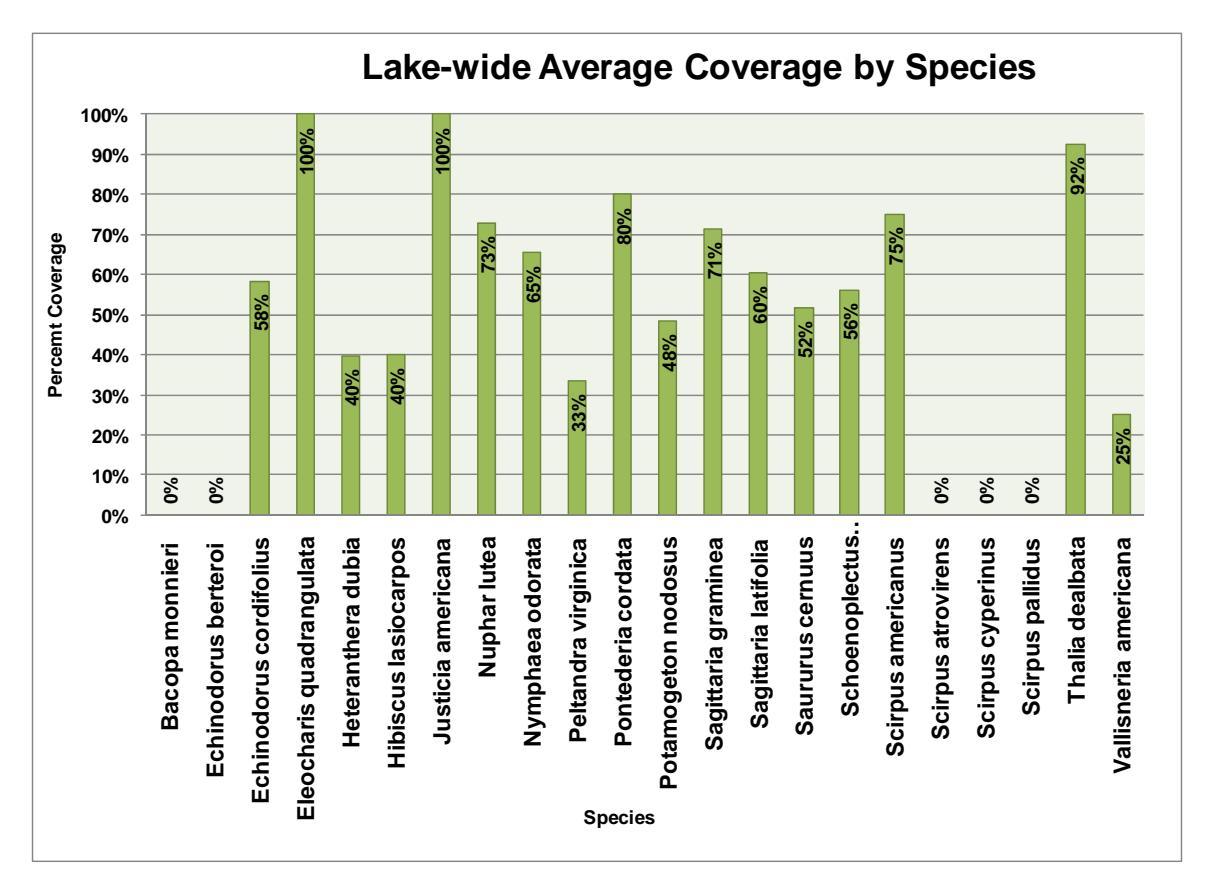
Coverage was also considered by species. Because the various species selected for the project grow at different rates and by different means (runners, rhizomes, tubers, etc.) variation in percent coverage by the final assessment was expected.

Lake-wide average coverage by species can be seen in Figure 26.

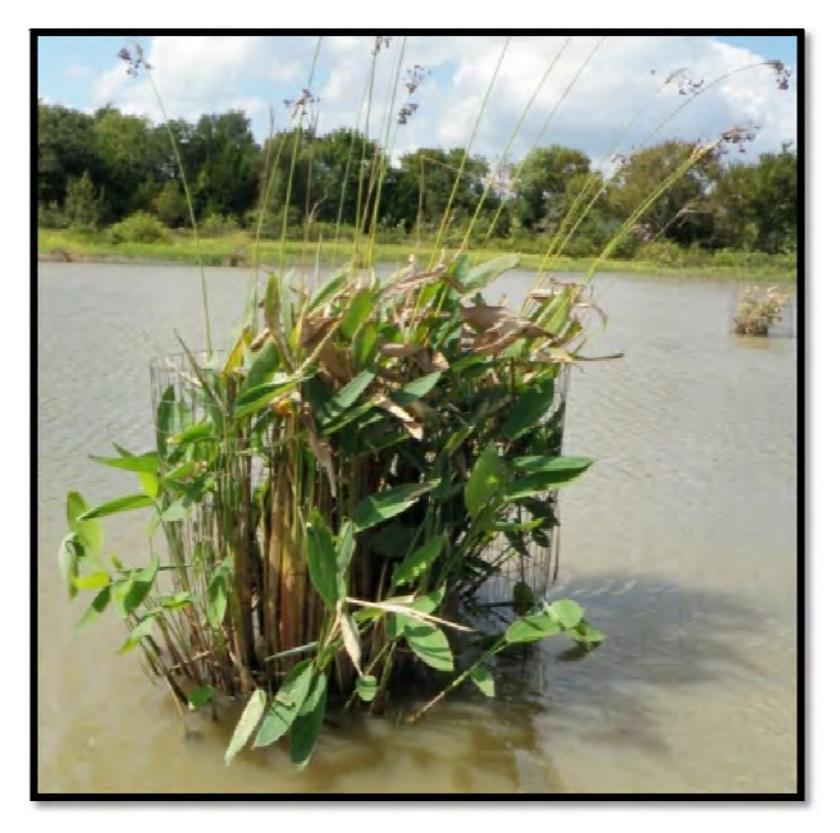
Several species, while not attaining 100% average coverage, did exhibit exceptional growth. These include: *Thalia dealbata* (Alligator Flag) at 92% (Figure 27), *Pontederia cordata* (Pickerelweed) at 80%, and *Scirpus americanus* (Three Square Bulrush) at 75%.

Figure 27: A full cage of *Thalia delbata* at site 3 during final assessment 2010.

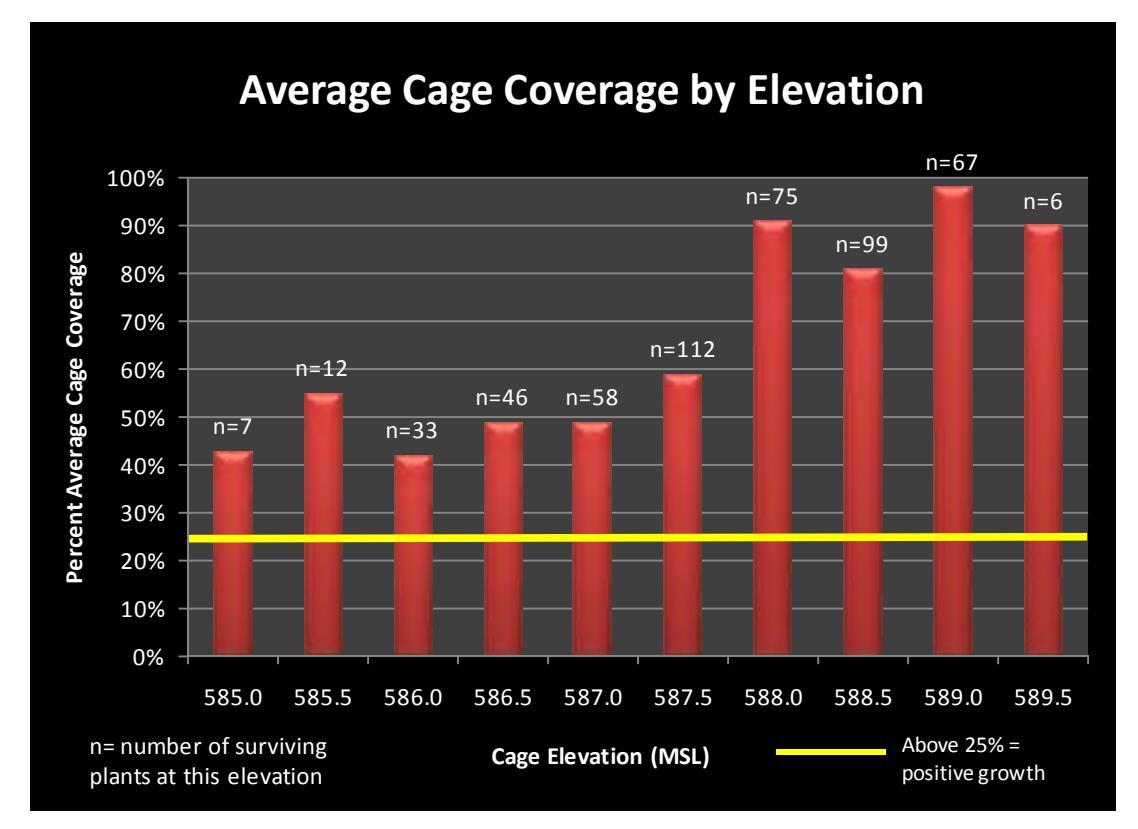
Coverage also varied by the elevation of the cage. Because water level varied greatly between the 2008 season when cages were first installed, and the 2009 and 2010 seasons when the pipeline was being repaired, cages placed at higher elevations tended to do better than those at lower elevations. Cages at elevations below 586.0' (mean sea level) msl, primarily at site 5 (and one cage at site 2), where deep water submersed plantings are held. A vast majority of the project cages are between 586.0' and 589.0'msl. Since the plantings are designated at 25% initially, elevations that showed average coverage greater than 25% had positive growth. All of the elevations planted had over 25% average coverage, which indicates that elevations selected for this project are appropriate elevations for aquatic plants in Atoka Lake. Figure 28 shows average cage coverage taking into account the cage elevation.

Figure 28: Average Cage Coverage by Elevation

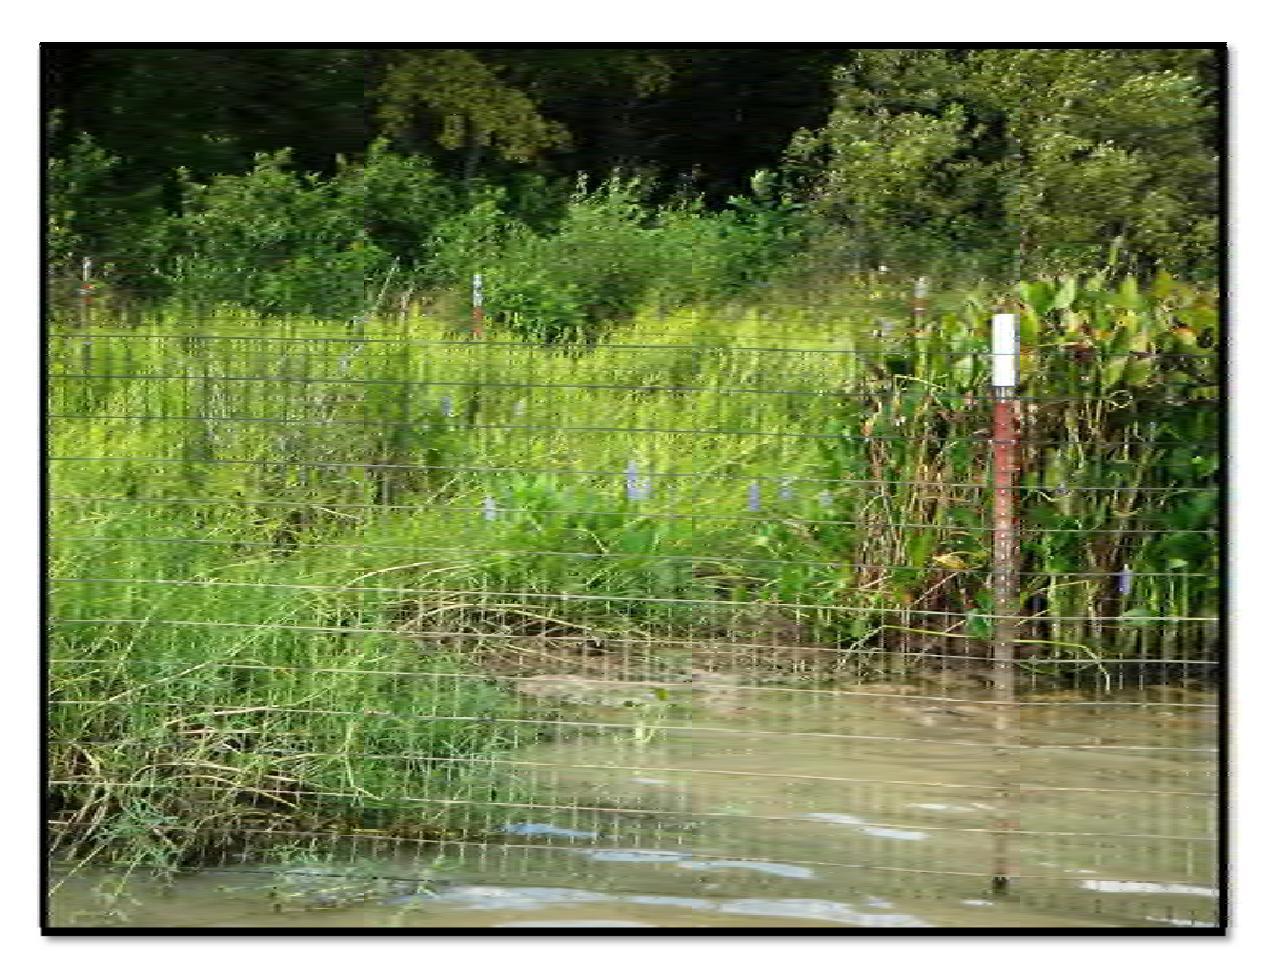
Figure 29: "Shallow" Pen at site 5 - Pontederia cordata, Schoenoplectus tabernaemontani, Justicia americana, and Eleocharis quadrangulata. At final assessment – fall 2010.

The most successful pen was the "Shallow" pen at site 5 (Figure 29) with a percent cover of 88%. At least seven (7) different species were prominent in this pen, giving it a community rating of 4. Species include: *Pontederia cordata, Schoenoplectus tabernaemontani, Eleocharis quadrangulata, Sagittaria graminea, Nuphar lutea, Saururus cernuus* and *Justicia americana*. The emergent species planted in this pen not only filled their cages, but also spread, with many new propagules (Figure 30) seen popping up throughout the pen.

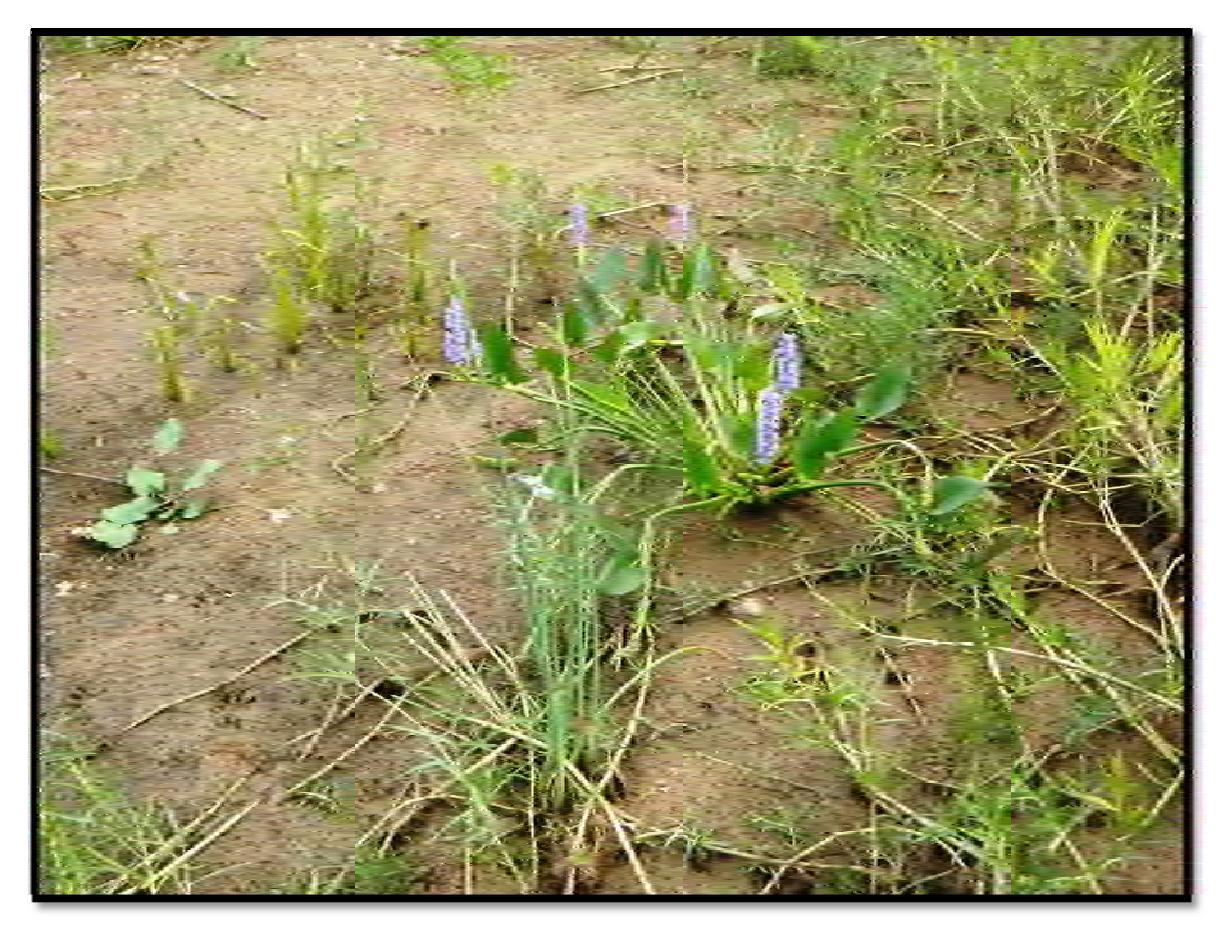
Figure 30: New propagules of *Pontederia cordata, Schoenoplectus tabernaemontani, Sagittaria graminea,* and *Nuphar lutea* along with *Justicia americana* are seen in this close-up shot from "Shallow" pen 5 at the final assessment – September 2010.

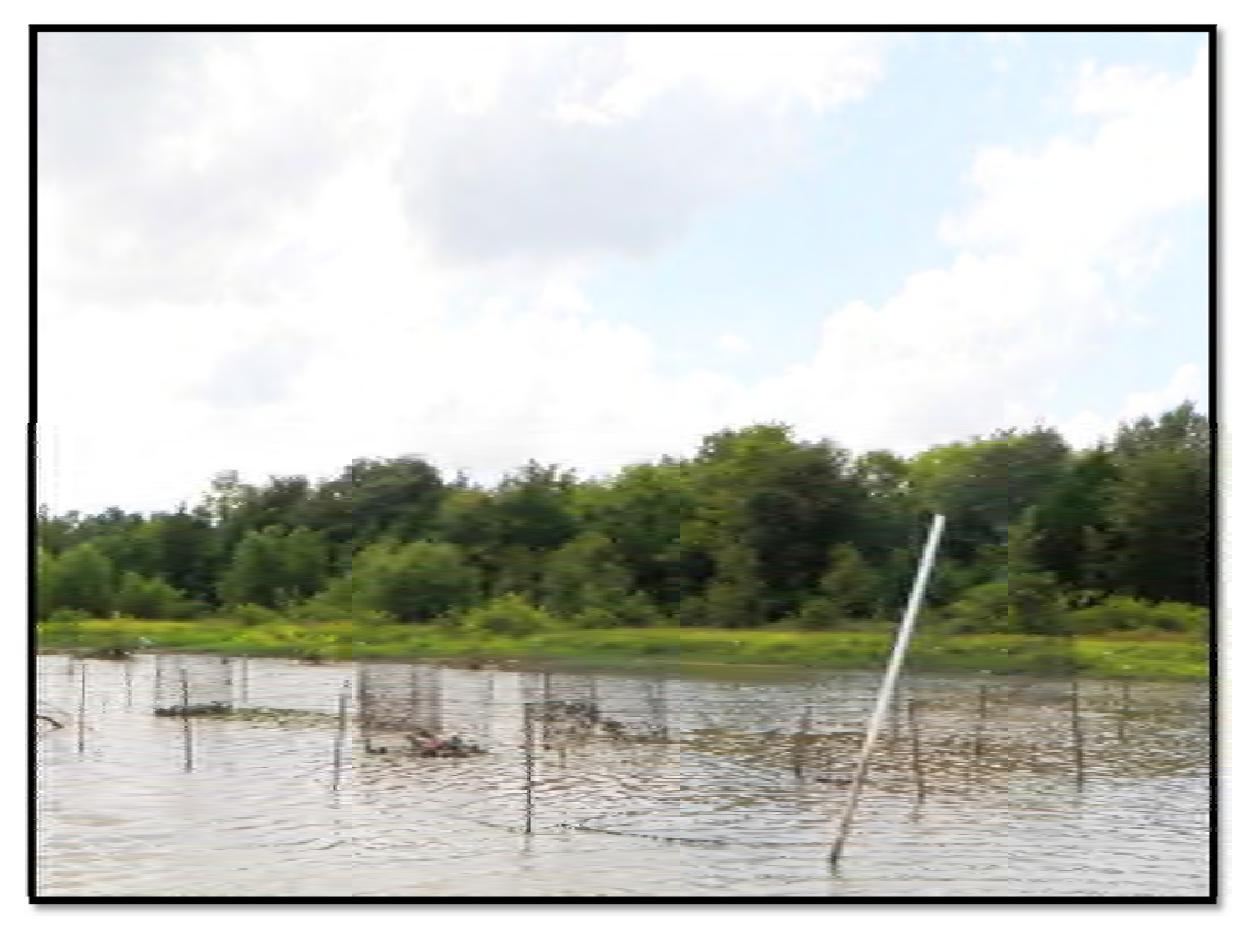
While the "Shallow" pens tended to have better percent cover than the submersed (Deeper) pens, the submersed pens still fared well despite a period of 15 straight months of high water. During the high water levels, the pens were often overtopped, allowing herbivory pressure as well as decreased light penetration in such deep water. The three "Deeper" pens that had the best results were pen 3 (69% cover), "Deeper" pen 1 (67% cover) and "Deeper" pen 5 (63% cover) each with a community rating of 4. Figure 33, Figure 34 and Figure 35 show "Deeper" pens at the final assessment.

Figure 33: "Deeper" Pen at site 3 at final assessment – September 2010.

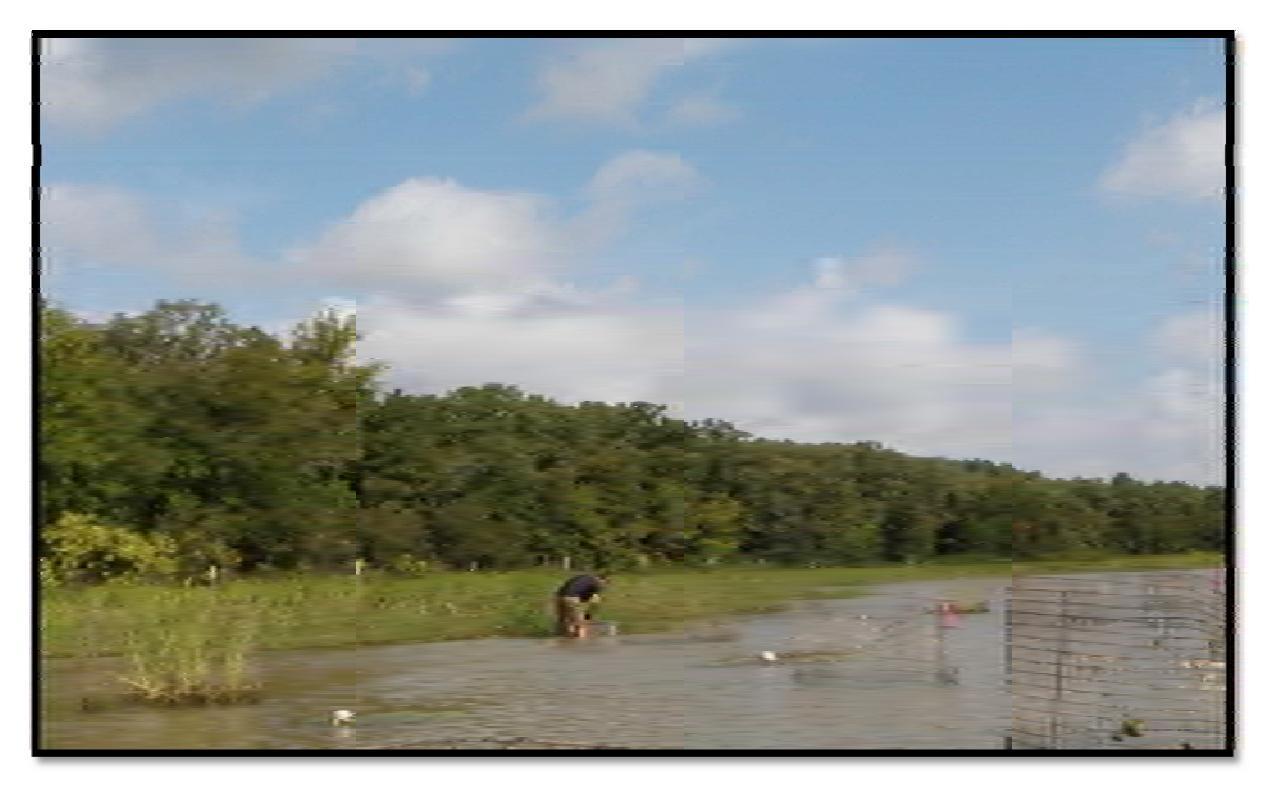
Figure 34: Site 5 "Deeper" pen with *Sagittaria graminea* and blooming *Nymphaea odorata* at the final assessment – September 2010.
