## EPA Grant CA# CD-966618-01 Project 2

# Initiating a Vegetated Wetland throughout the Littoral Zone of Atoka Lake, Atoka County, Oklahoma

## FINAL REPORT

Agency: Oklahoma Water Resources Board (OWRB)

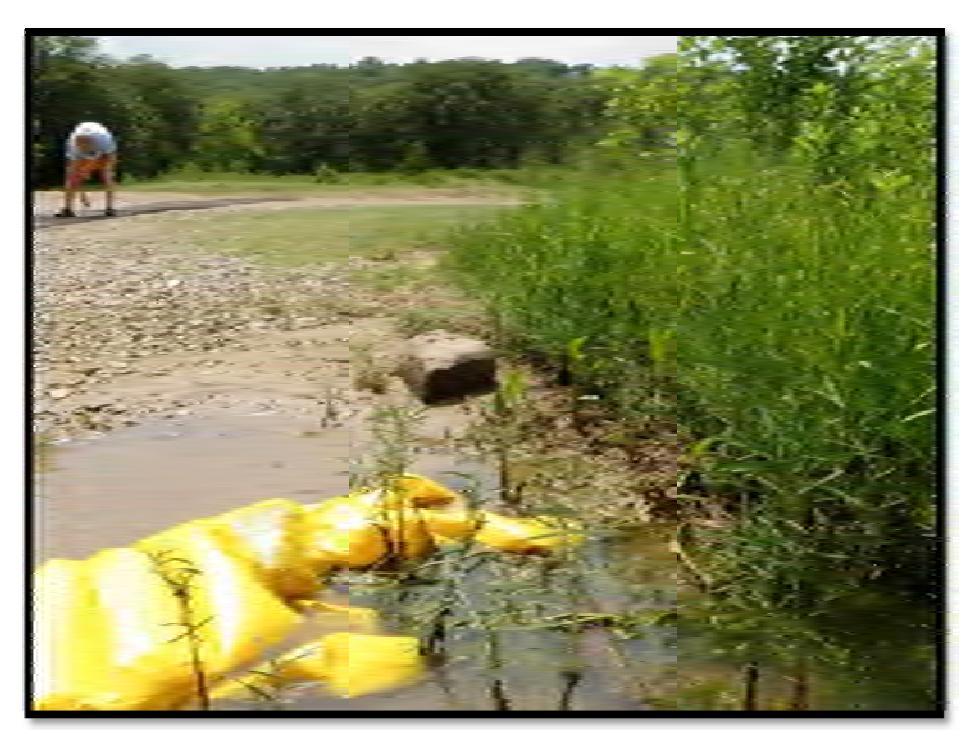
While 5.18 acres planted is relatively small when compared to the 70 miles of shoreline that surrounds Atoka Lake, spread of plants to areas outside of the site boundaries has already started to occur. New propagules of *Sagittaria graminea* were found at the boat ramp near aquatic plant site 2. Figure 36 shows the new plants on the north side (pictured on the right) of the boat ramp at site 2. Figure 37 shows another angle of the *Sagittaria graminea*, in this photo flowers are evident on the plant indicating that this plant is mature enough to spread seeds to this area of the lake. The way in which these plants spread to this area of the lake is unknown. It could be by seeds from site 2, or perhaps from fragments that broke off when loading and unloading the boat at this site. Regardless of how it happened, the plants look strong and at least one was already flowering, making the potential for a new founder colony in this location a likely possibility. Figure 38 is a map showing the distance between site 2 and the boat ramp. The closest cage at site 2 is 547 feet away from where the new plants were found.

Figure 36: New propagules of *Sagittaria graminea* at the boat ramp adjacent to site 2. Large stand of *Justicia americana* also visible – July 2010

**Objective initiated.** While spread to other parts of the lake was not assessed, it was observed that at one location (boat ramp at site 2) plant propagules were seen growing and producing flowers well outside the site boundaries. There is optimism from this observation the aquatic plants introduced in this project will spread to other parts of Atoka Lake.

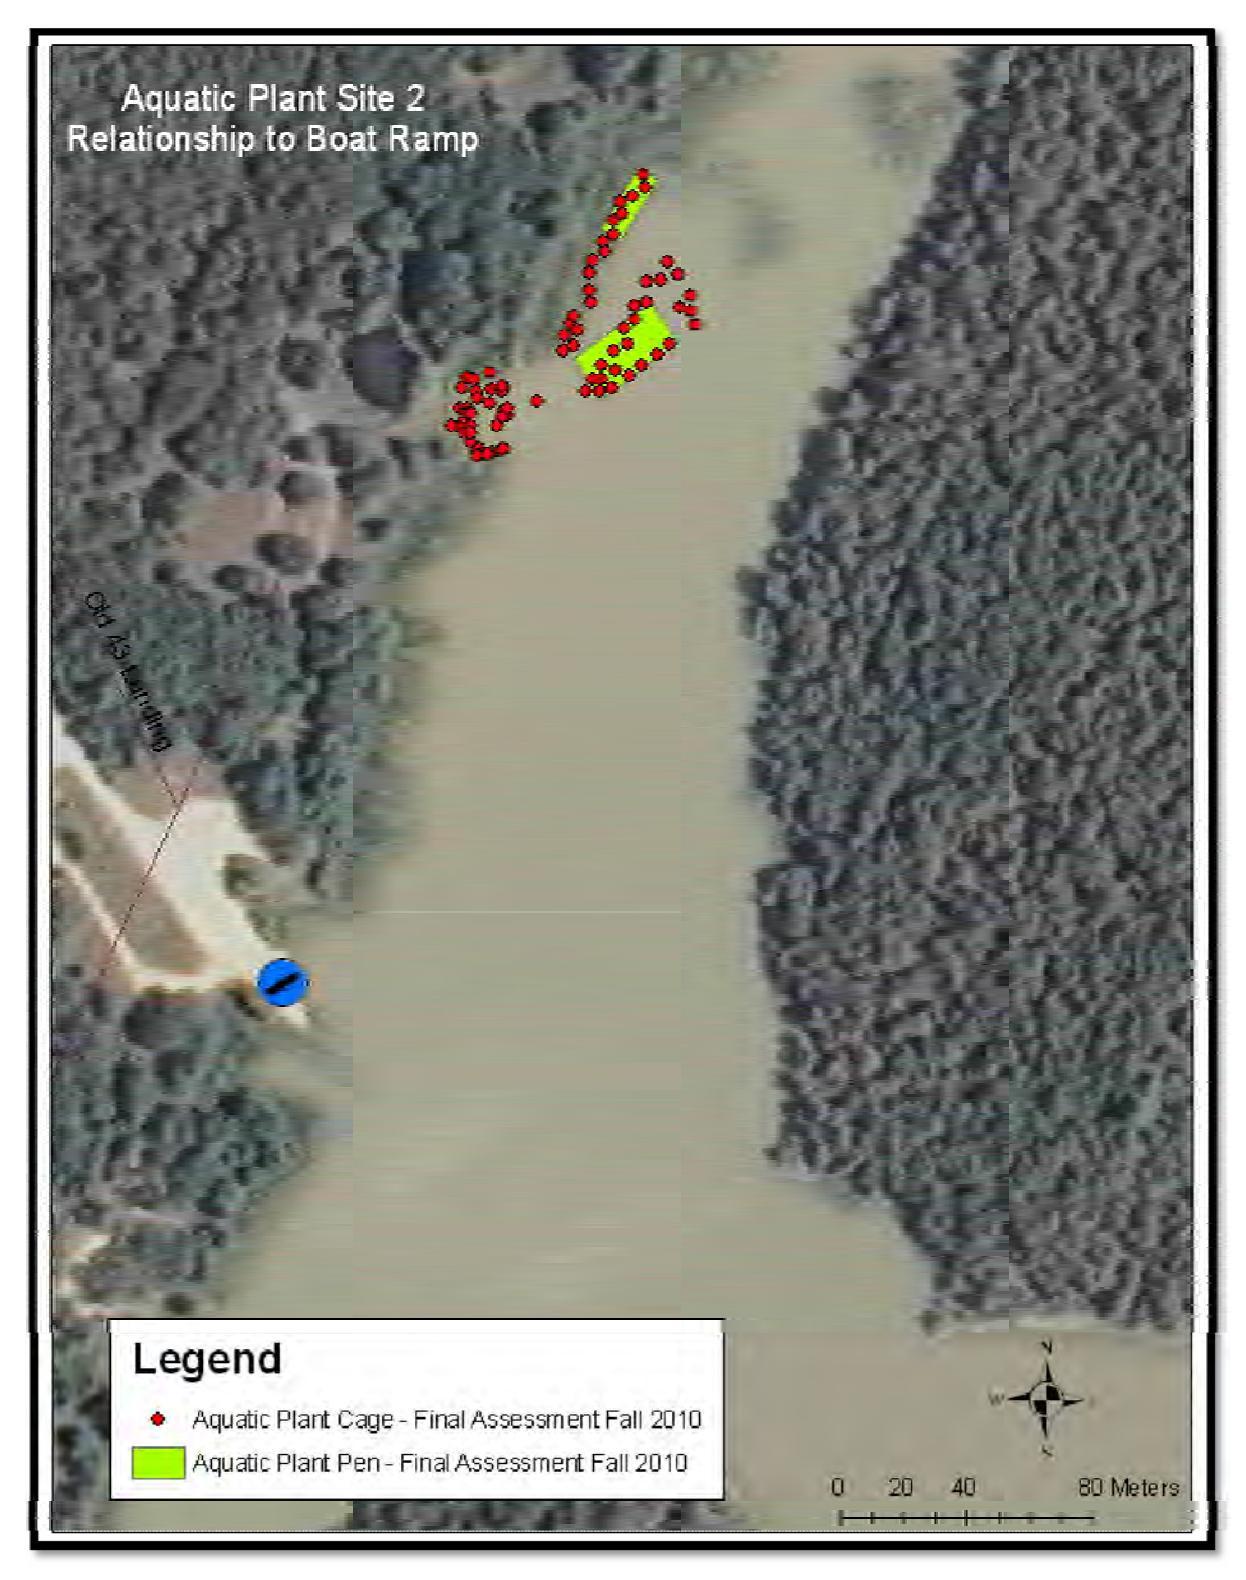
Figure 38: Relationship of Aquatic Plant site 2 to boat ramp (blue icon) where unprotected propagules were found reproducing.

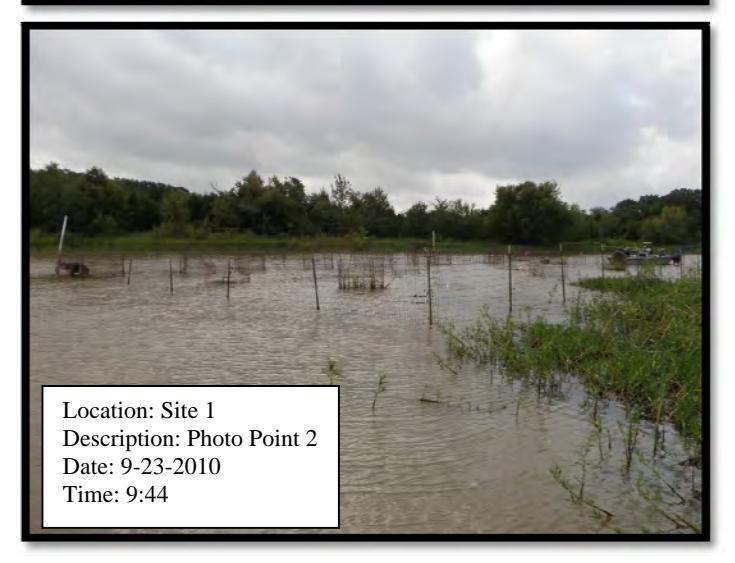
Two preexisting species in particular are worth noting at Atoka Lake. The first, Justicia americana (American Water-willow) is a native species found in Atoka Lake, and it was identified at several locations throughout the lake by LAERF and Owen Mills during the site selection trip. Justicia americana was planted in year one of the project, but it was not planted in subsequent plantings, simply because there was no need to plant it. Over the course of the project, Justicia americana experienced tremendous growth at all project sites, and it was coming in on its own from the pre-existing seed bank, see Figure 40. At the final assessment not only was Justicia americana growing in the cages where it was planted, it was also a predominant species at all of the sites and was growing inside other cages, inside the pens and outside the protected areas. It's possible the three years of protection from predators allowed it to produce the numbers of propagules necessary to overcome the herbivory pressure. Another speculation is that the water levels over the project timeframe provided the perfect conditions for the proliferation of Justicia americana. Whatever the circumstances, we feel confident that Justicia americana has been successfully established at Atoka Lake. Figure 41 illustrates the spread of Justicia americana at site 1 over the course of the project.

Figure 41: Spread of *Justicia americana* at site 1; upper photo taken fall 2008, middle taken fall 2009, and lower taken fall 2010

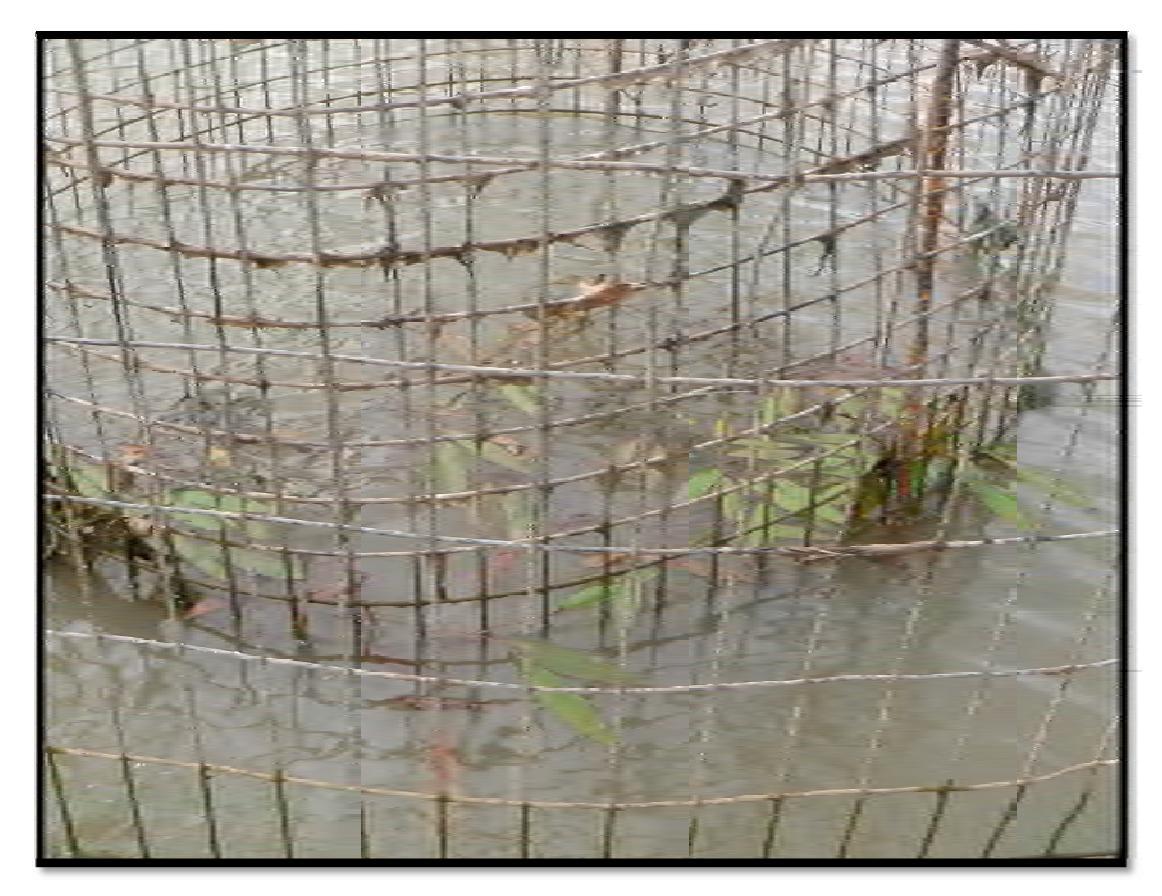
The primary focus of this project was to establish "founder colonies" that would, over time, produce quantities of seeds and fragments to disseminate across Atoka Lake creating wetland habitat along much of the shoreline. Because of the relatively high turbidity, the initial objective was to focus on emergent plant species as a means of controlling erosion. When the conditions are right, "bumper crops" are able to be produced and colonies can be established despite herbivore pressure. The quick success of emergent plants allowed efforts to assess the feasibility of floating leaved and submerged plant species in Atoka Lake to add to the diversity of the aquatic plant community, increase habitat and improve water quality within the lake. Figure 43 shows the successful emergent plants growing at site 3 in September 2010 and Figure 44 shows a cage of *Potamogeton nodosus*, at the final assessment.

Figure 44: *Potamogeton nodosus* growing in a penned cage - final assessment, September 2010
