# HYDROGRAPHIC SURVEY OF DAVE BOYER (WALTERS) LAKE

**Prepared by:**  
**Oklahoma Water Resources Board**

December 20, 2005

# DAVE BOYER (WALTERS) LAKE HYDROGRAPHIC SURVEY REPORT

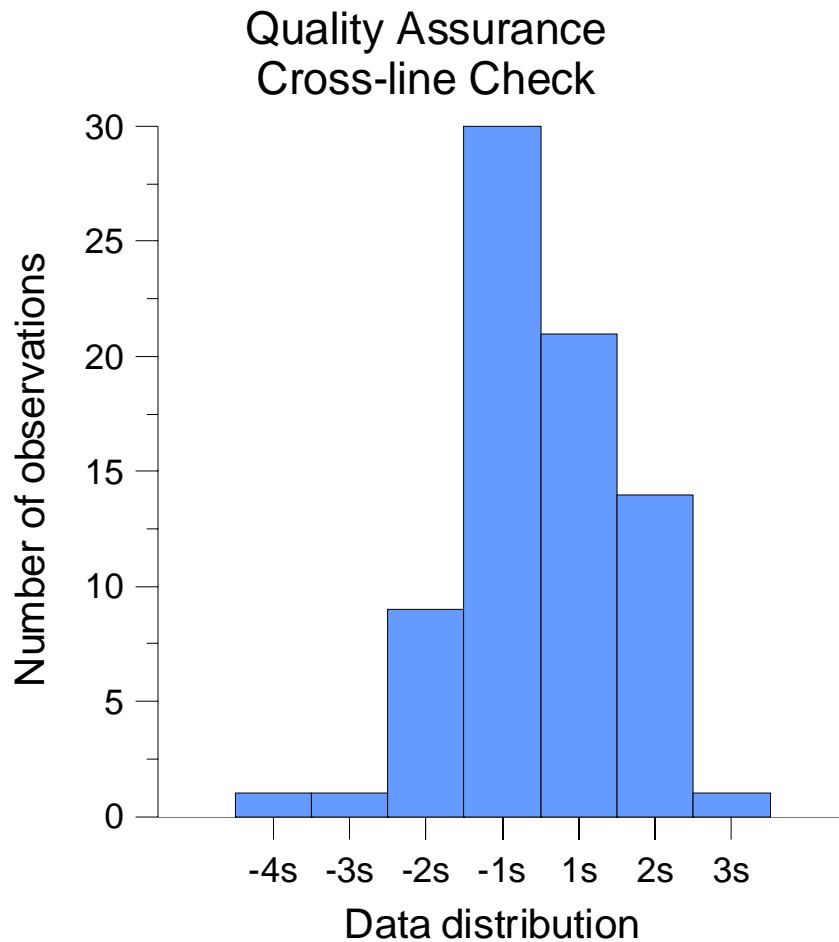
The data plotted in **Figure 2** illustrates that the measurements have high precision, high repeatability, and high absolute accuracy. It must be noted that high precision or repeatability does not necessarily indicate high accuracy. Tightly scattered data may be highly accurate, whereas highly repeatable data could have large undetected biases (USACE, 2002). These error estimates likely represent the inner limits of the survey error. There was no wind present the day the survey took place; wind has a tendency to bias the data set. Were there a higher percentage of data collected from cross-sections near creek channels (if they existed) the error estimate would likely be more than reported due to creek channels being where the sharpest changes in depth occurs.

**Figure 2: Histogram of relative depth distribution, in standard deviations, at cross-line intersections.**

A mean difference of 0.02 ft and a standard deviation of 0.25 ft were computed from a number of 77 data points. Using the following formulas, a 95% depth accuracy of  $\pm 0.07$  ft was calculated.

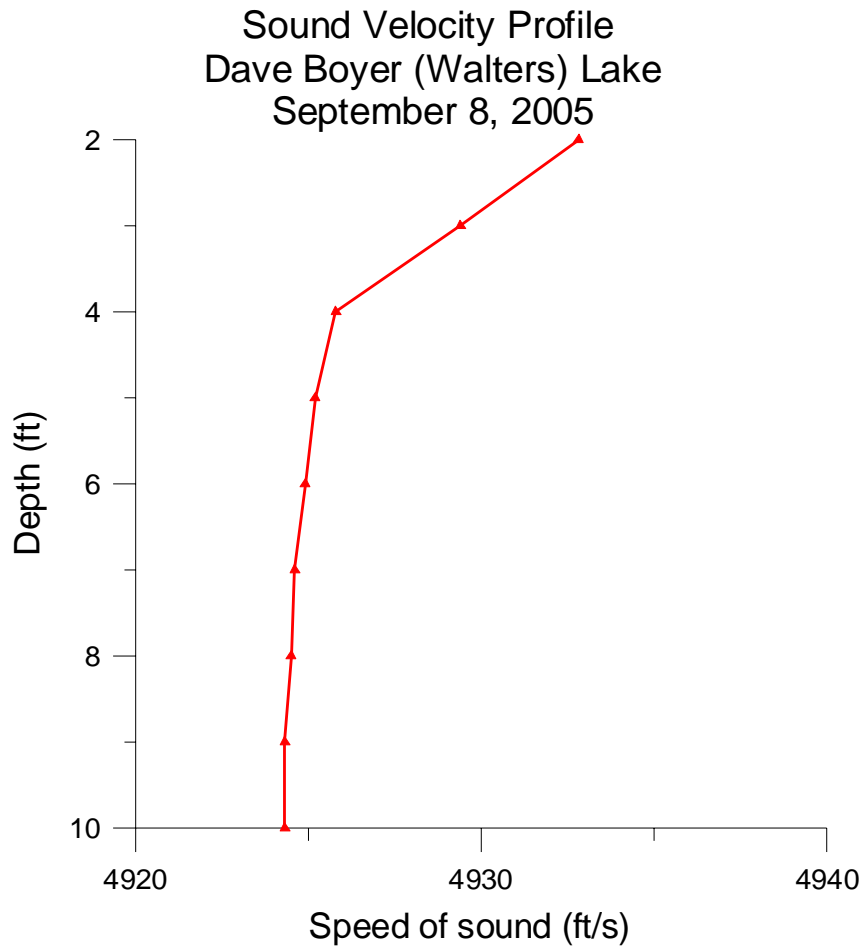
Depth (ft)	9/8/05
2	4932.81
3	4929.40
4	4925.79
5	4925.20
6	4924.90
7	4924.61
8	4924.51
9	4924.31
10	4924.31

**Figure A. 1: Sound Velocity Profiles for September 8, 2005.**

The average speed of sound in the water column was 4,926.20 ft/sec during the Dave Boyer (Walters) Lake survey. The sound velocity profile readings are shown in **Appendix A**.

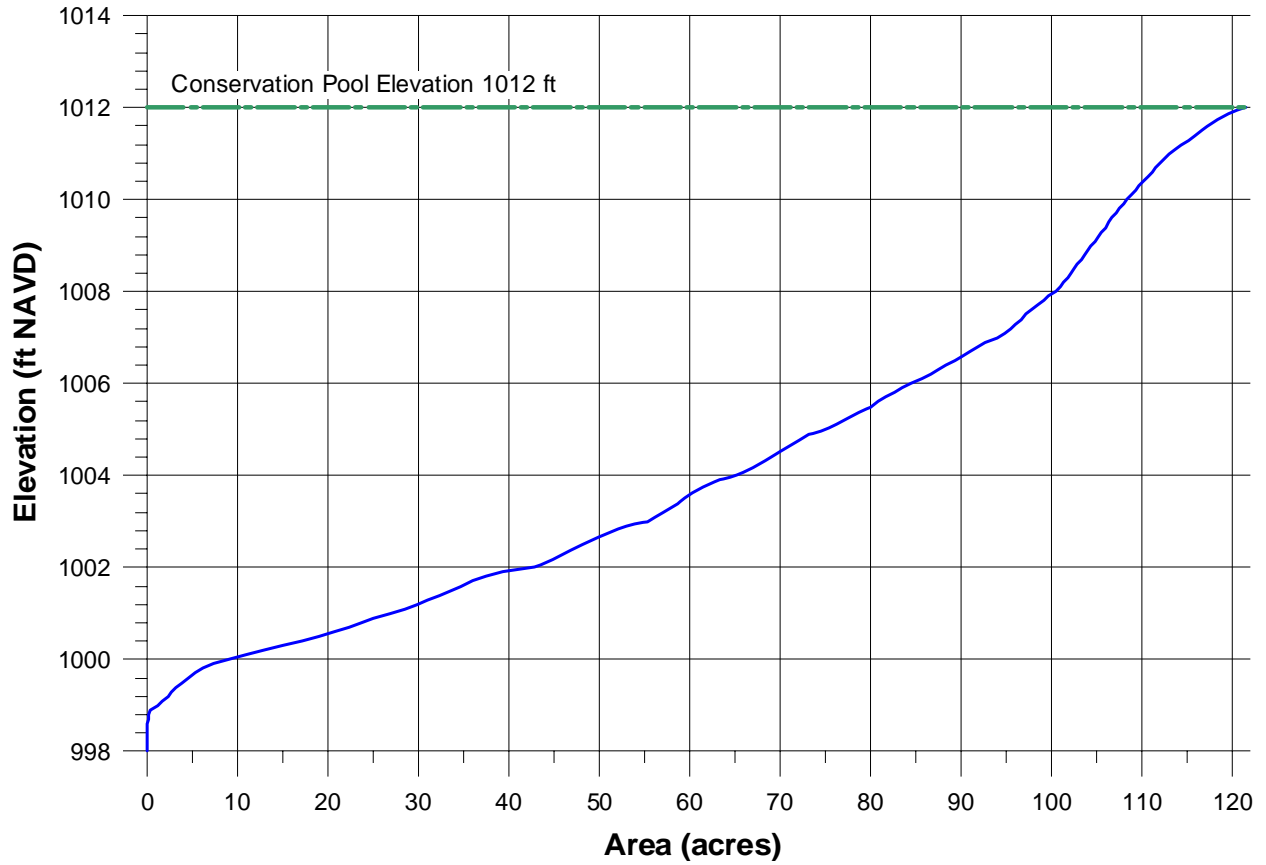
Dave Boyer (Walters) Lake  
Cumulative area by elevation  
September 8, 2005 Survey  
Oklahoma Water Resources Board

Figure B. 1: Dave Boyer (Walters) Lake Area-Elevation Curve.

Volumetric and area calculations were derived using a TIN surface model. The TIN model was created in ArcInfo, using the collected survey data points and the lake boundary inputs. The TIN consists of connected data points that form a network of triangles representing the bottom surface of the lake. Approximately 4,313 data points were used to create the TIN model. The lake volume was calculated by slicing the TIN horizontally into planes 0.1 ft thick. The volume and area of each slice are shown in **Appendix B**.

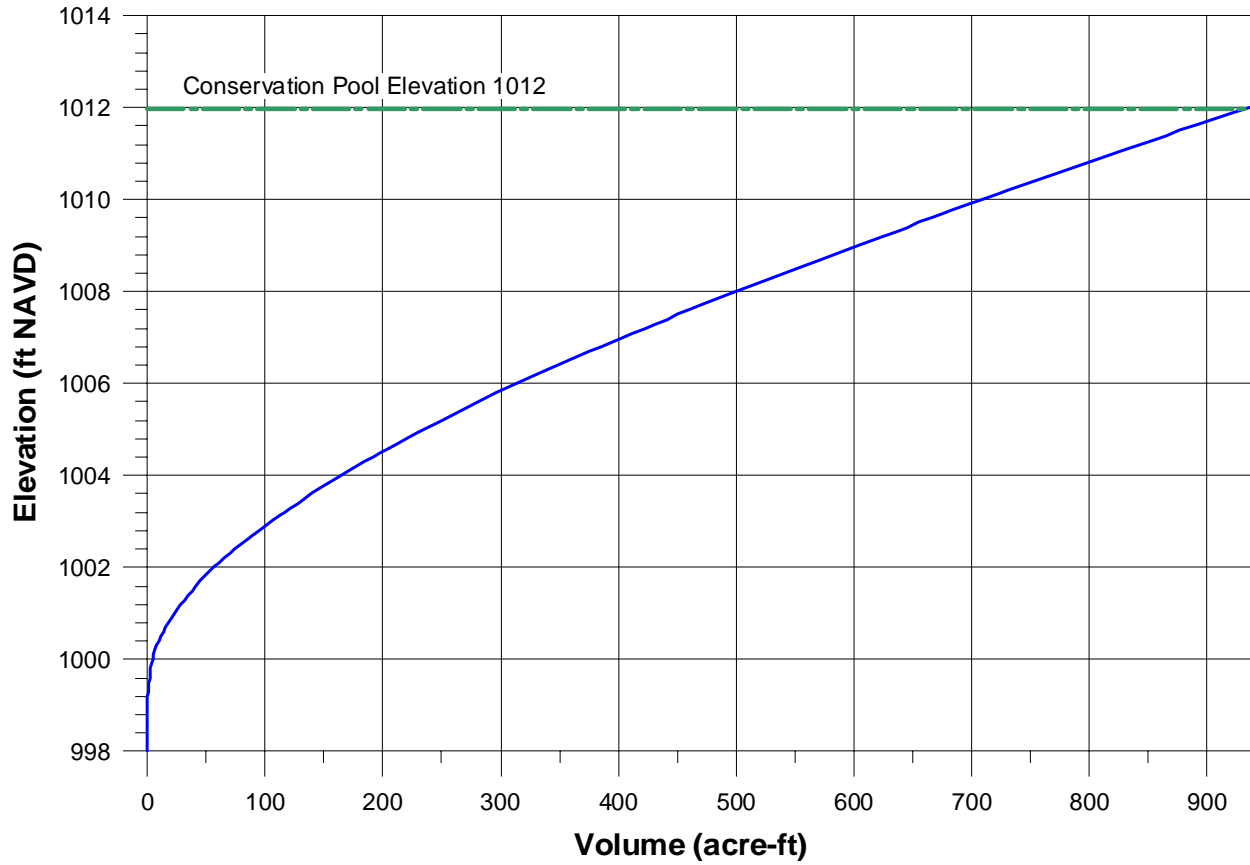
Dave Boyer (Walters) Lake  
Cumulative volume by elevation  
September 8, 2005 Survey  
Oklahoma Water Resources Board

Figure B. 2: Dave Boyer (Walters) Lake Volume-Elevation Curve.

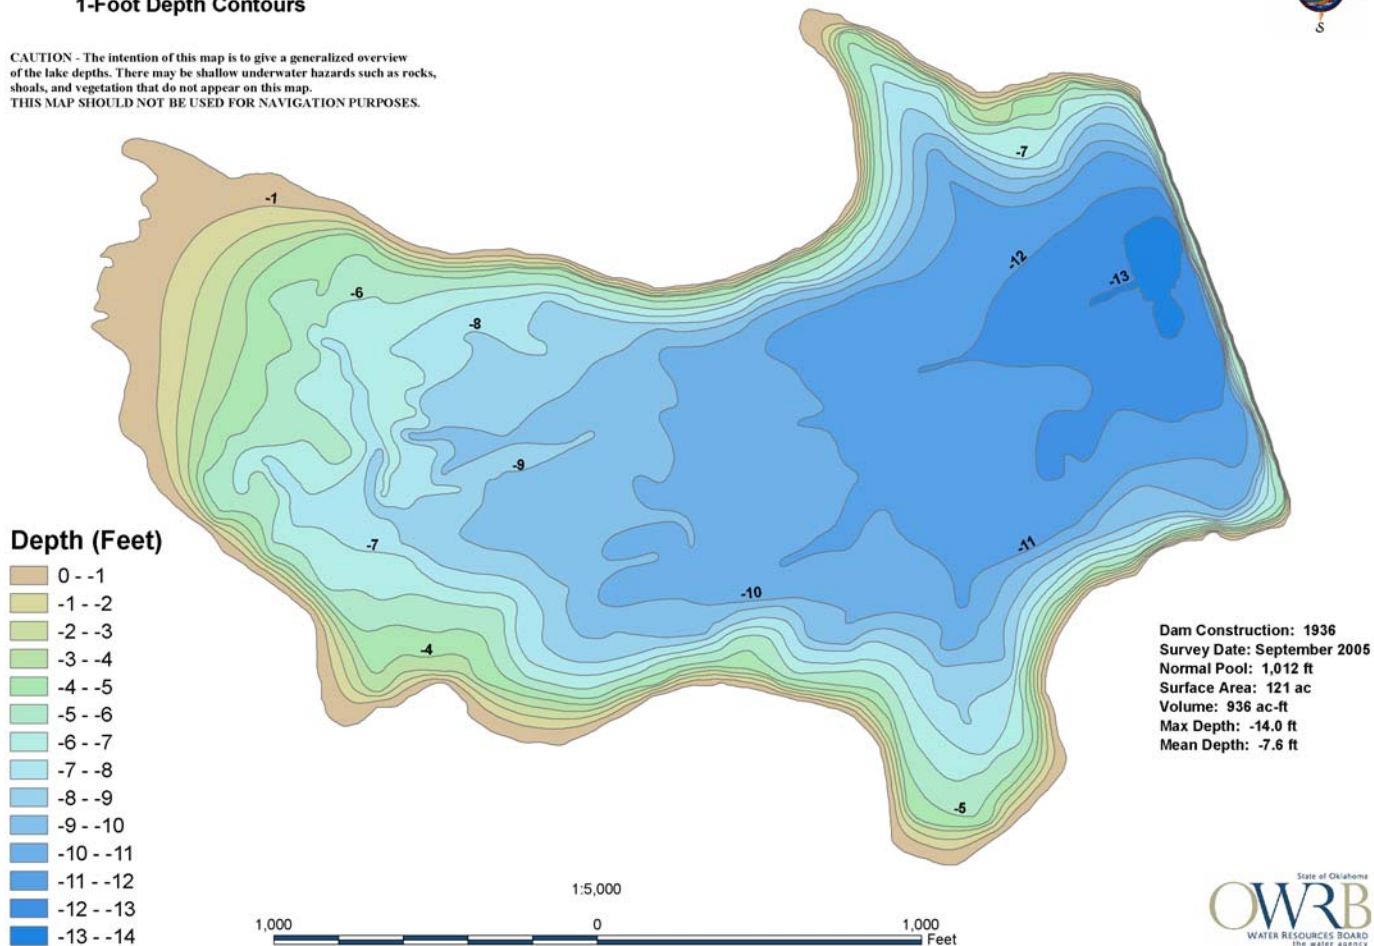
Figure C. 1: Dave Boyer (Walters) Lake Bathymetric Map with 1-foot Contour Intervals.

had a spatial resolution of 10 ft. A low pass 3x3 filter was run to lightly smooth the grid to improve contour generation. The contours were created at a 1-ft interval using the ArcInfo LATTICECONTOUR command. Some contour lines required editing to allow for polygon topology and to improve general smoothness of the lines. The contours were then converted to a polygon coverage and attributed to show 1-ft depth ranges across the lake. The bathymetric map of the lake is shown with 1-ft contour intervals in **Appendix C**.

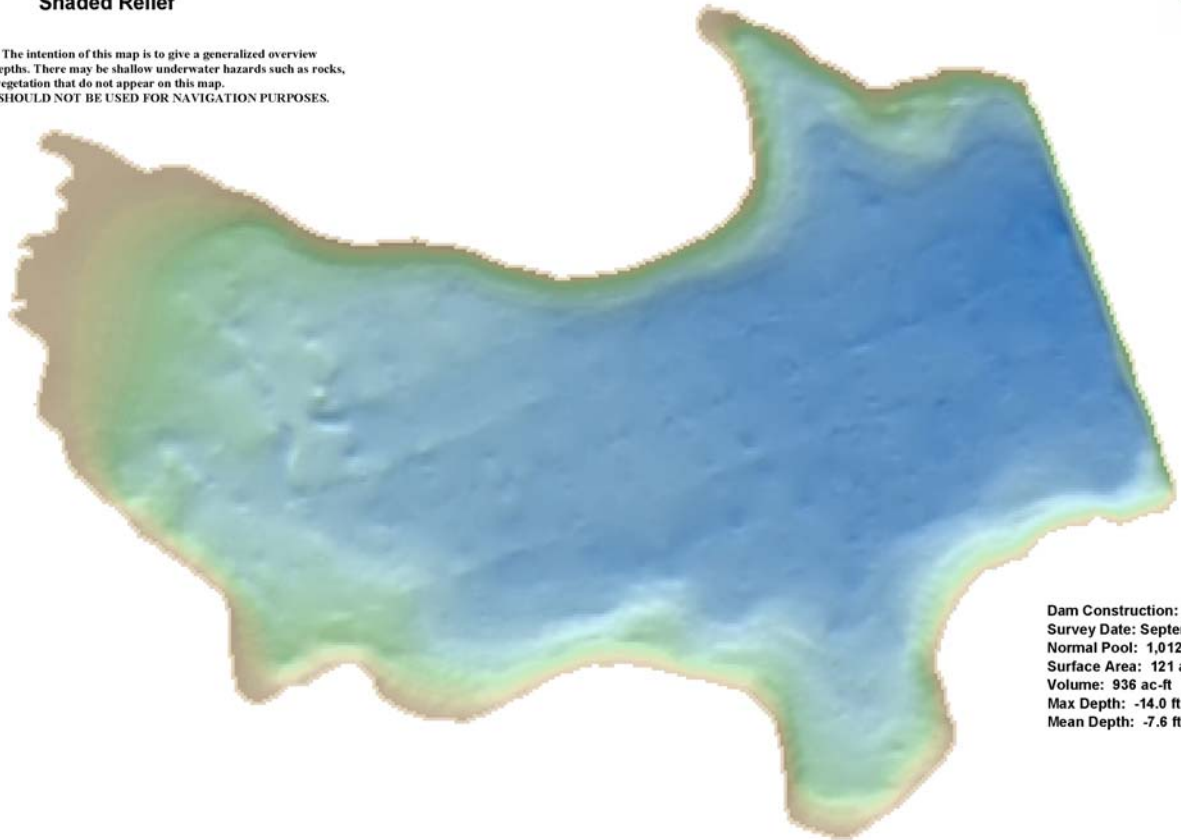
Dam Construction: 1936  
Survey Date: September 2005  
Normal Pool: 1,012 ft  
Surface Area: 121 ac  
Volume: 936 ac-ft  
Max Depth: -14.0 ft  
Mean Depth: -7.6 ft

Figure C. 2: Dave Boyer (Walters) Lake Shaded Relief Bathymetric Map.

Contours, depth ranges, and the shaded relief map were derived from a digital elevation model grid. This grid was created using the ArcInfo TOPOGRIDTOOL command and

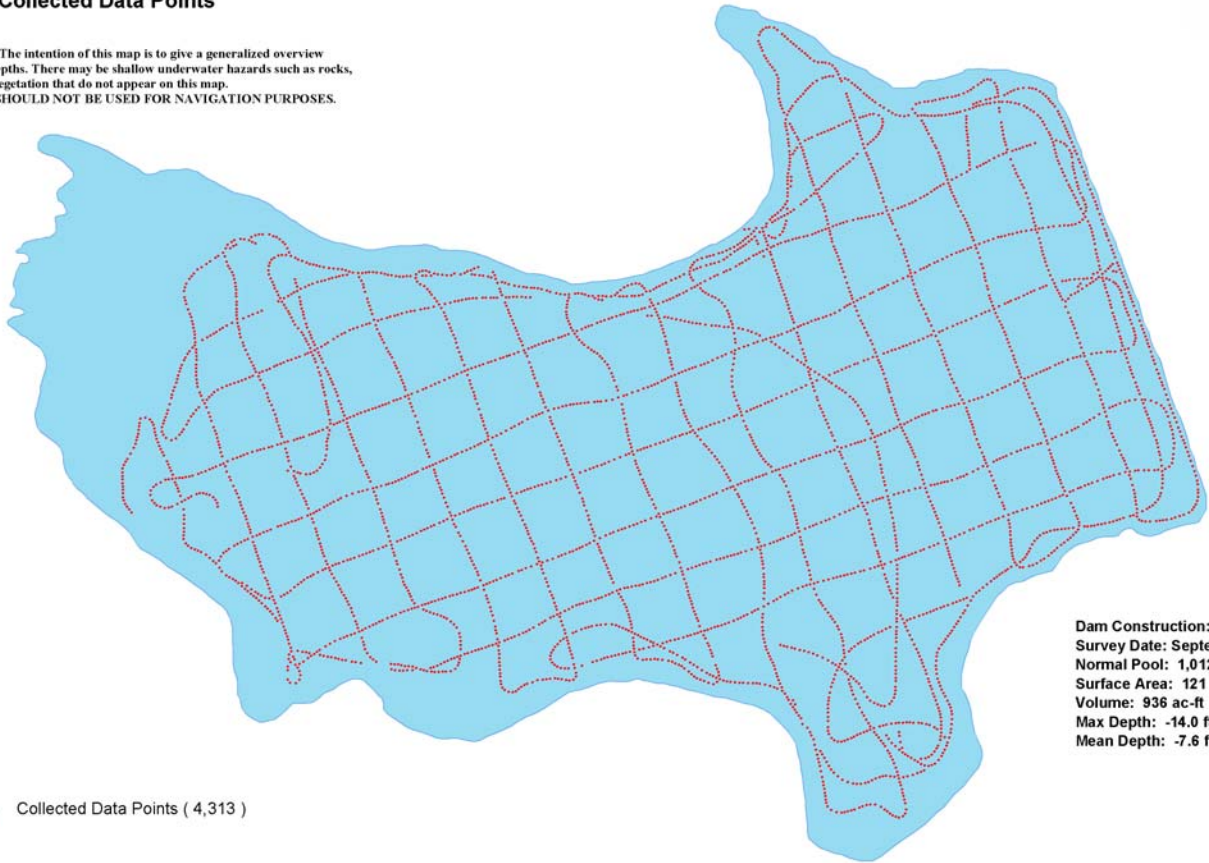
Collected Data Points ( 4,313 )

Figure C. 3: Collected Data Points.

Once the entire lake had been surveyed on transects that ran perpendicular to the shoreline, Hypack software was used to create 14 transects that ran parallel to the shoreline. This formed a grid of survey lines on the lake. It would not be feasible to conduct this method on a reservoir of 1,000 acres or more because it would be too time-intensive. The addition of this method allowed for the best delineation of the lake contours. If data were collected on 200 ft increment perpendicular transects alone, this critical detail would be missing. Data was collected in the upper end of Dave Boyer (Walters) Lake until the boat could no longer navigate in the shallow waters **Appendix C**.

The crew was able to collect data on 16 of the 17 pre-plotted perpendicular transect lines. Data was collected on all but one of the 14 parallel transect lines created. For all the transects, approximately 4,313 data points were collected while traversing a total of 9.8 US nautical miles. The data points were stored on the boat's computer in 38 data files.
